ASBESTOS INSPECTION REPORT

22 RYE STREET
PROVIDENCE, RI

Report Date: 12.1.2021

EEA PROJECT #: 210914-A

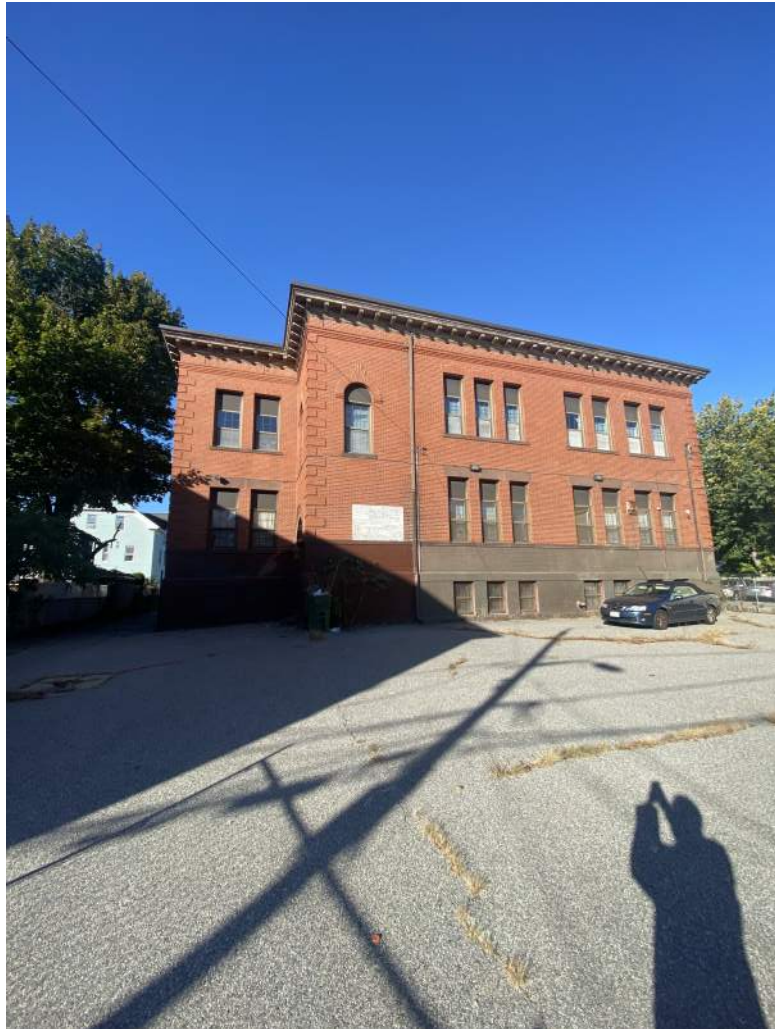
Photograph – 1: Photo depicts the structure as scheduled for planned renovation.

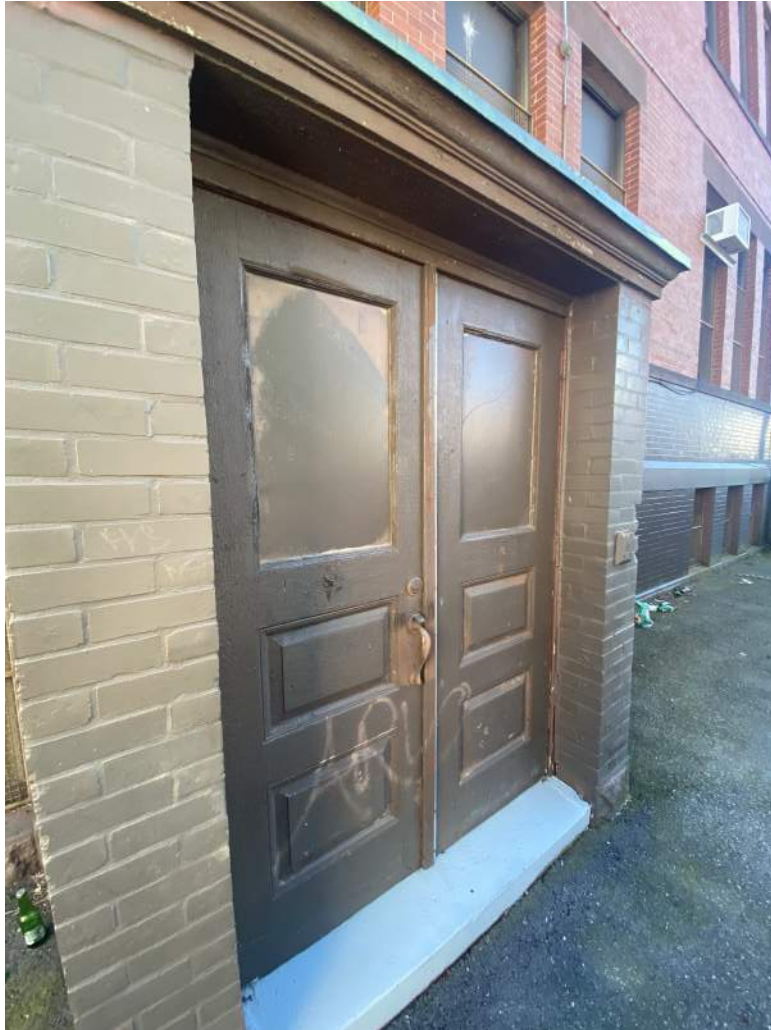
Photograph – 2: Photo depicts the typical application of asbestos caulk at window and door frames throughout the structure.

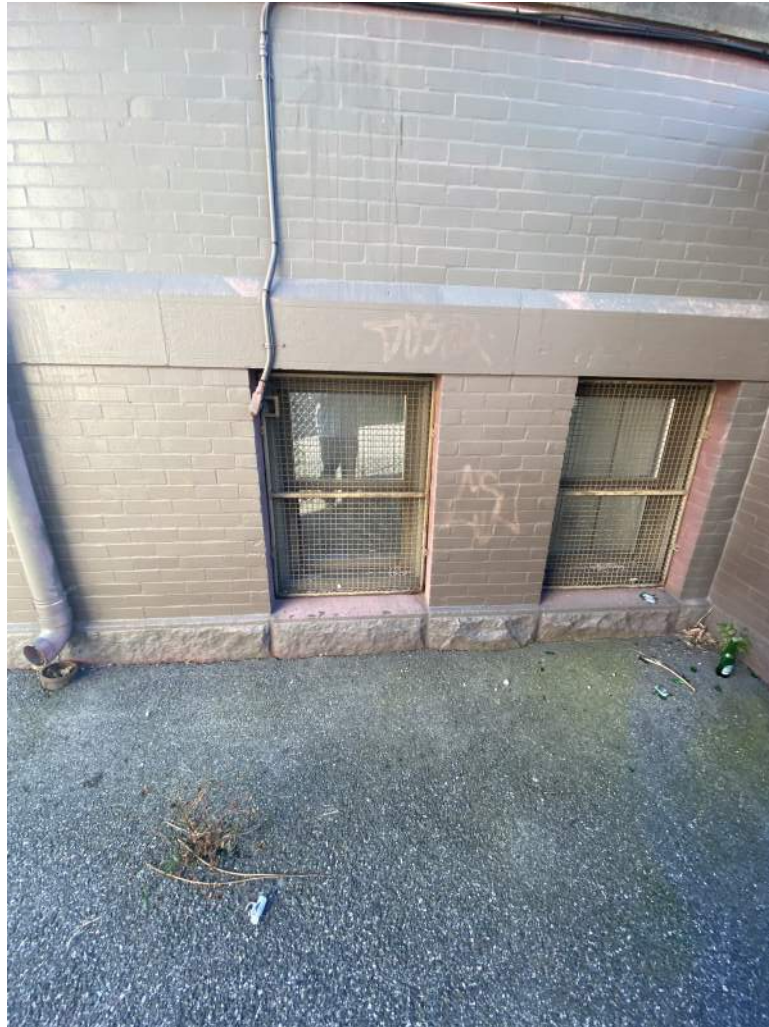
Photograph – 3: Photo depicts the typical application of asbestos caulk at window and door frames throughout the structure.

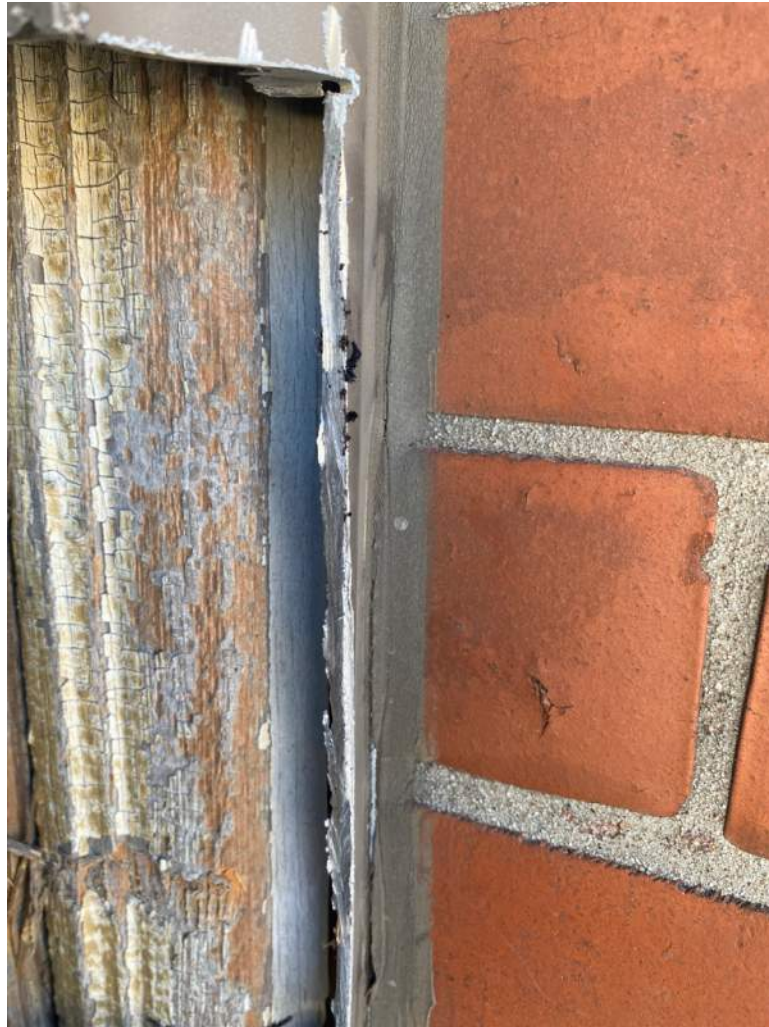
Photograph – 4: Photo depicts the typical application of asbestos caulk at window and door frames throughout the structure. Asbestos caulk is applied to the wood window frames enclosed behind the existing metal double hung windows. The removal of metal windows cannot be done without impact to the existing caulk at the wood window frames throughout

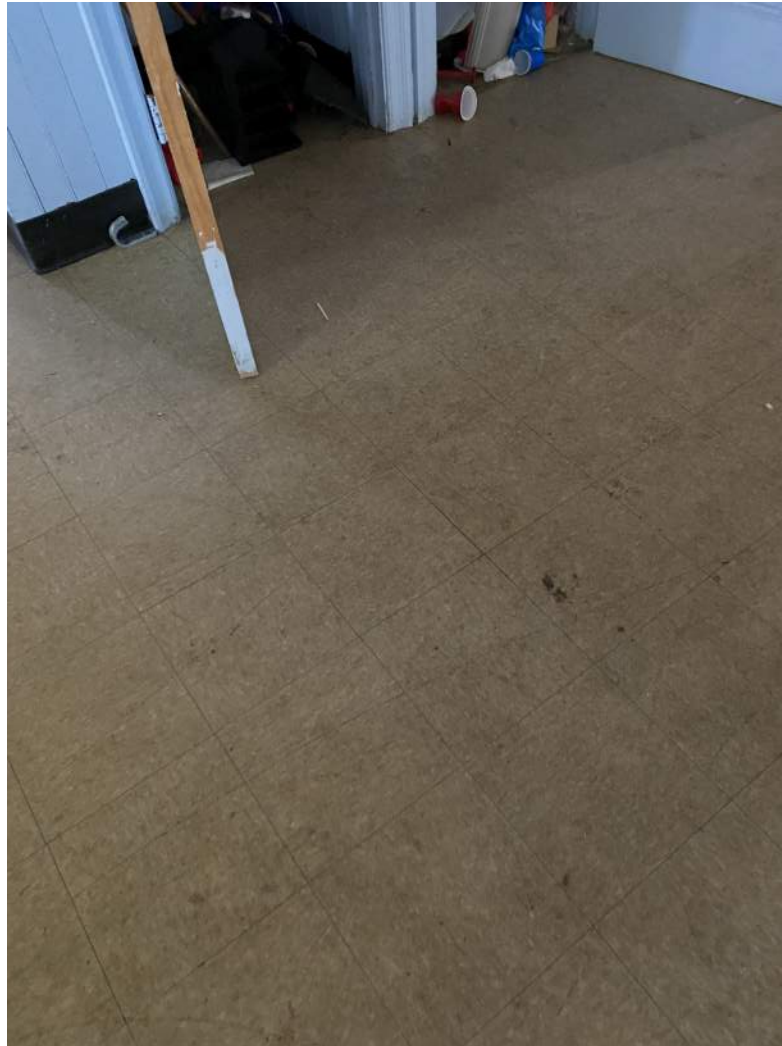
Photograph – 5: Photo depicts the typical application of asbestos vinyl flooring and associated glue throughout the structure, as scheduled for planned renovation.

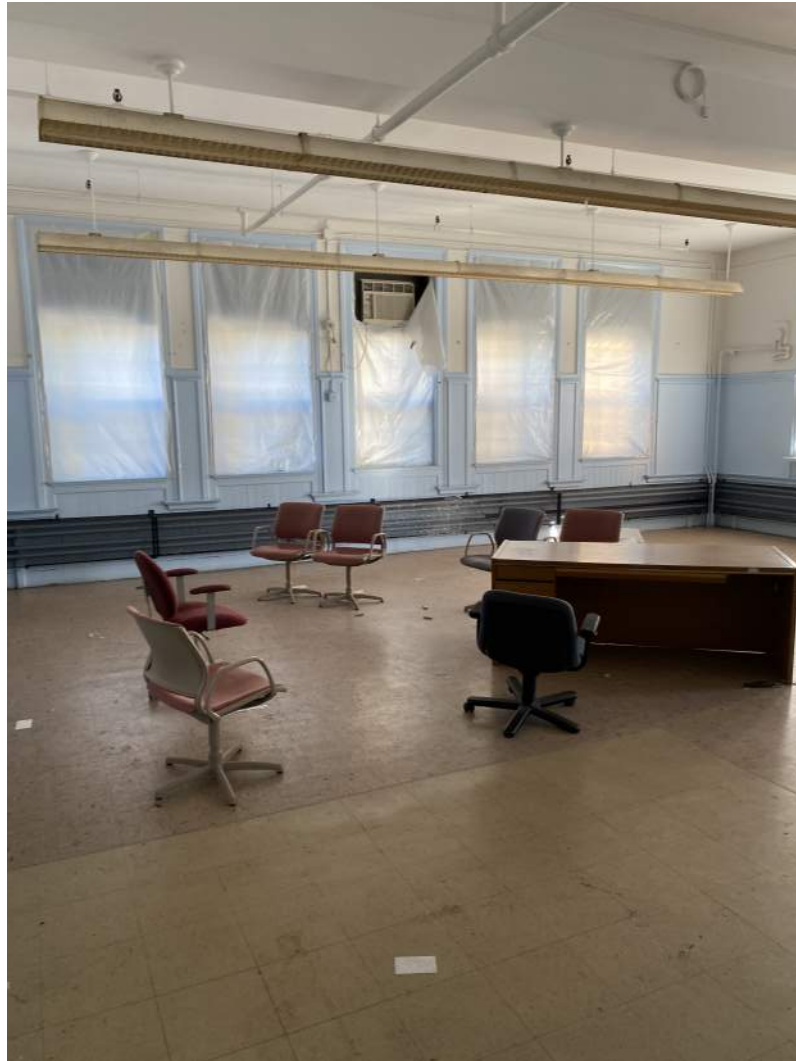
Photograph – 6: Photo depicts the typical application of asbestos vinyl flooring and associated glue throughout the structure, as scheduled for planned renovation.

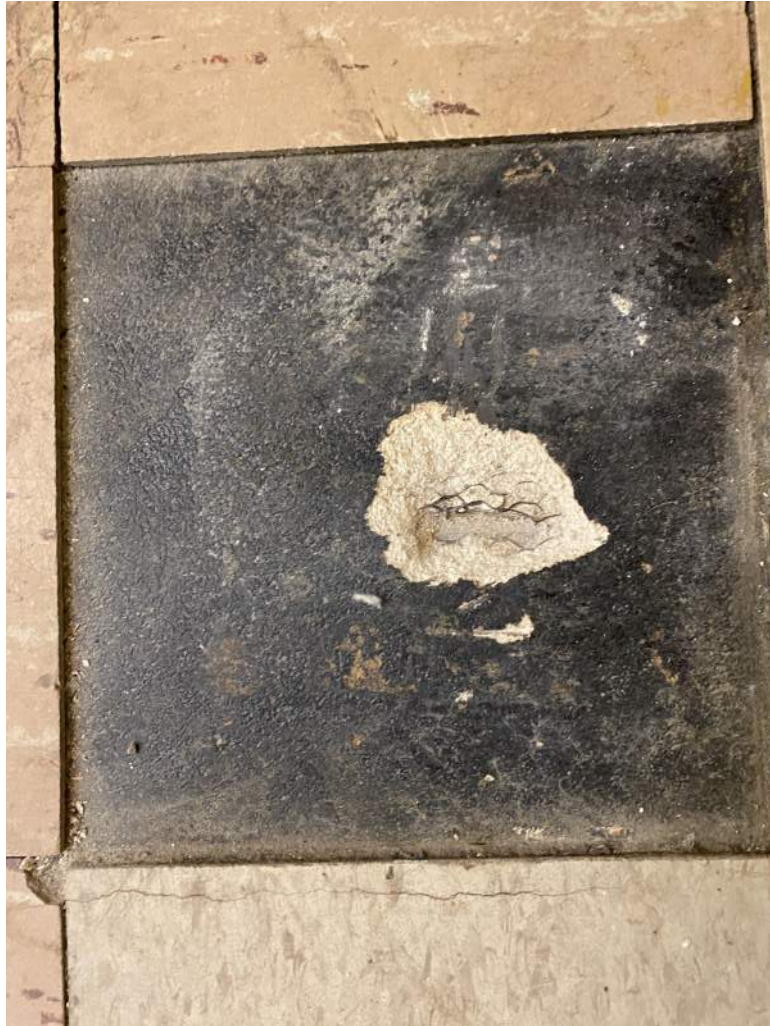
Photograph – 7: Photo depicts the typical application of asbestos concrete floor leveler existing or assumed to be existing at all floor surface areas throughout the structure, as scheduled for planned renovation.

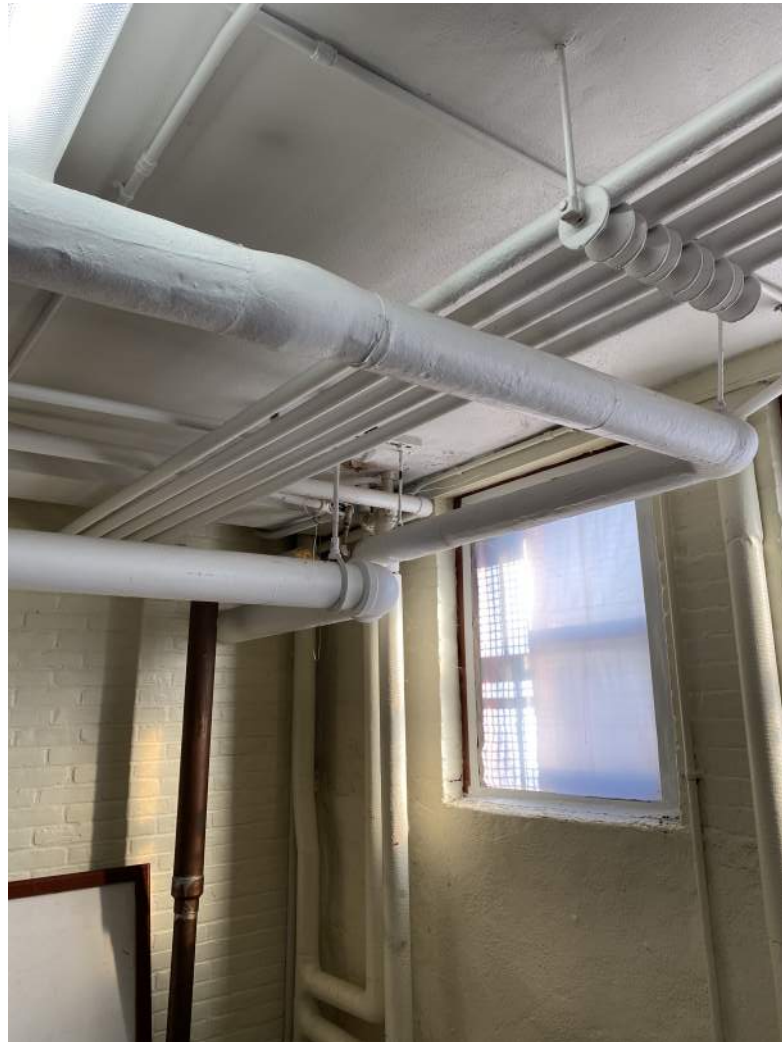
Photograph – 8: Photo depicts the typical application of asbestos thermal pipe insulation as applied to plumbing / heating systems throughout the Basement area of the structure, as scheduled for planned renovation.

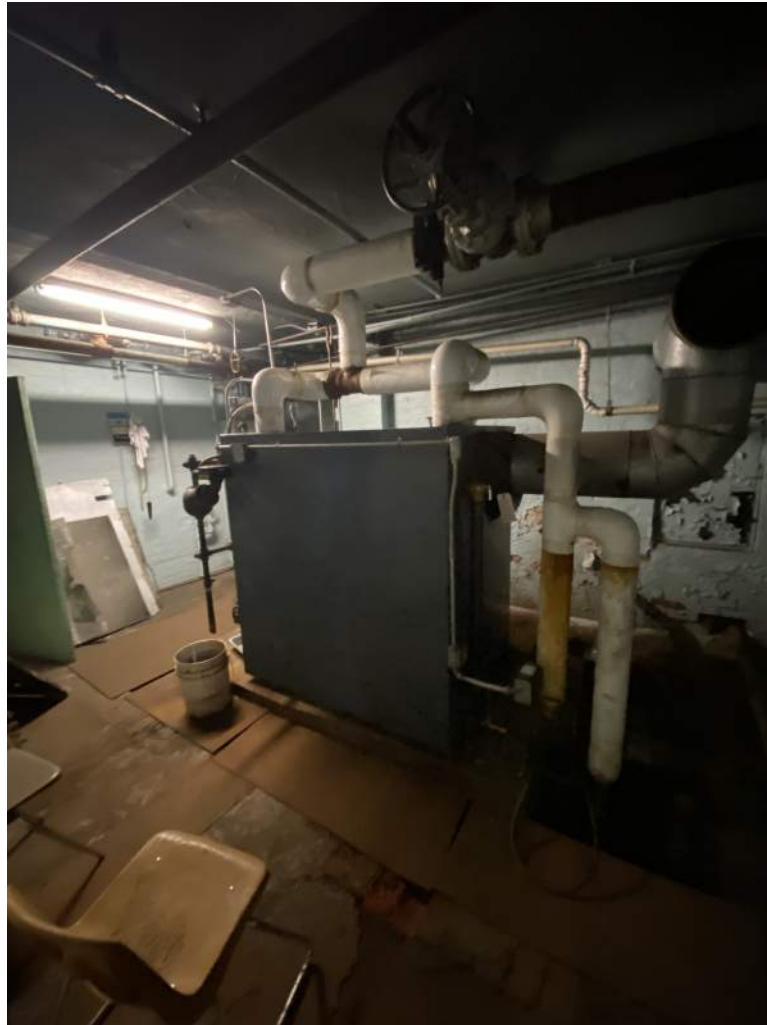
Photograph – 9: Photo depicts the existing boilers within the structure. These boilers are assumed to contain asbestos gasketing and packings. Additional investigation of the boilers should be conducted prior to removal.
