CITY OF PROVIDENCE, RHODE ISLAND

**RFP Title: URBAN DESIGN CONSULTING SERVICES RELATING TO CROOK POINT BRIDGE
PRESERVATION**

Addendum #: 1

A potential respondent has asked for supporting pictures referenced in the bid materials. This addendum adds those pictures.

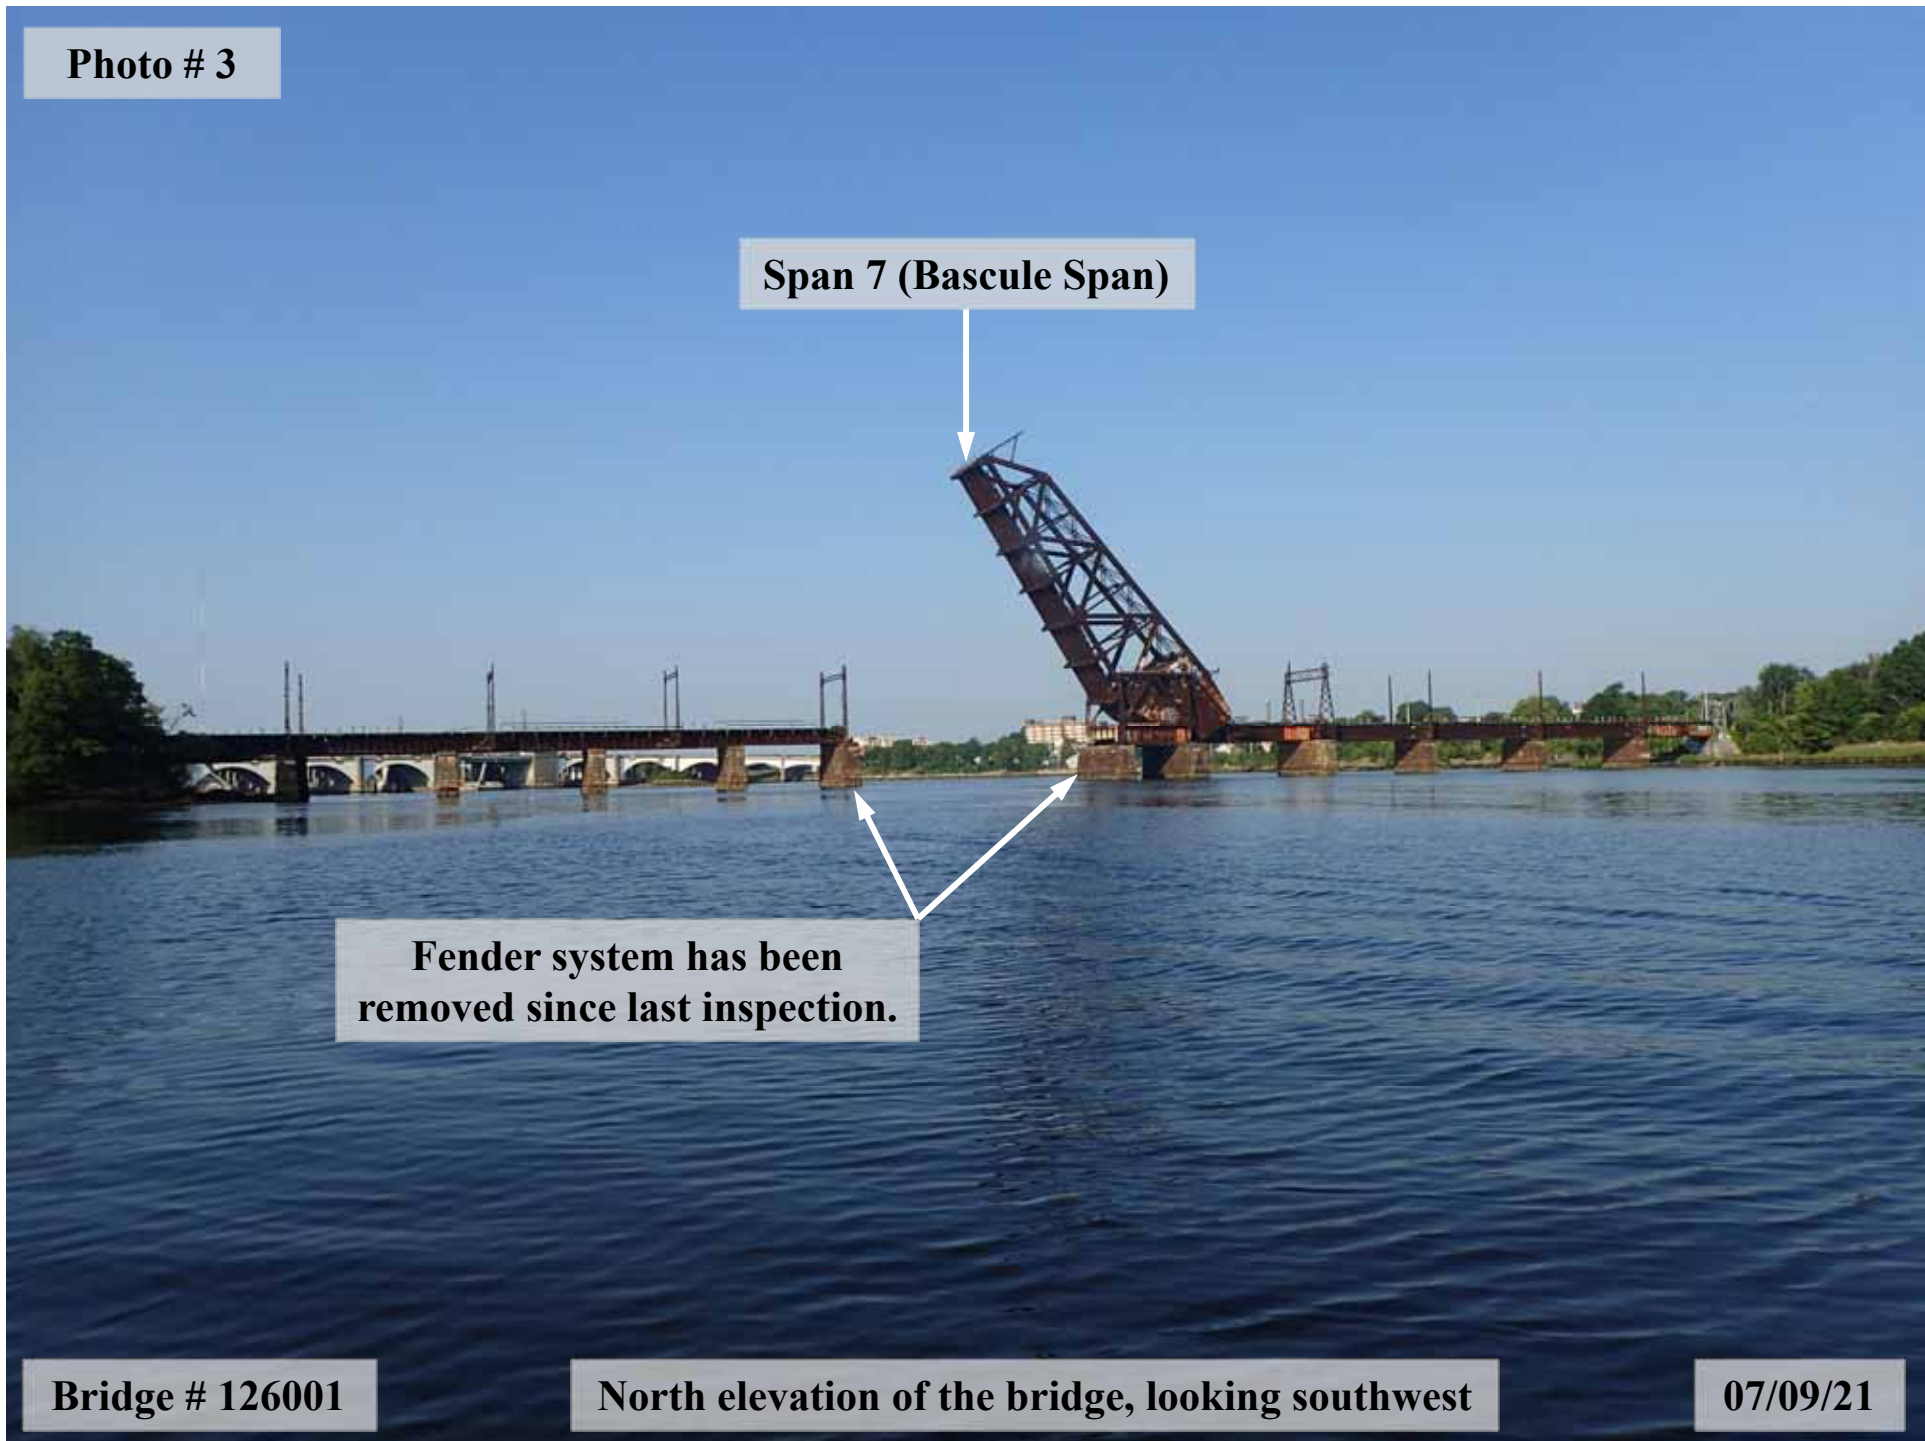
Photo # 3

Fender system has been removed since last inspection.

North elevation of the bridge, looking southwest

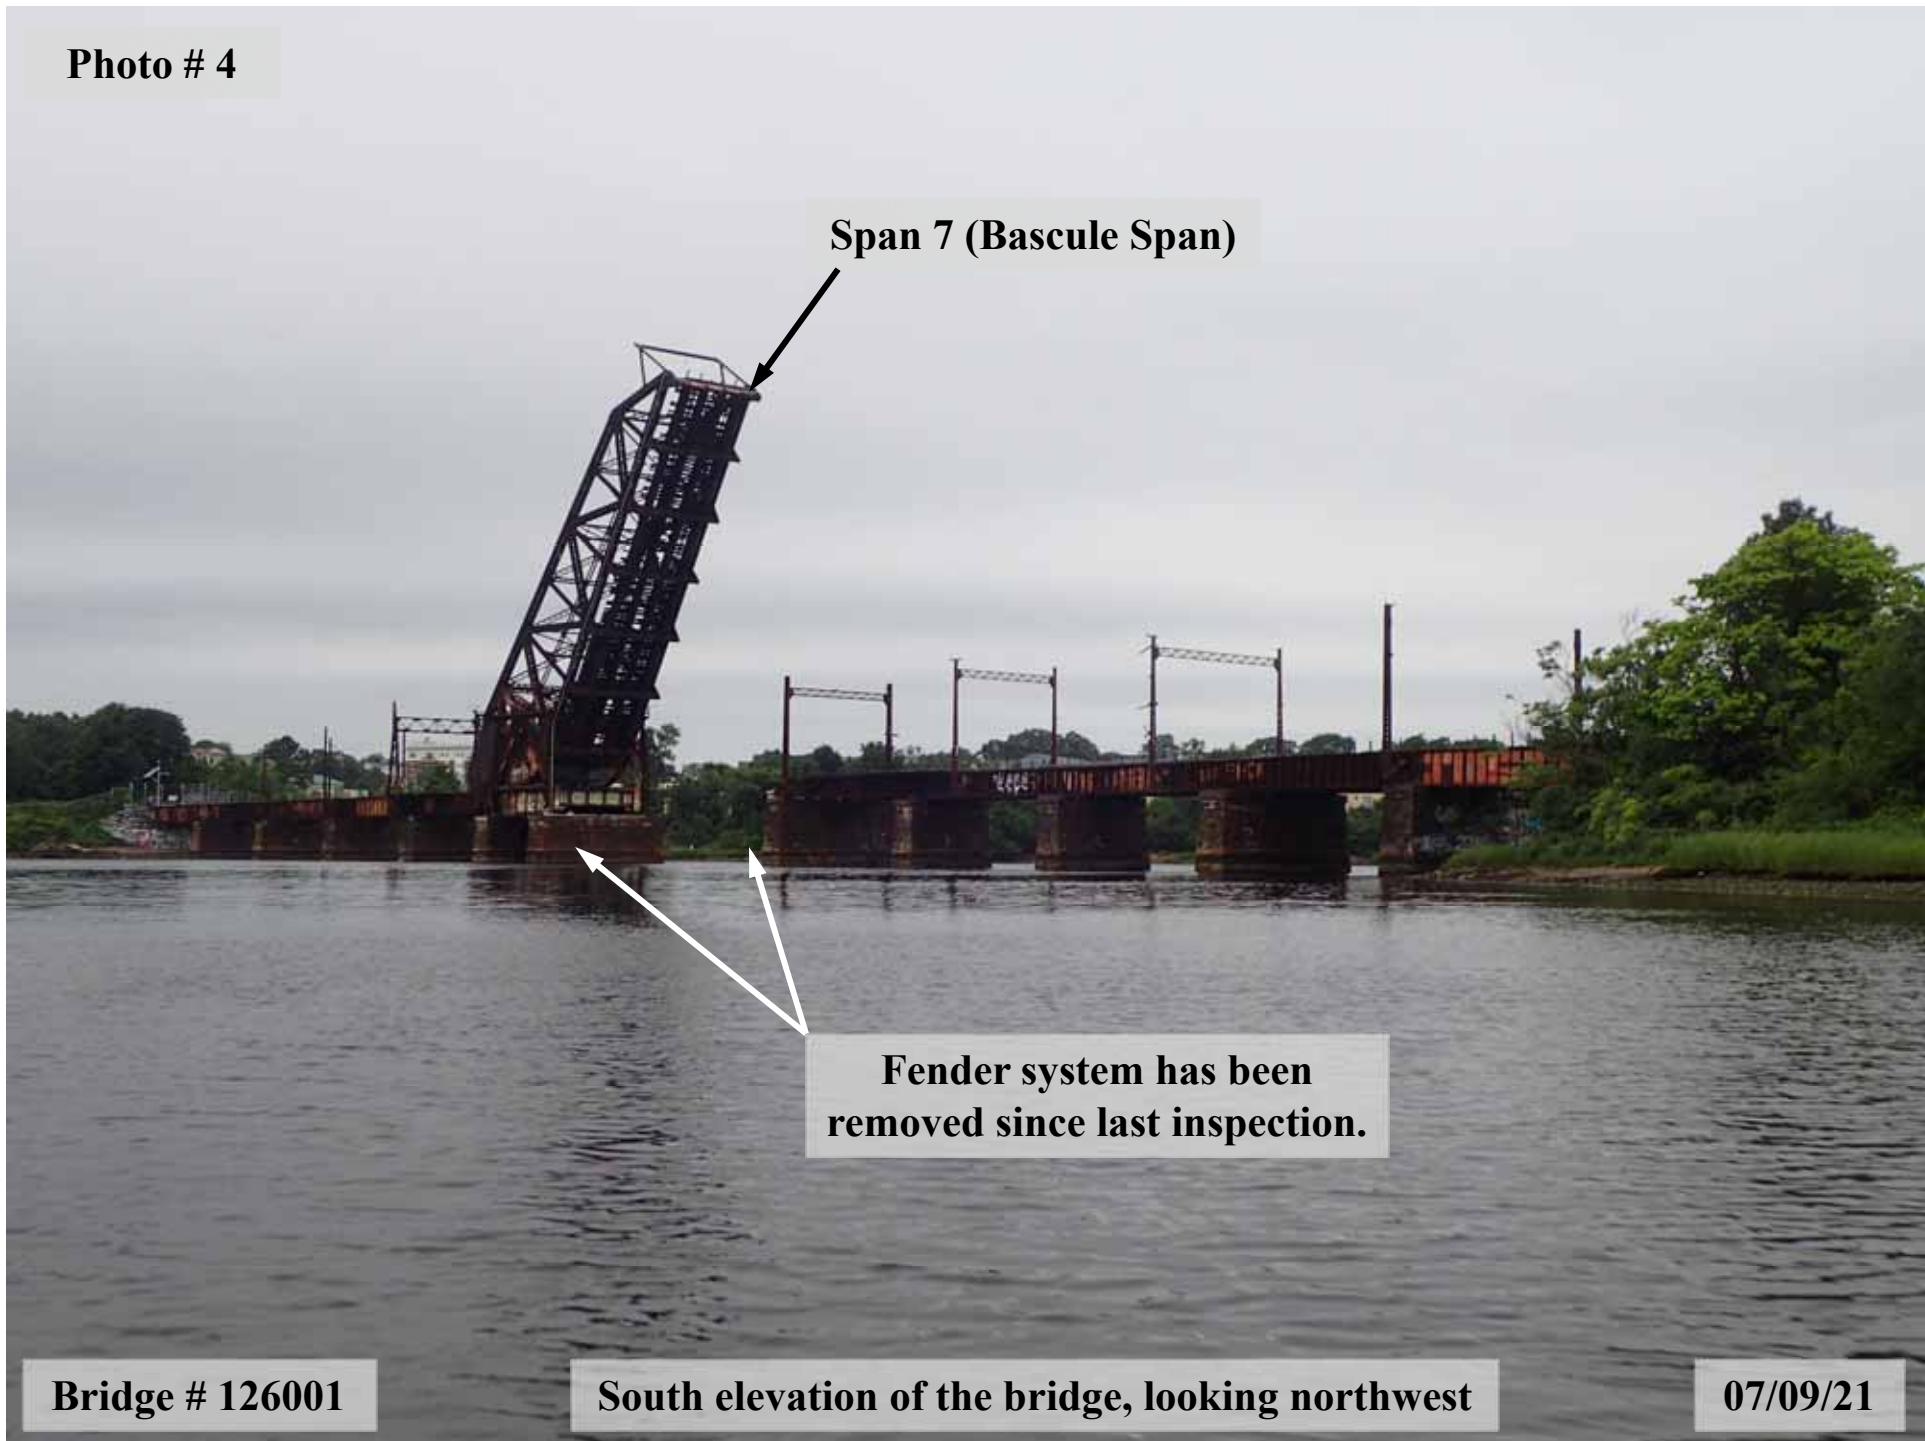
Photo # 4

Fender system has been removed since last inspection.

South elevation of the bridge, looking northwest

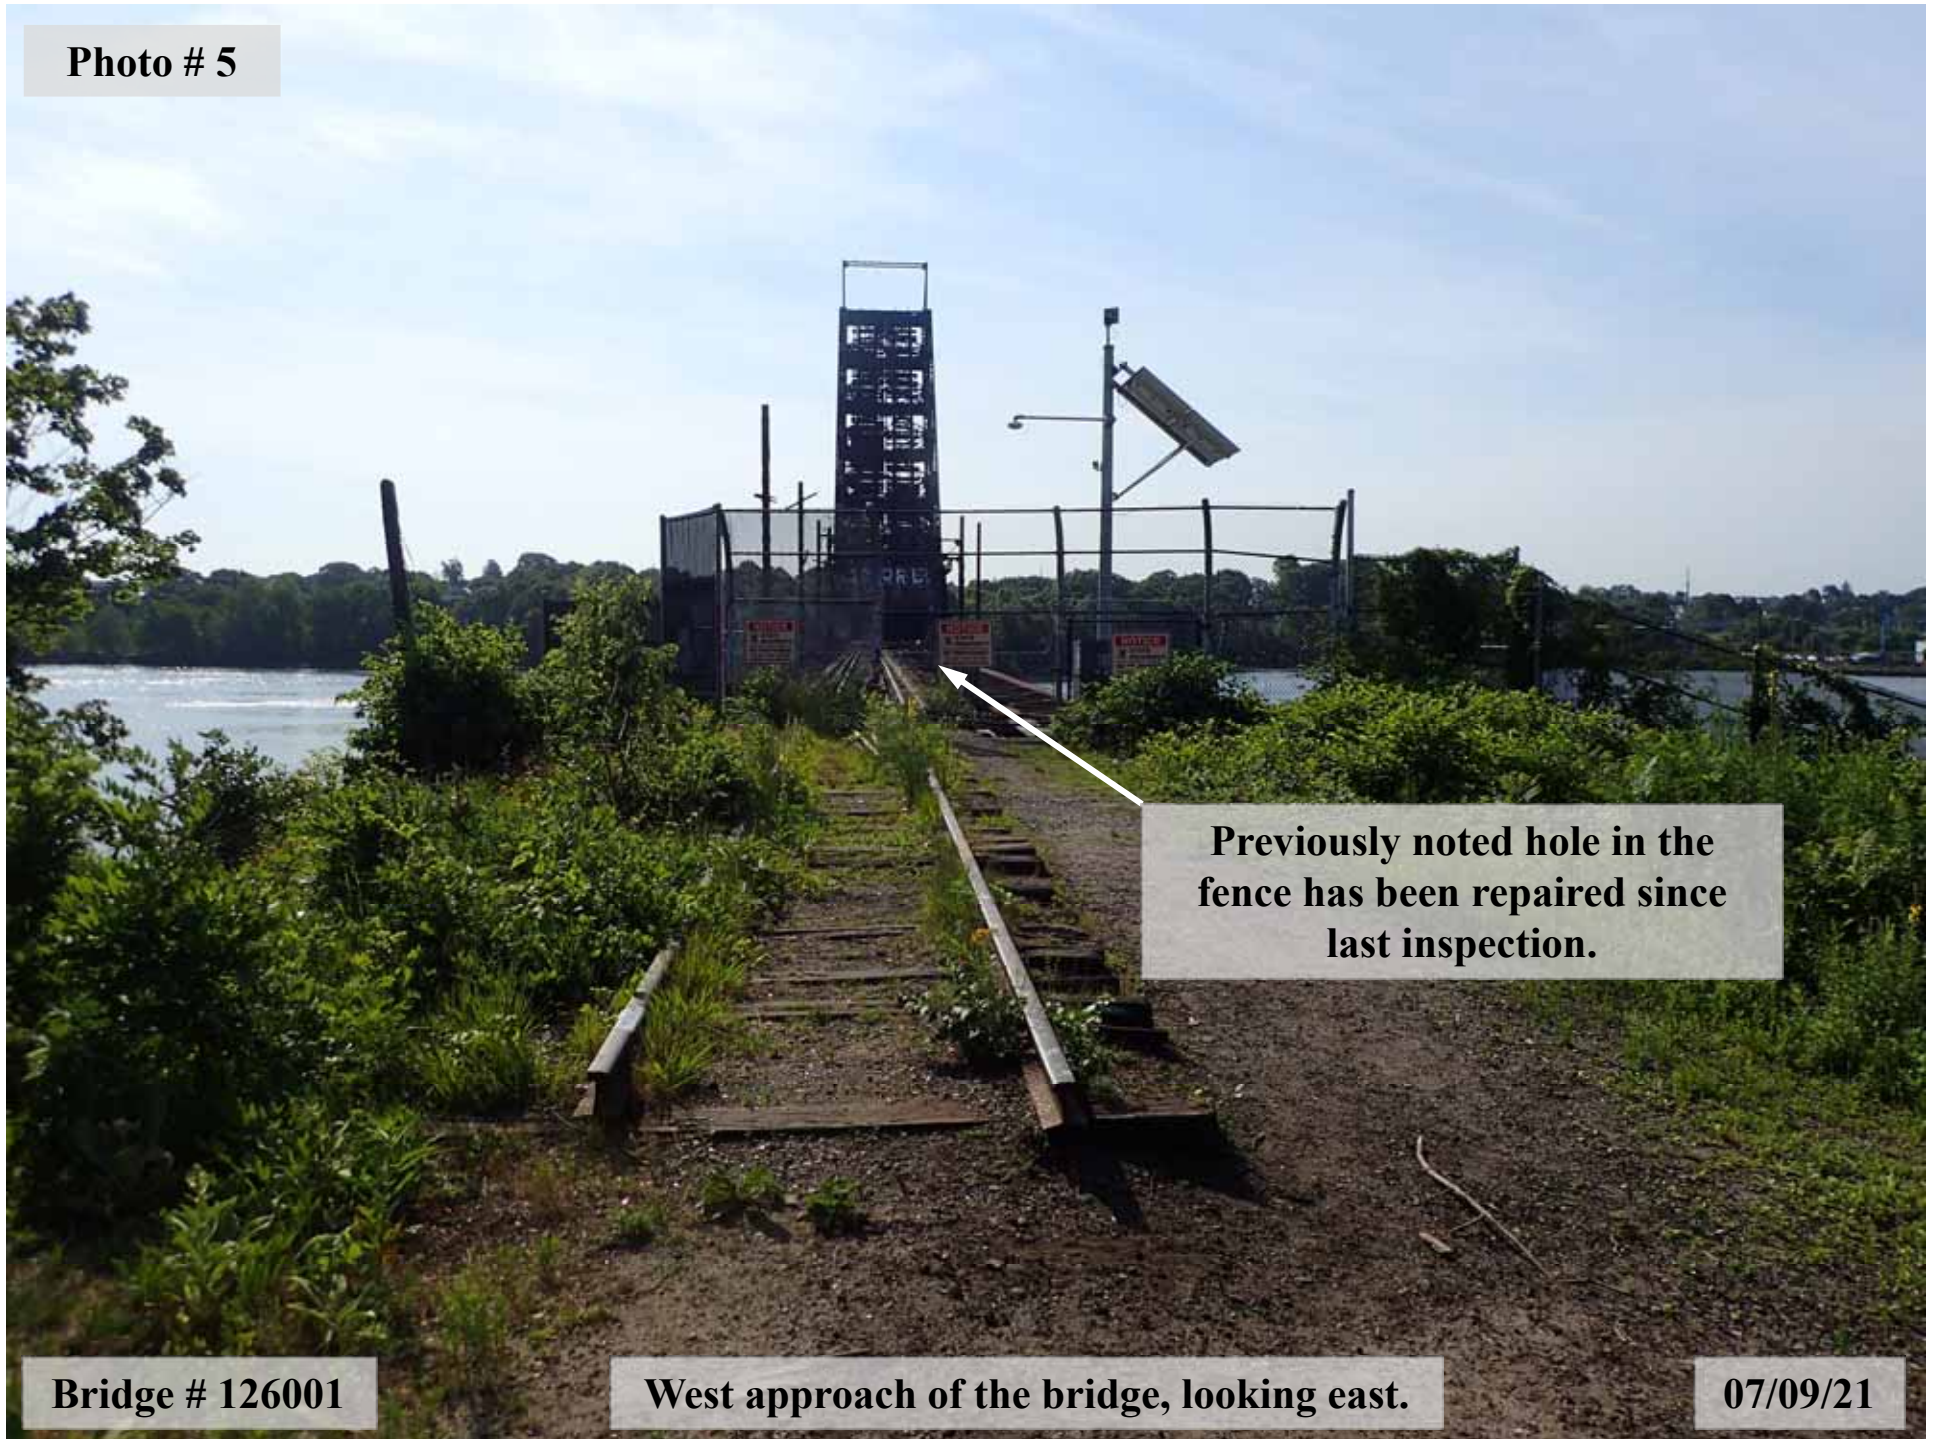
Photo # 5

Previously noted hole in the fence has been repaired since last inspection.

West approach of the bridge, looking east.

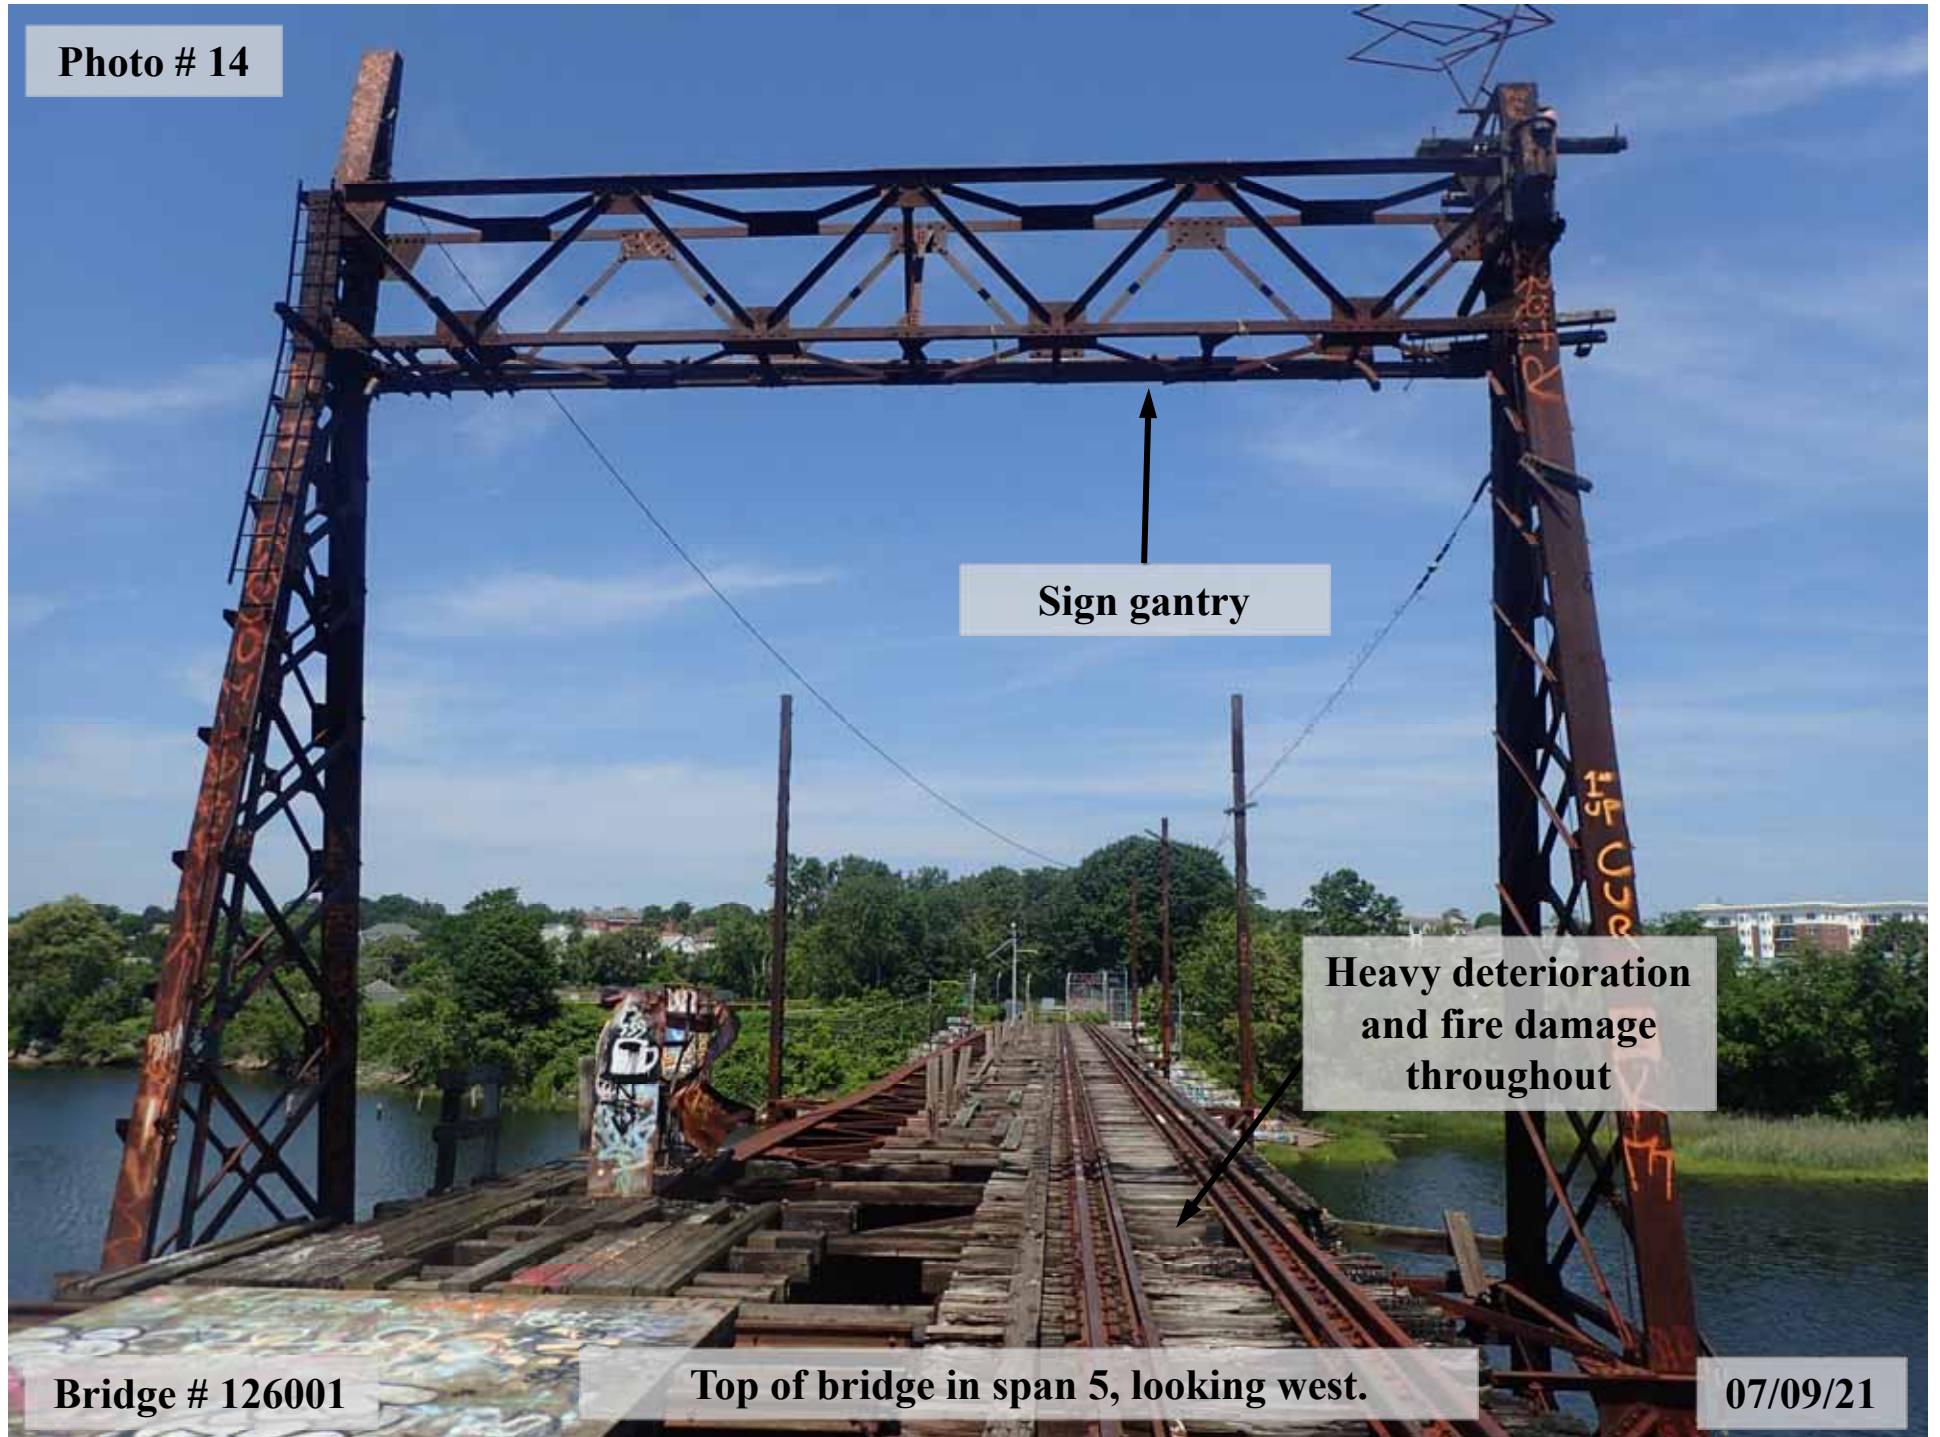
Photo # 14

**Heavy deterioration
and fire damage
throughout**

Top of bridge in span 5, looking west.

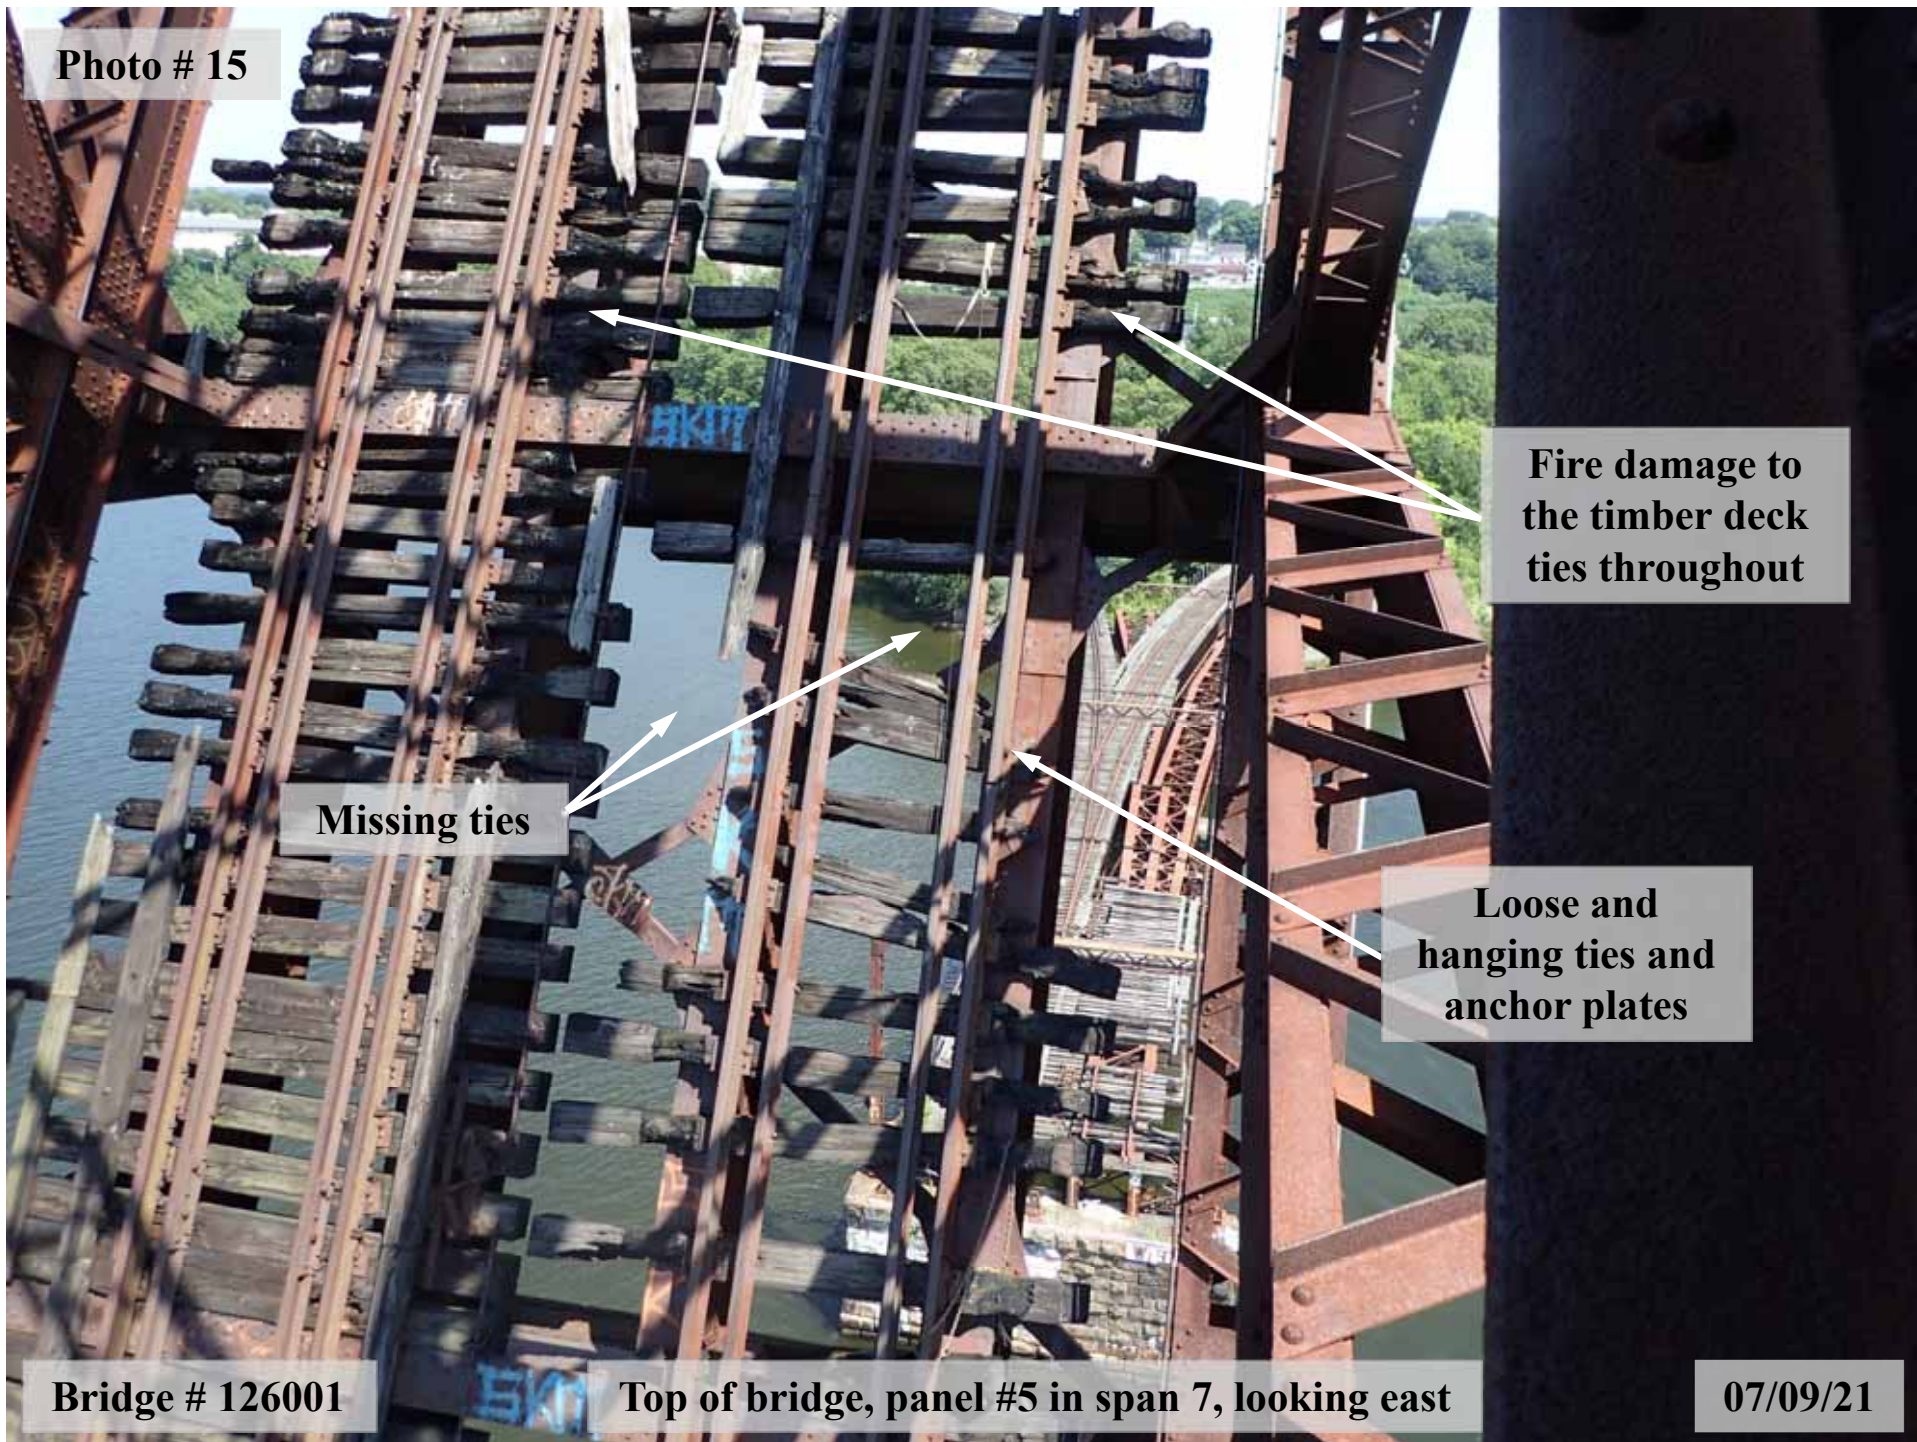
Photo # 15

Missing ties

Fire damage to the timber deck ties throughout

Loose and hanging ties and anchor plates

Top of bridge, panel #5 in span 7, looking east

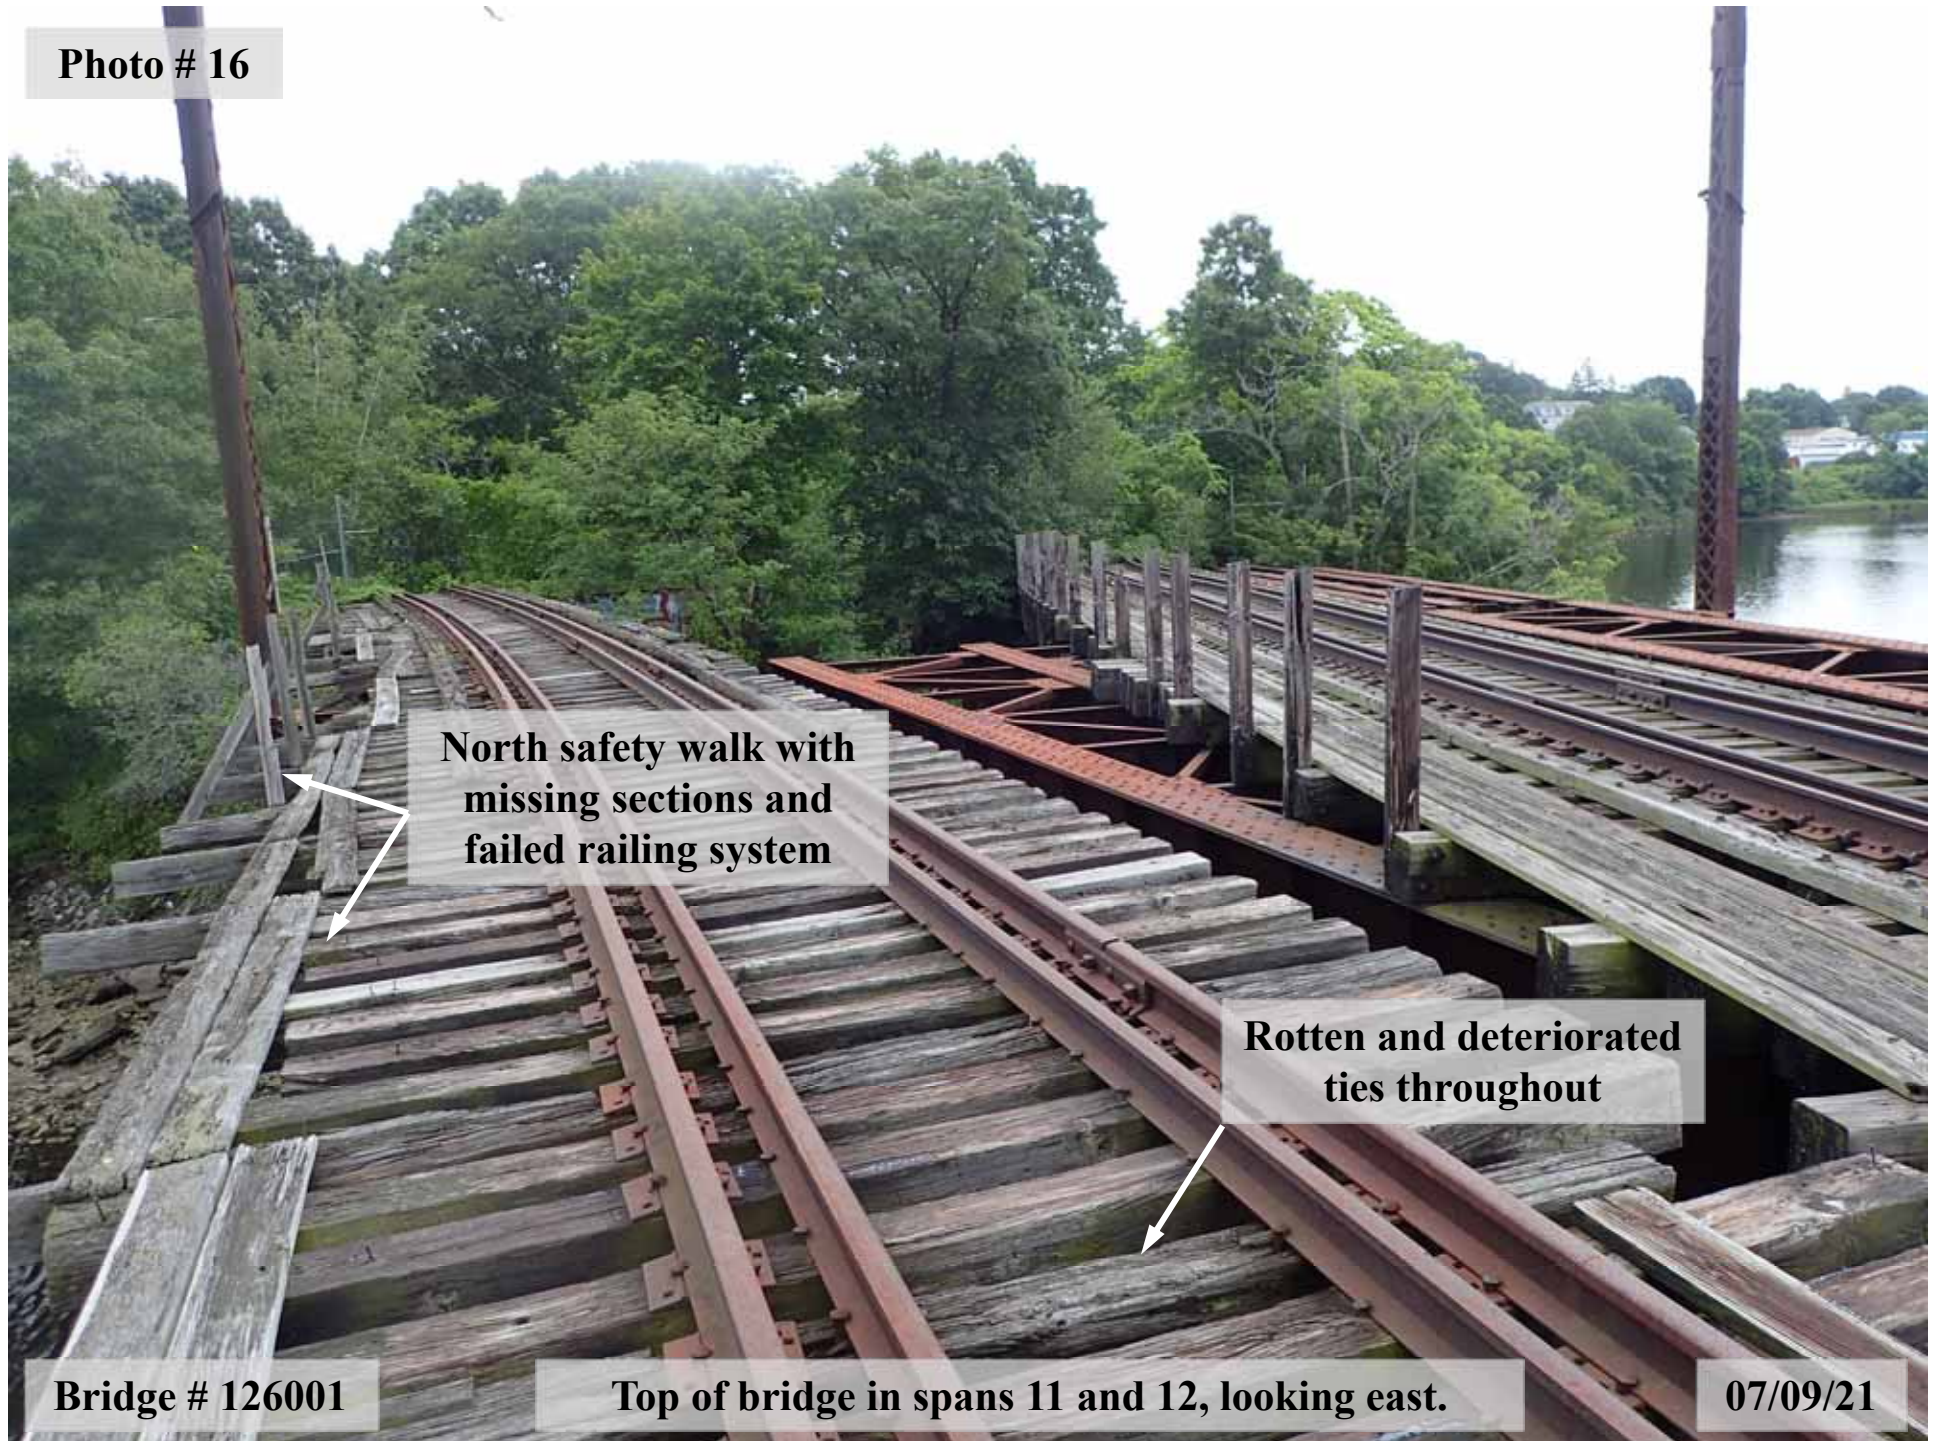
Photo # 16

North safety walk with missing sections and failed railing system

Rotten and deteriorated ties throughout

Top of bridge in spans 11 and 12, looking east.

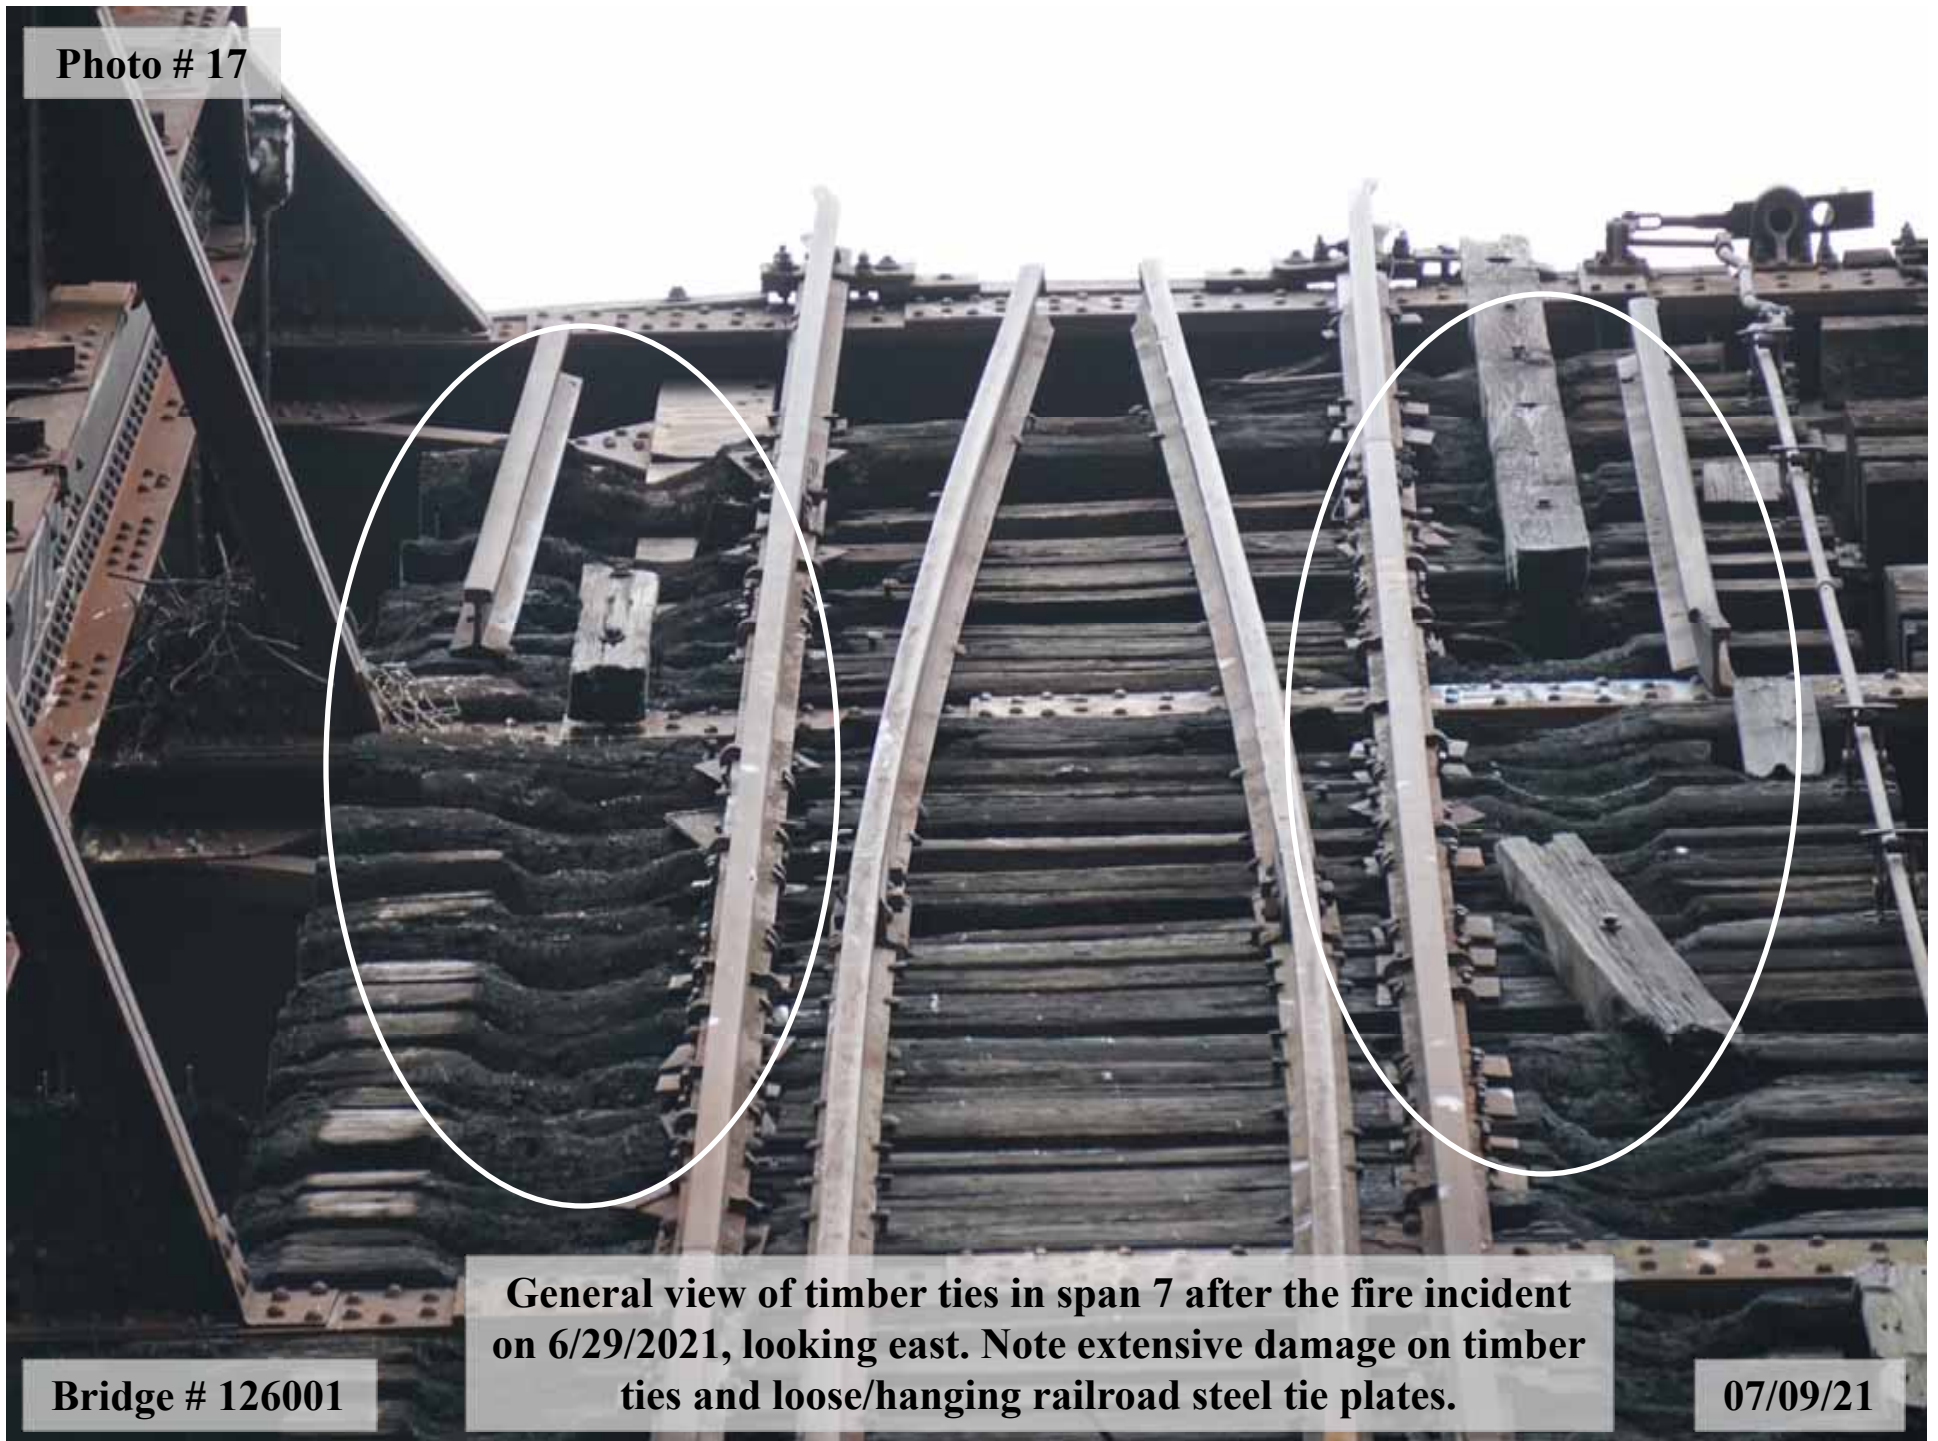
Photo # 17

General view of timber ties in span 7 after the fire incident on 6/29/2021, looking east. Note extensive damage on timber ties and loose/hanging railroad steel tie plates.

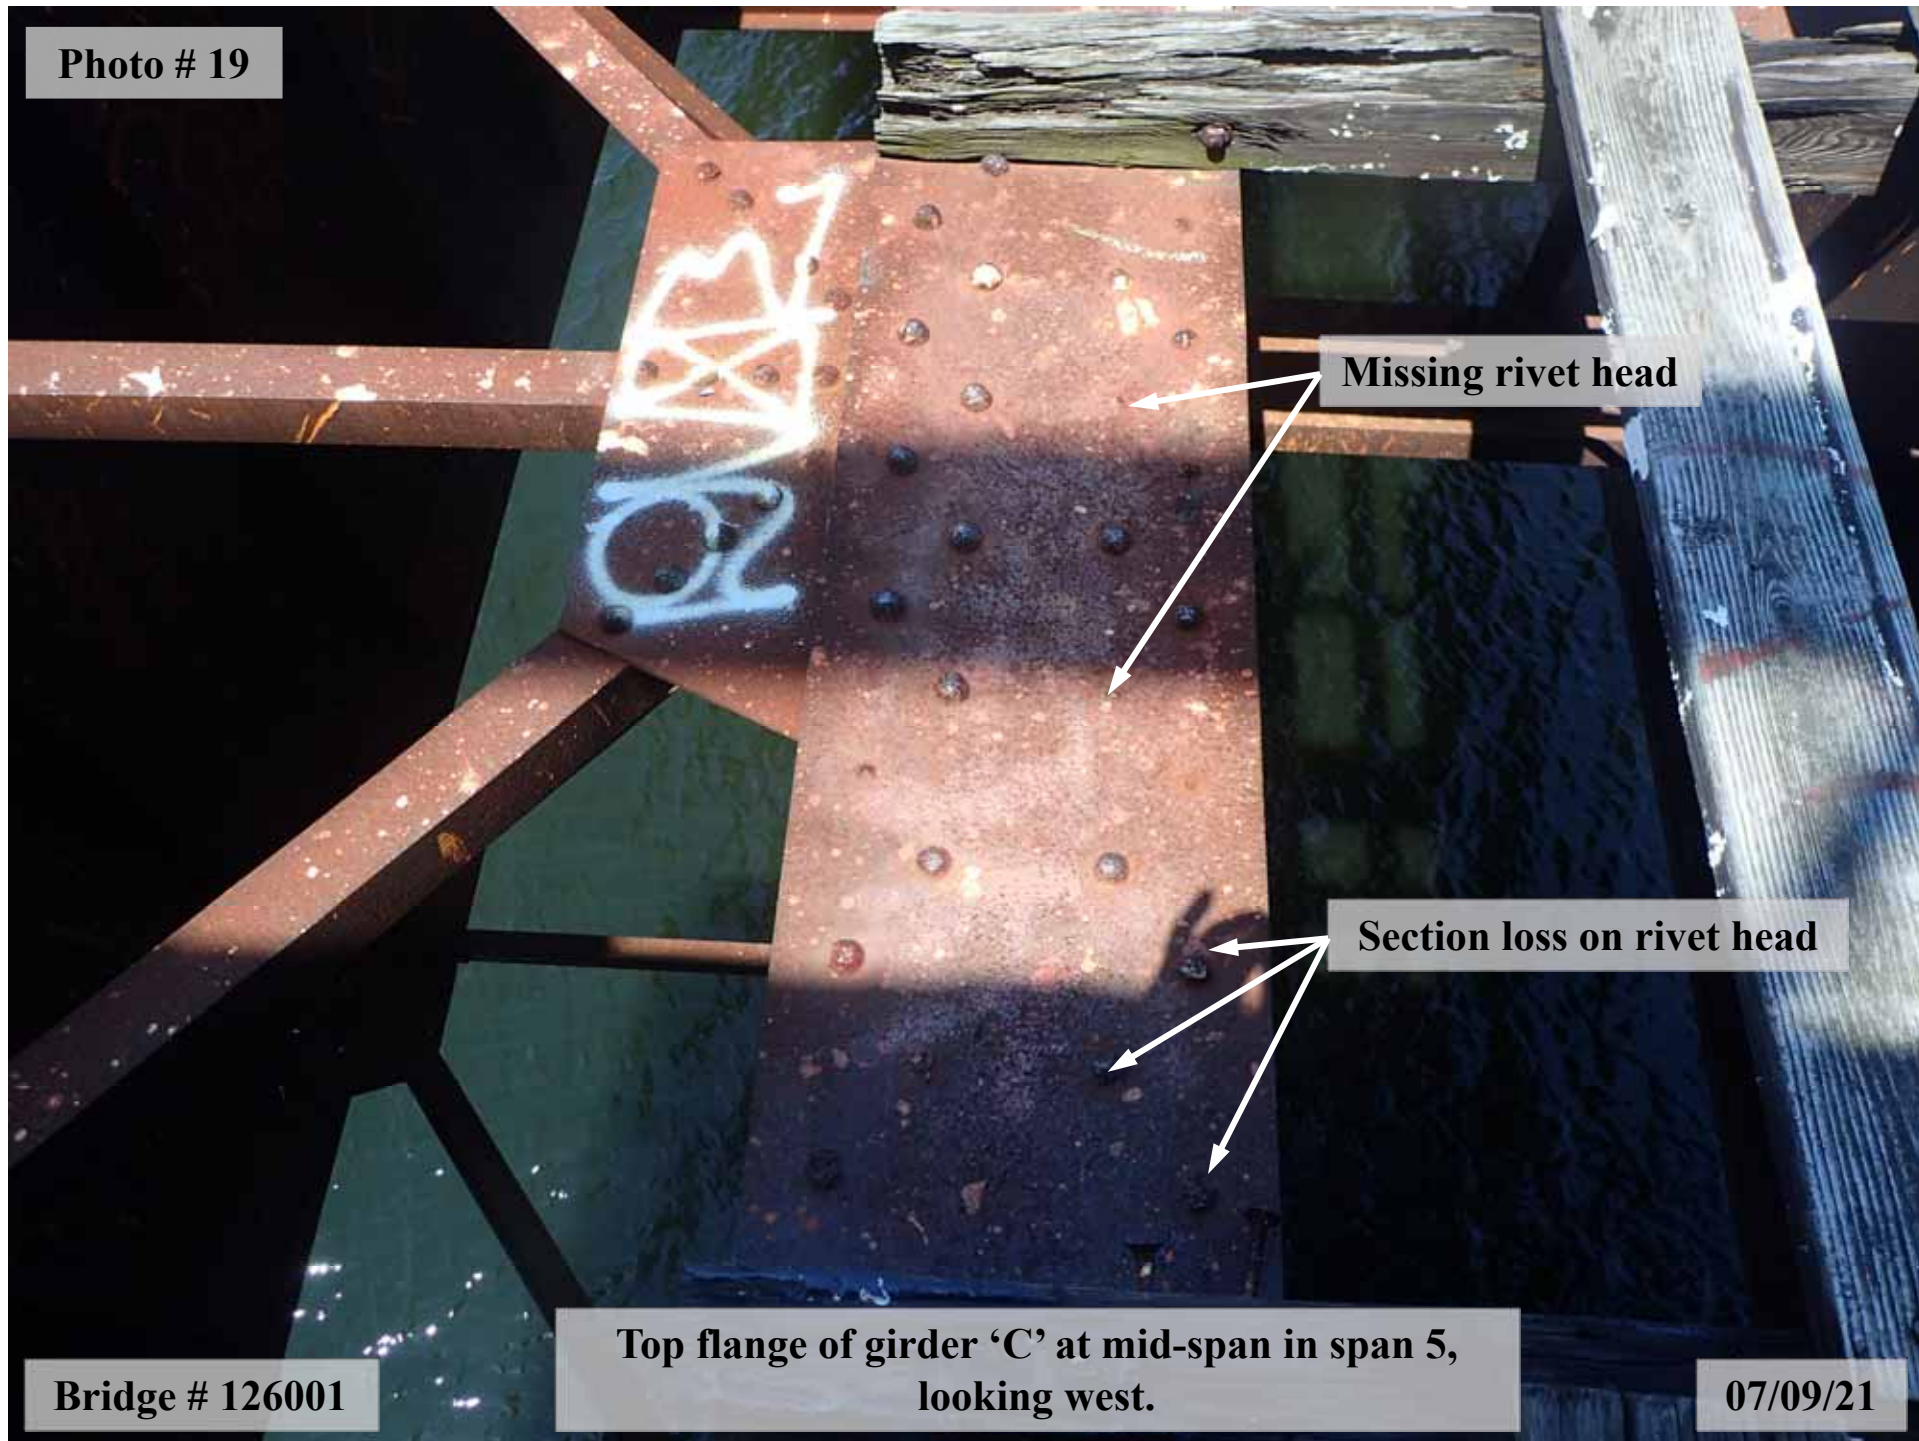
Photo # 19

Missing rivet head

Section loss on rivet head

Top flange of girder 'C' at mid-span in span 5, looking west.
