CITY OF PROVIDENCE, RHODE ISLAND

**RFP Title: URBAN DESIGN CONSULTING SERVICES RELATING TO CROOK POINT BRIDGE
PRESERVATION**

Addendum #: 1

A potential respondent has asked for supporting pictures referenced in the bid materials. This addendum adds those pictures.

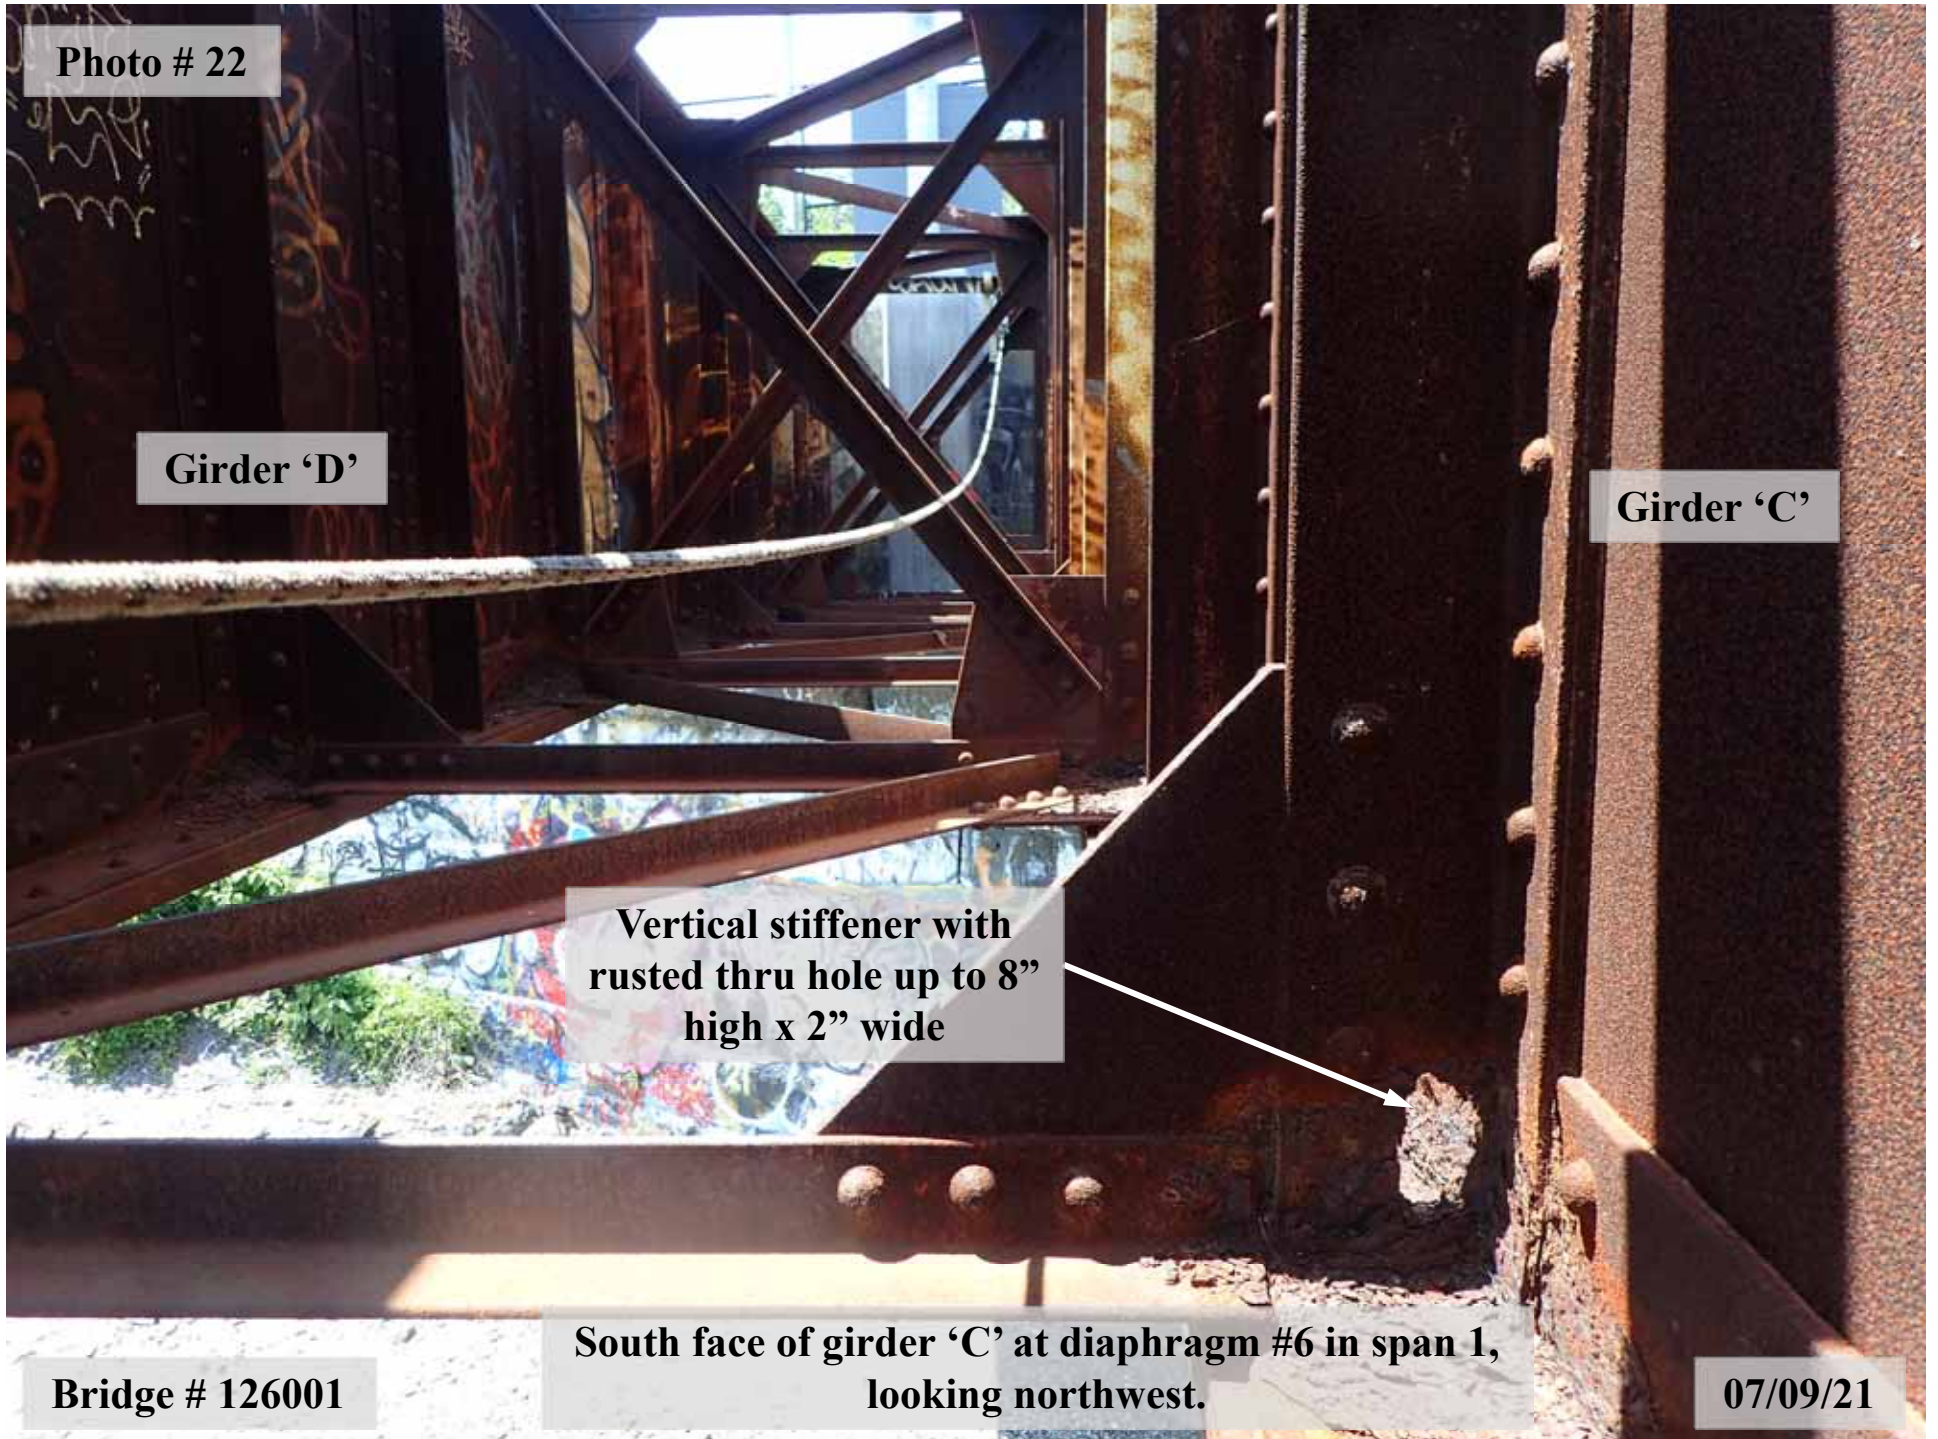
Photo # 22

**Vertical stiffener with
rusted thru hole up to 8"
high x 2" wide**

**South face of girder 'C' at diaphragm #6 in span 1,
looking northwest.**

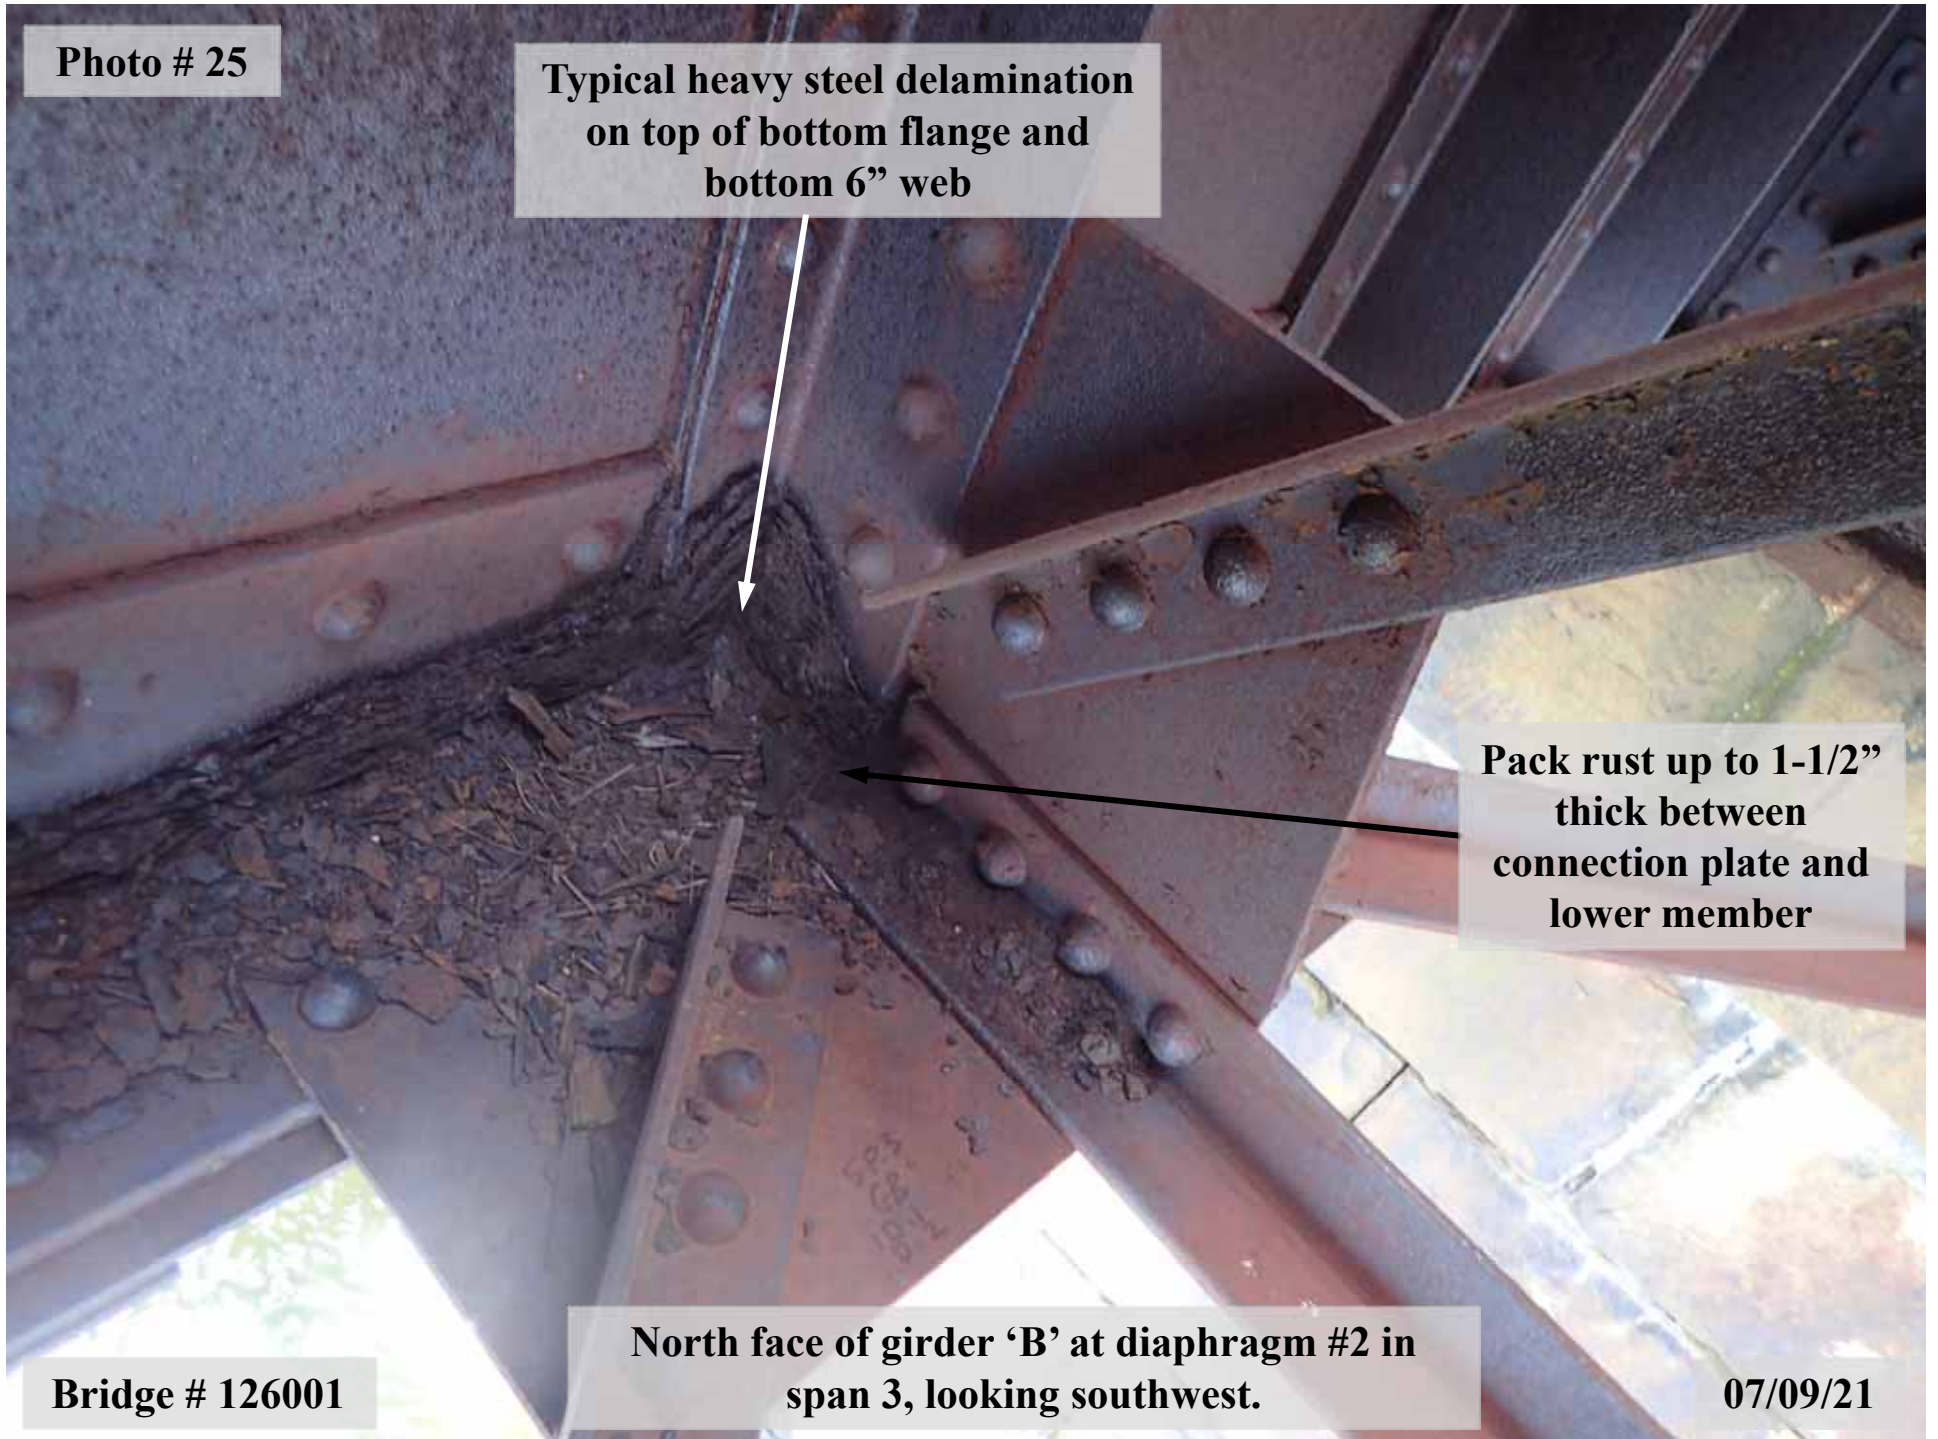
Photo # 25

**Typical heavy steel delamination
on top of bottom flange and
bottom 6" web**

**Pack rust up to 1-1/2"
thick between
connection plate and
lower member**

**North face of girder 'B' at diaphragm #2 in
span 3, looking southwest.**

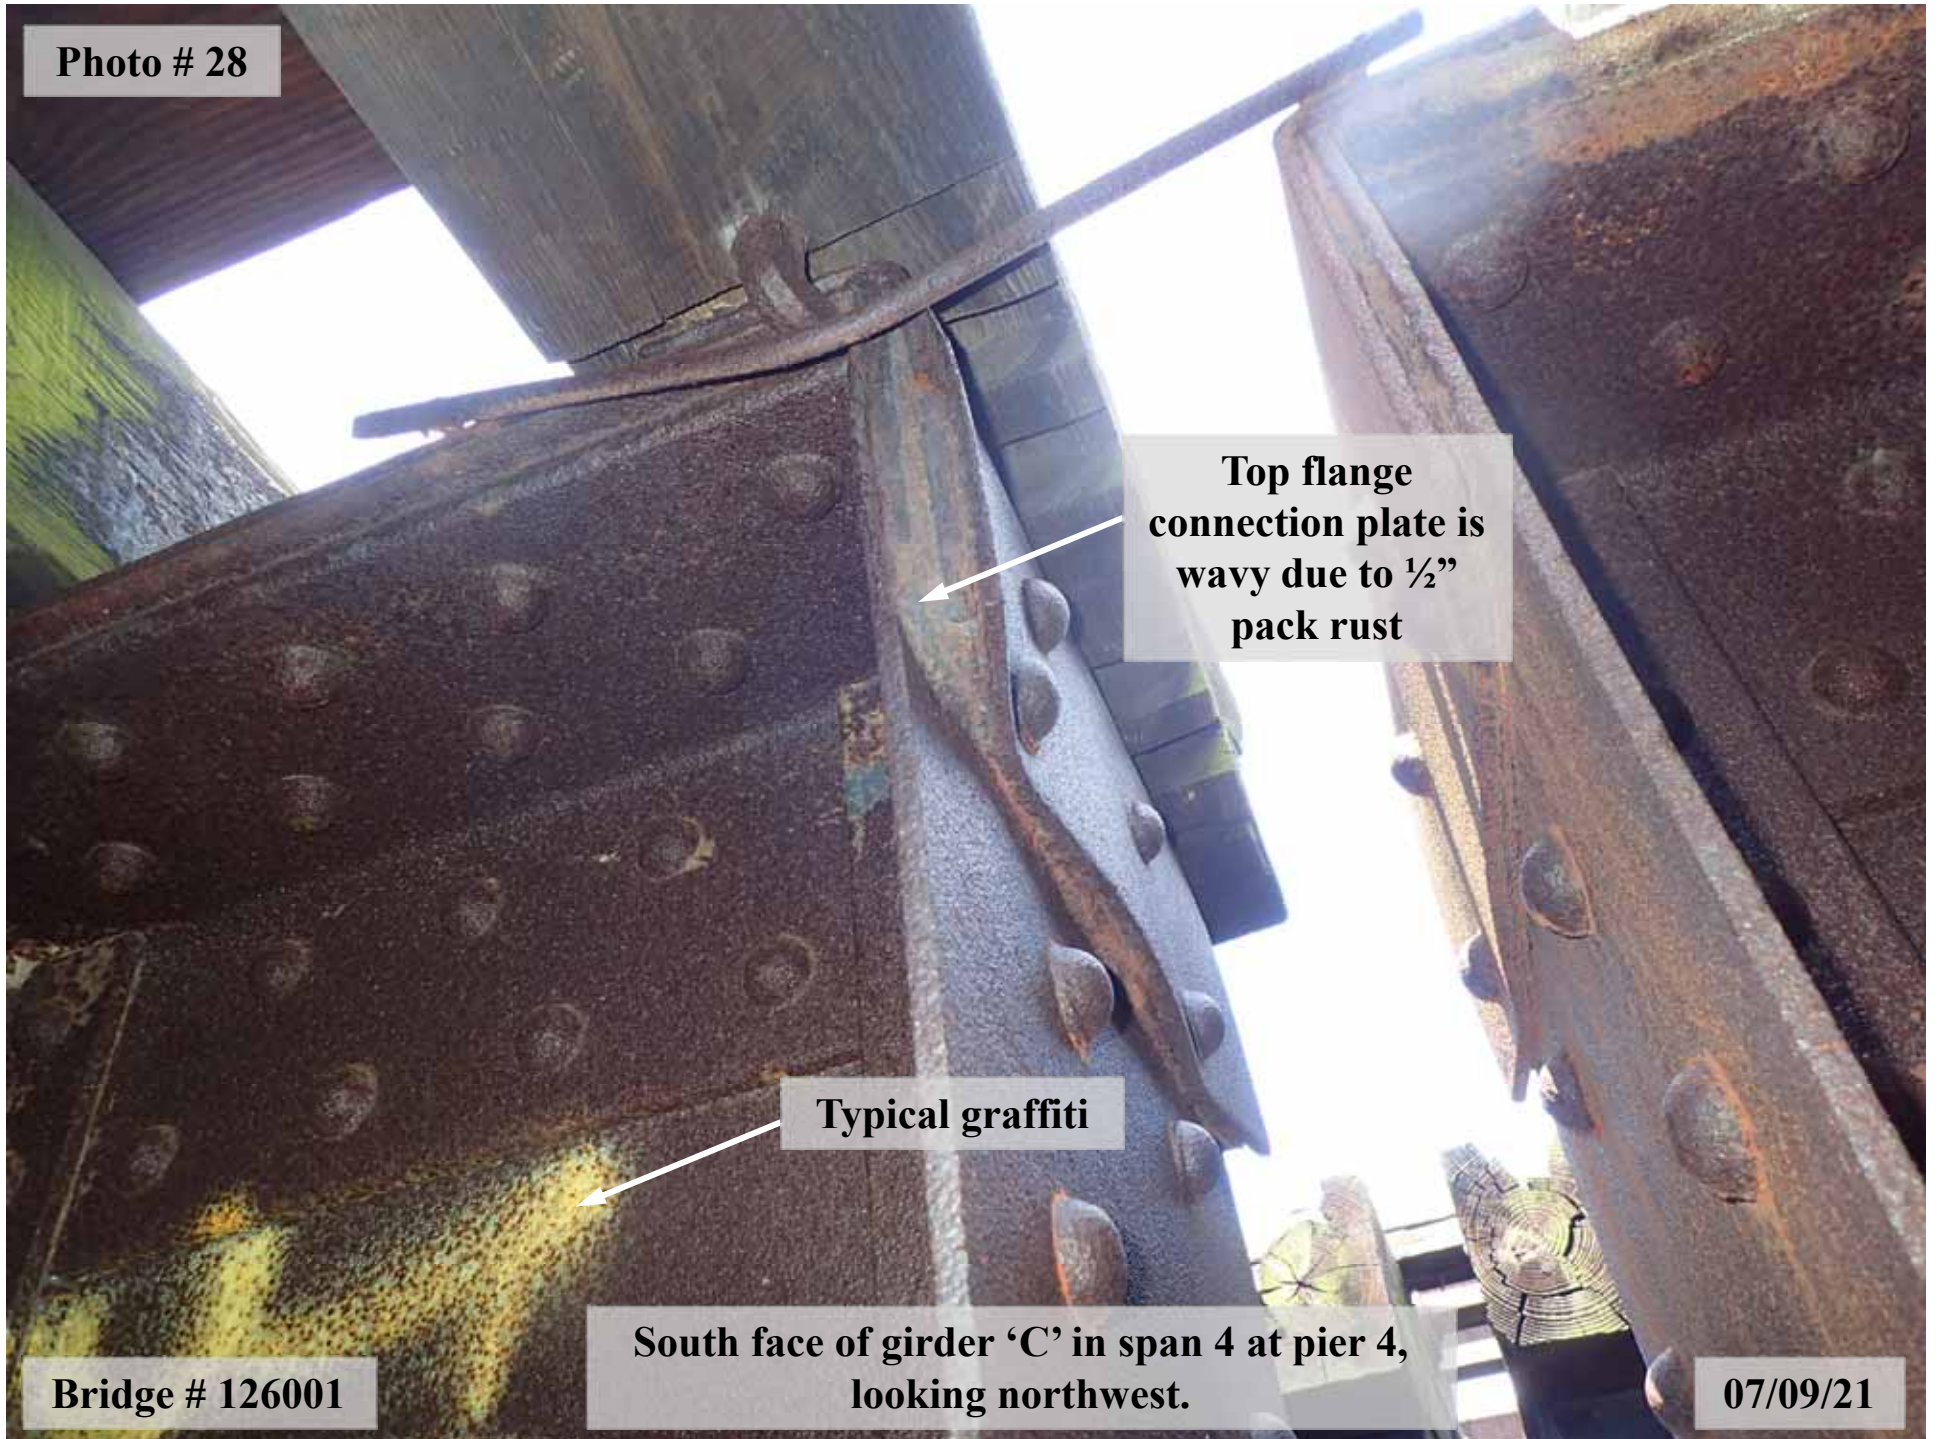
Photo # 28

**Top flange
connection plate is
wavy due to ½”
pack rust**

**South face of girder 'C' in span 4 at pier 4,
looking northwest.**

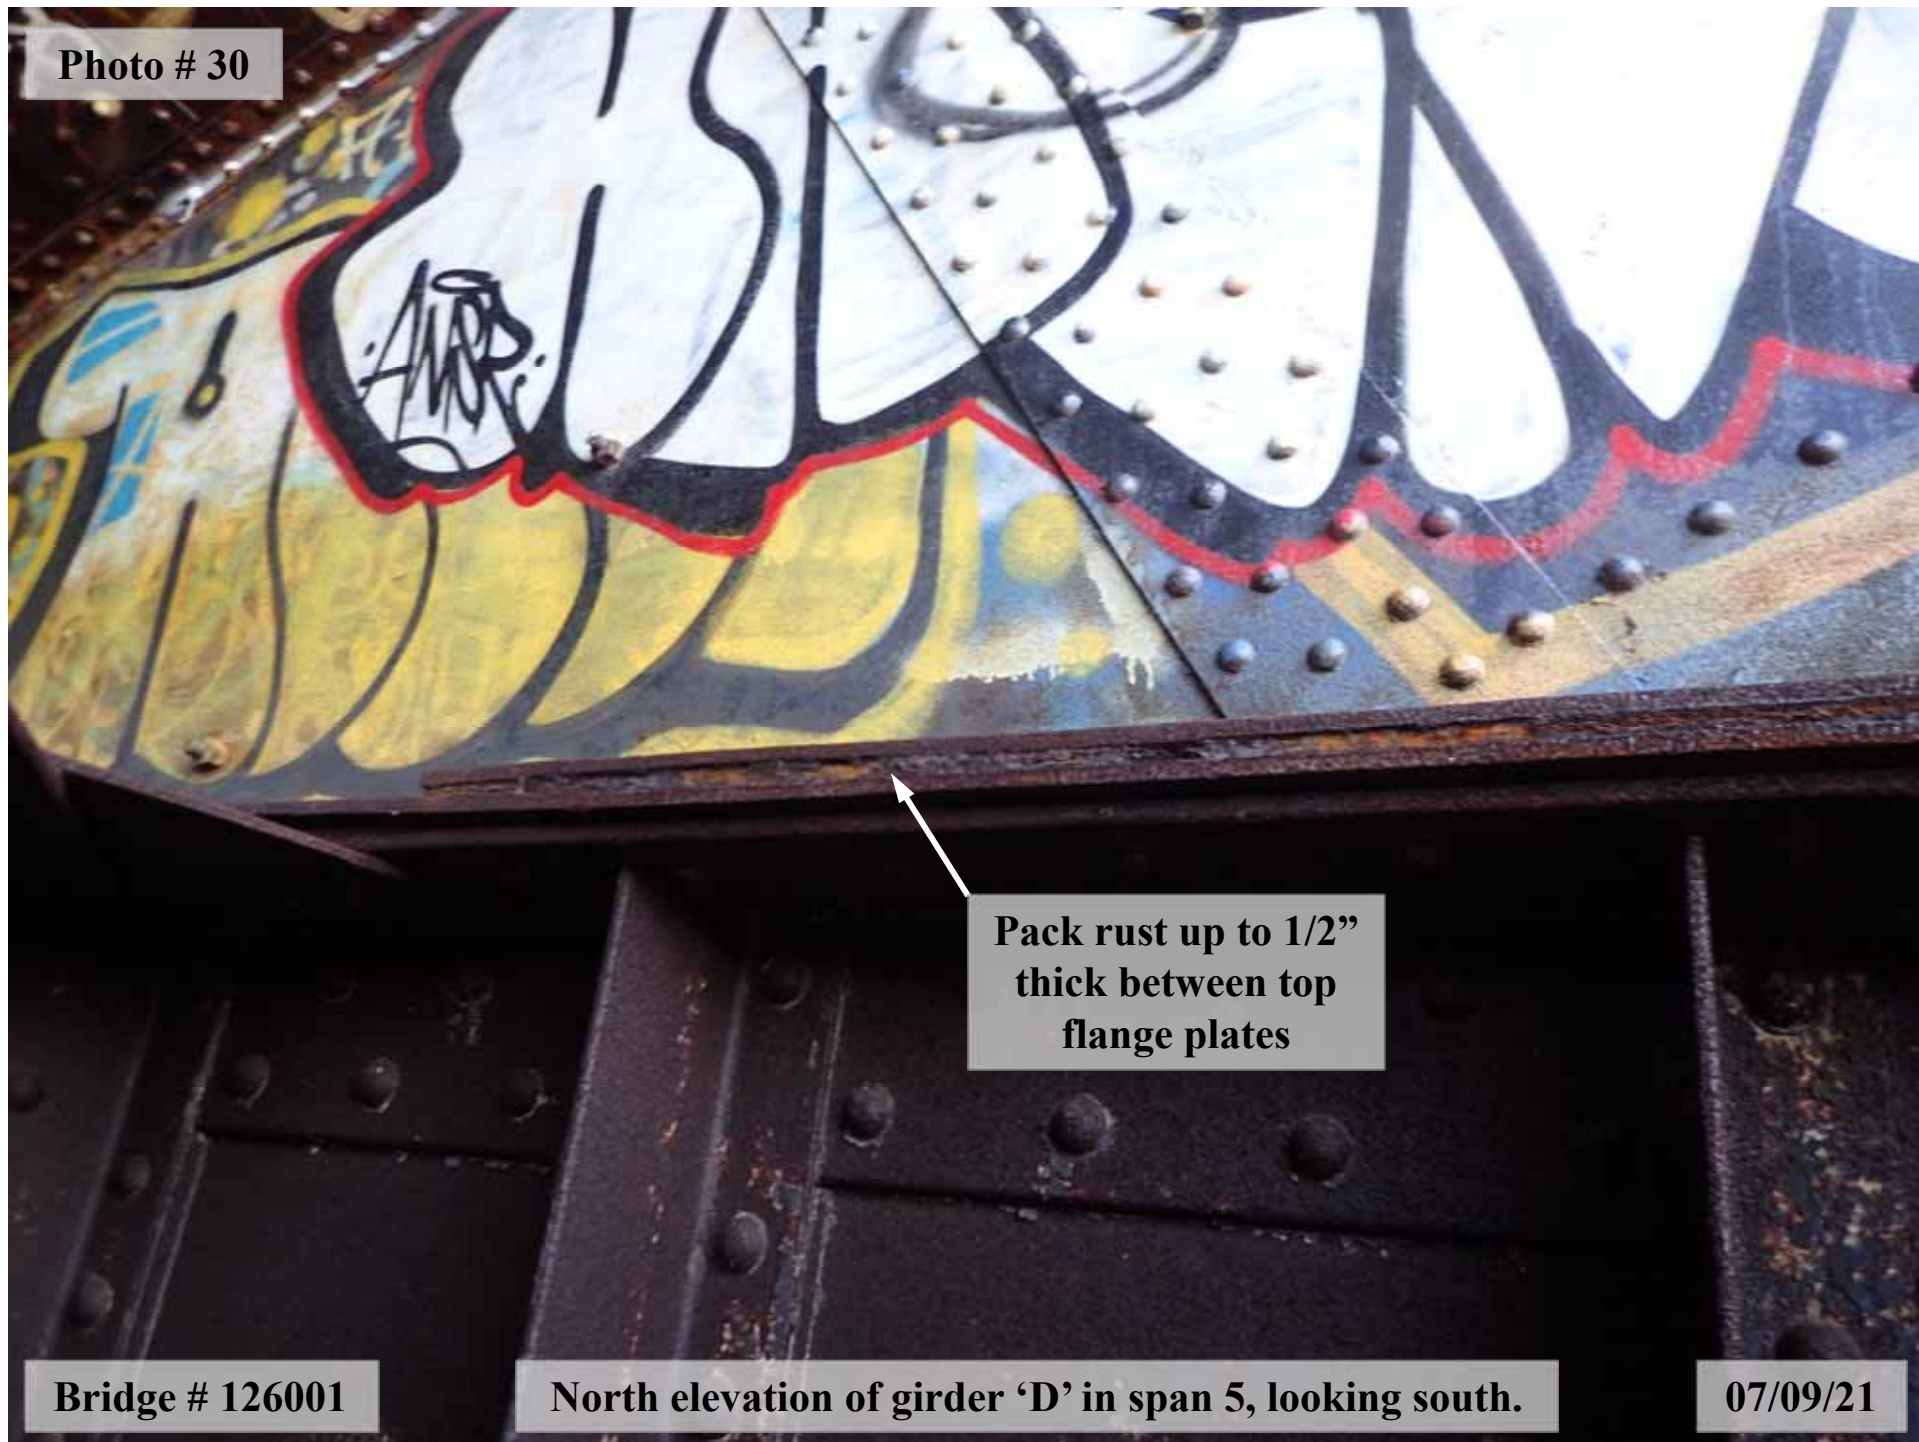
Photo # 30

**Pack rust up to 1/2"
thick between
flange plates**

North elevation of girder 'D' in span 5, looking south.

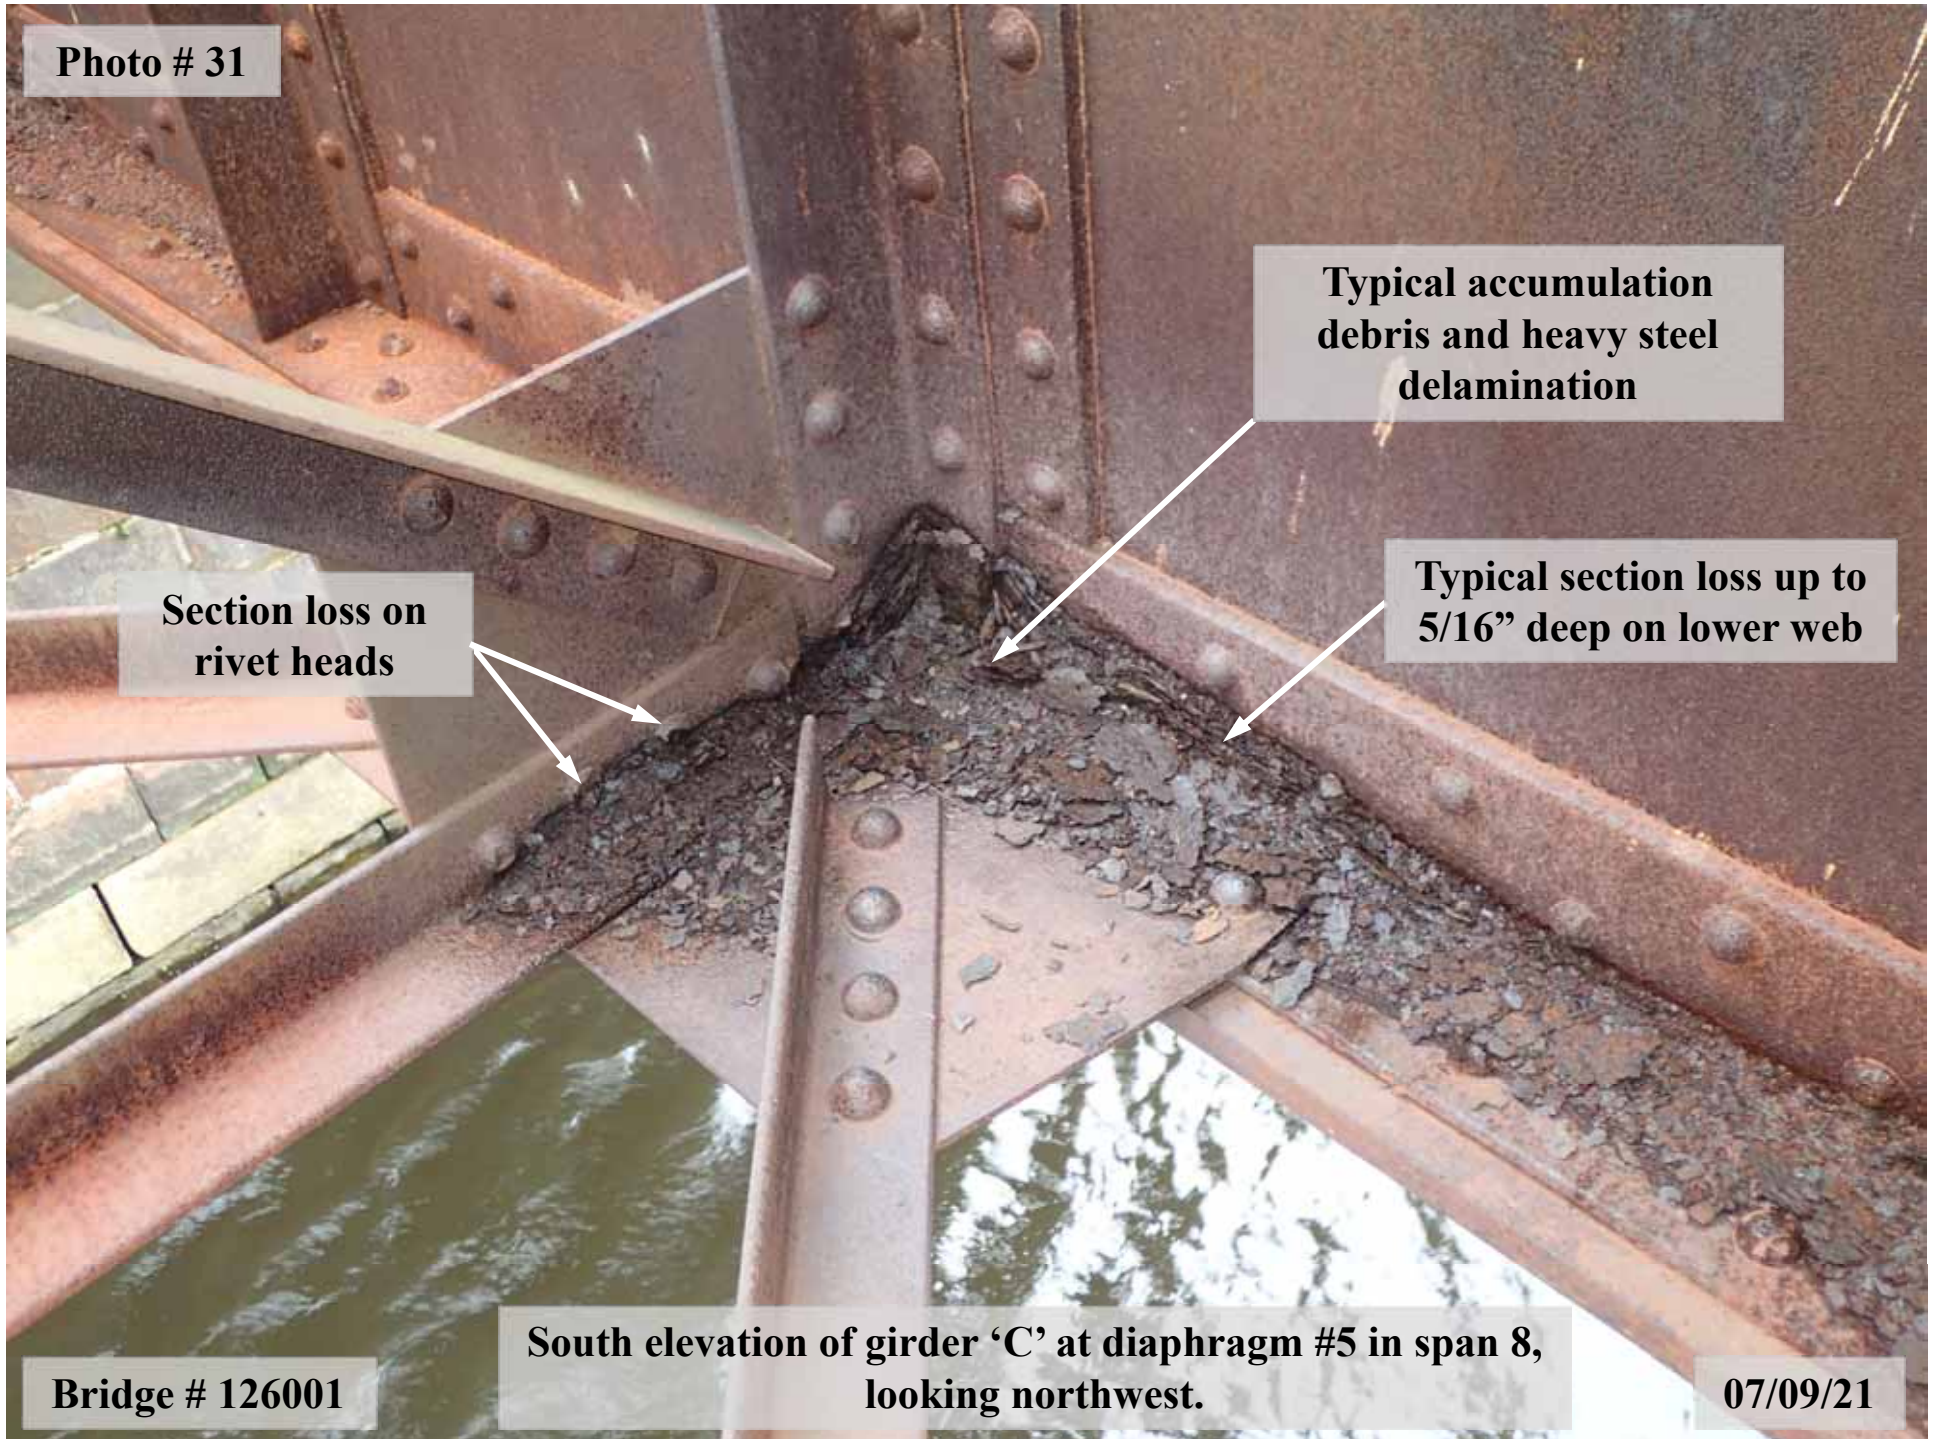
Photo # 31

Section loss on rivet heads

Typical accumulation debris and heavy steel delamination

Typical section loss up to 5/16" deep on lower web

South elevation of girder 'C' at diaphragm #5 in span 8, looking northwest.

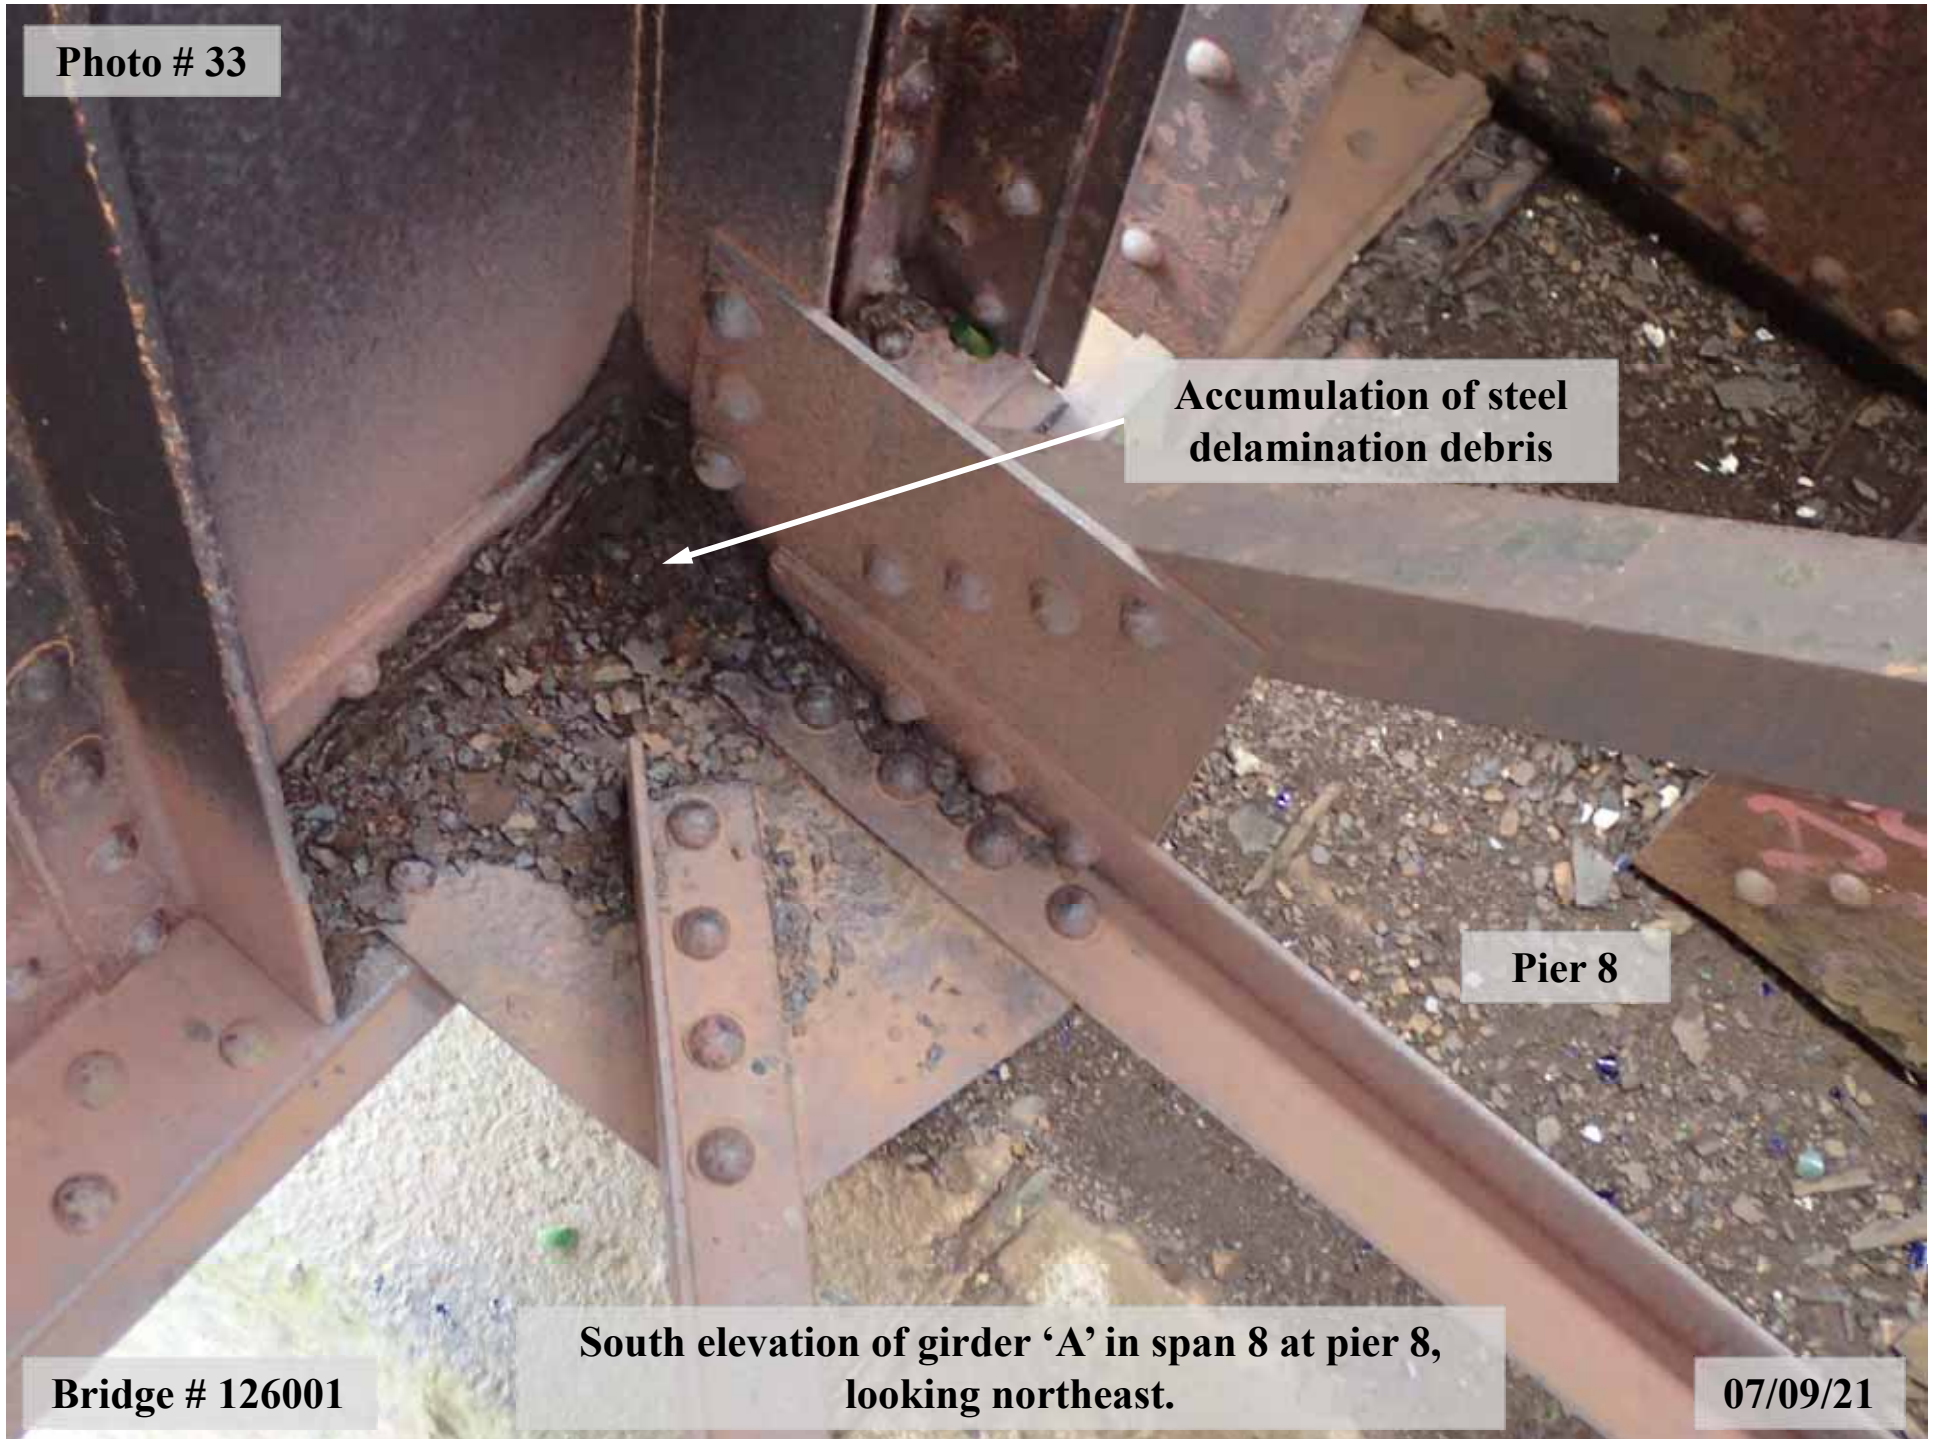
Photo # 33

**Accumulation of steel
delamination debris**

**South elevation of girder 'A' in span 8 at pier 8,
looking northeast.**

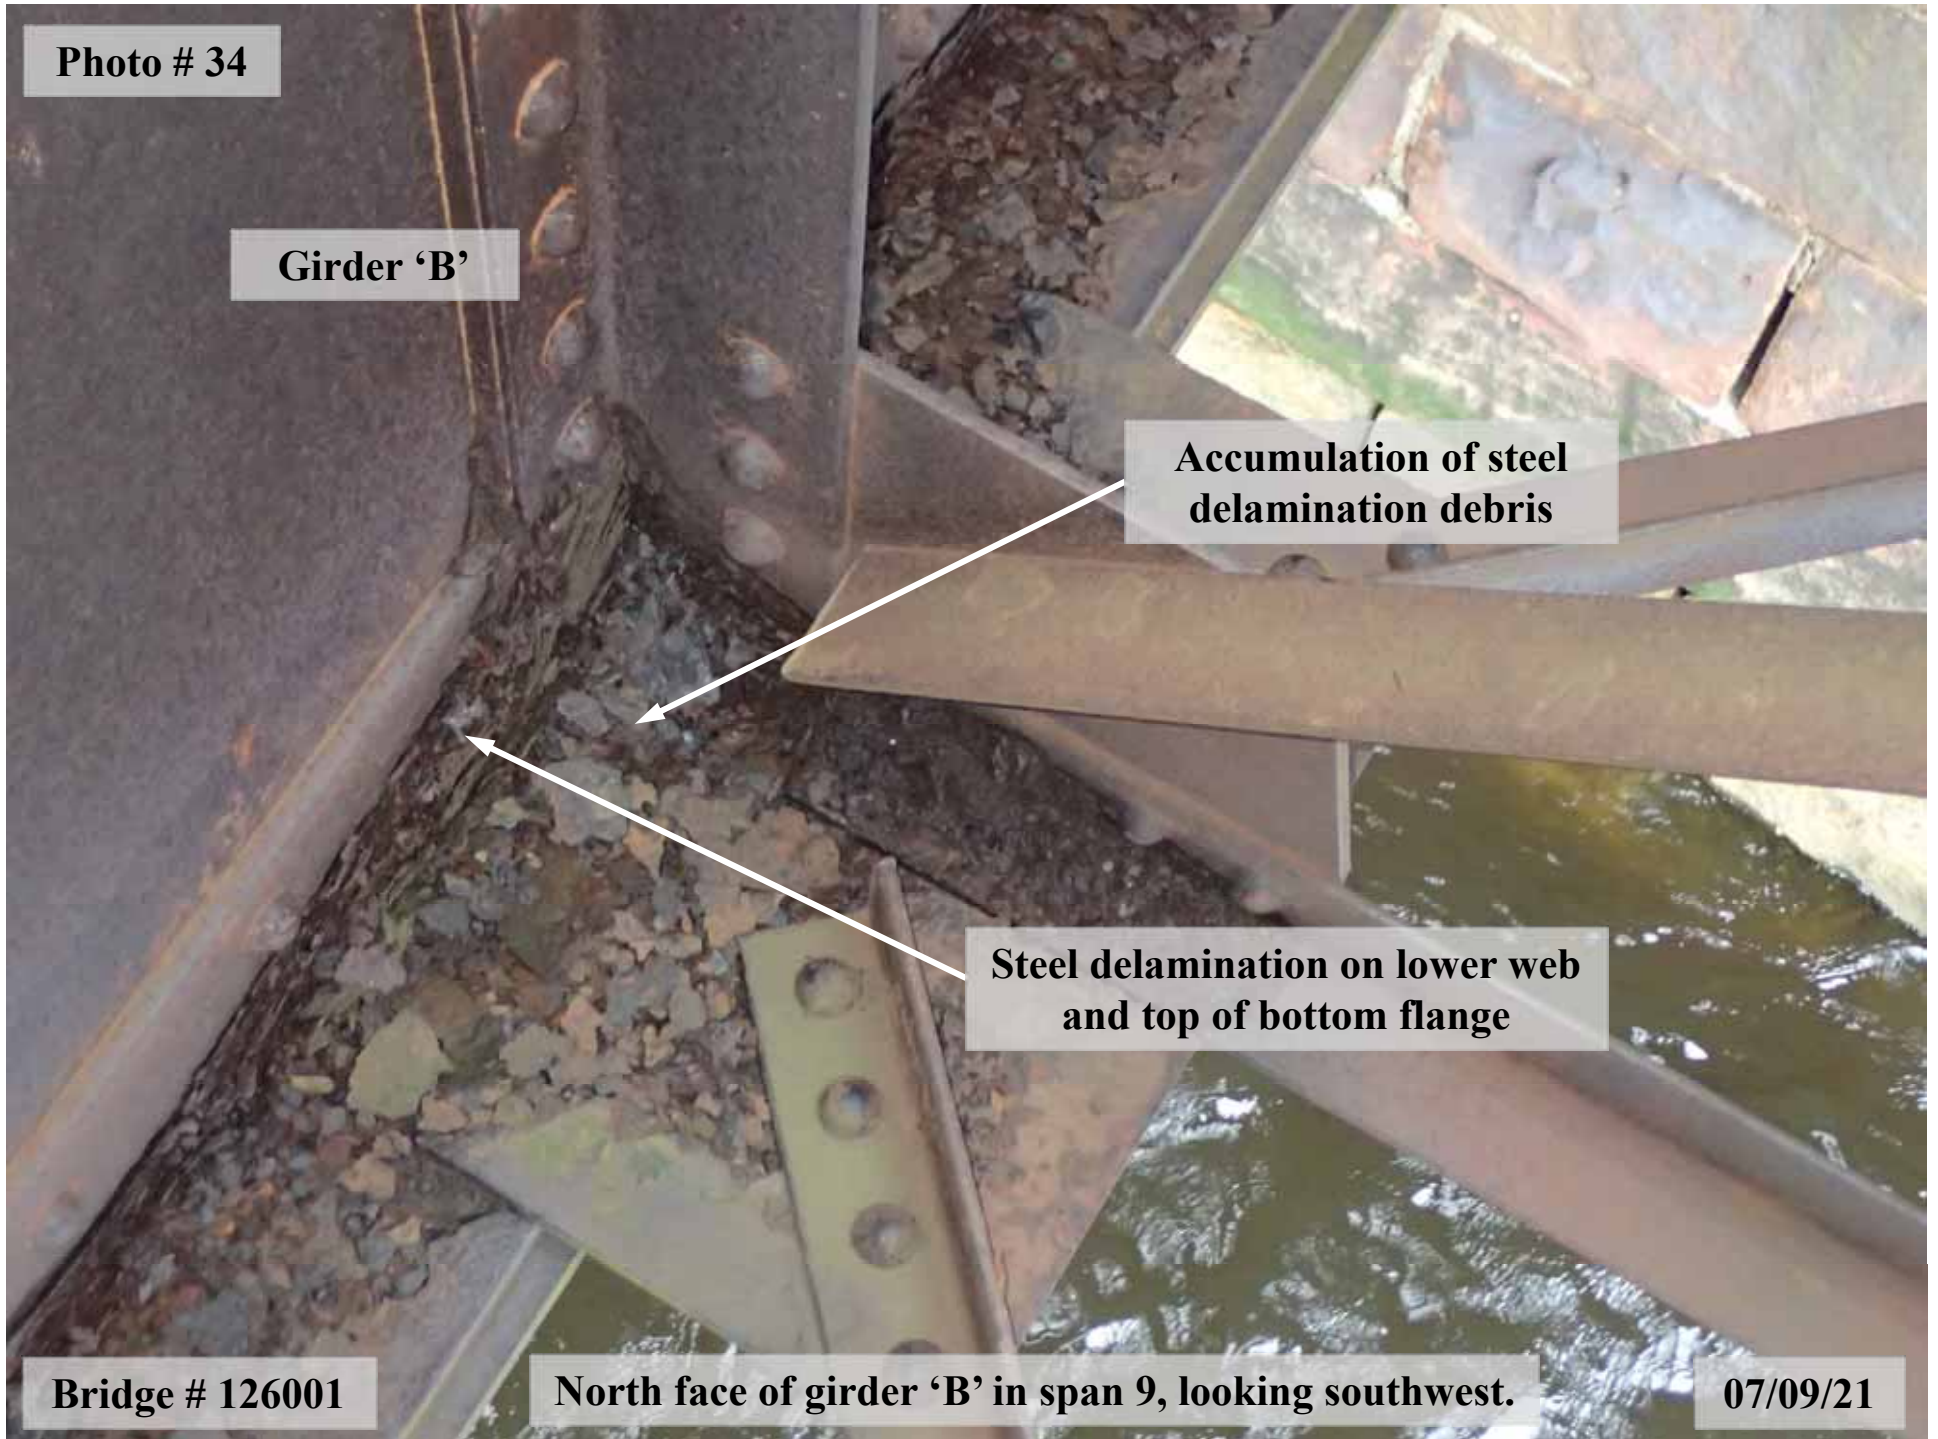
Photo # 34

Accumulation of steel delamination debris

Steel delamination on lower web and top of bottom flange

North face of girder 'B' in span 9, looking southwest.

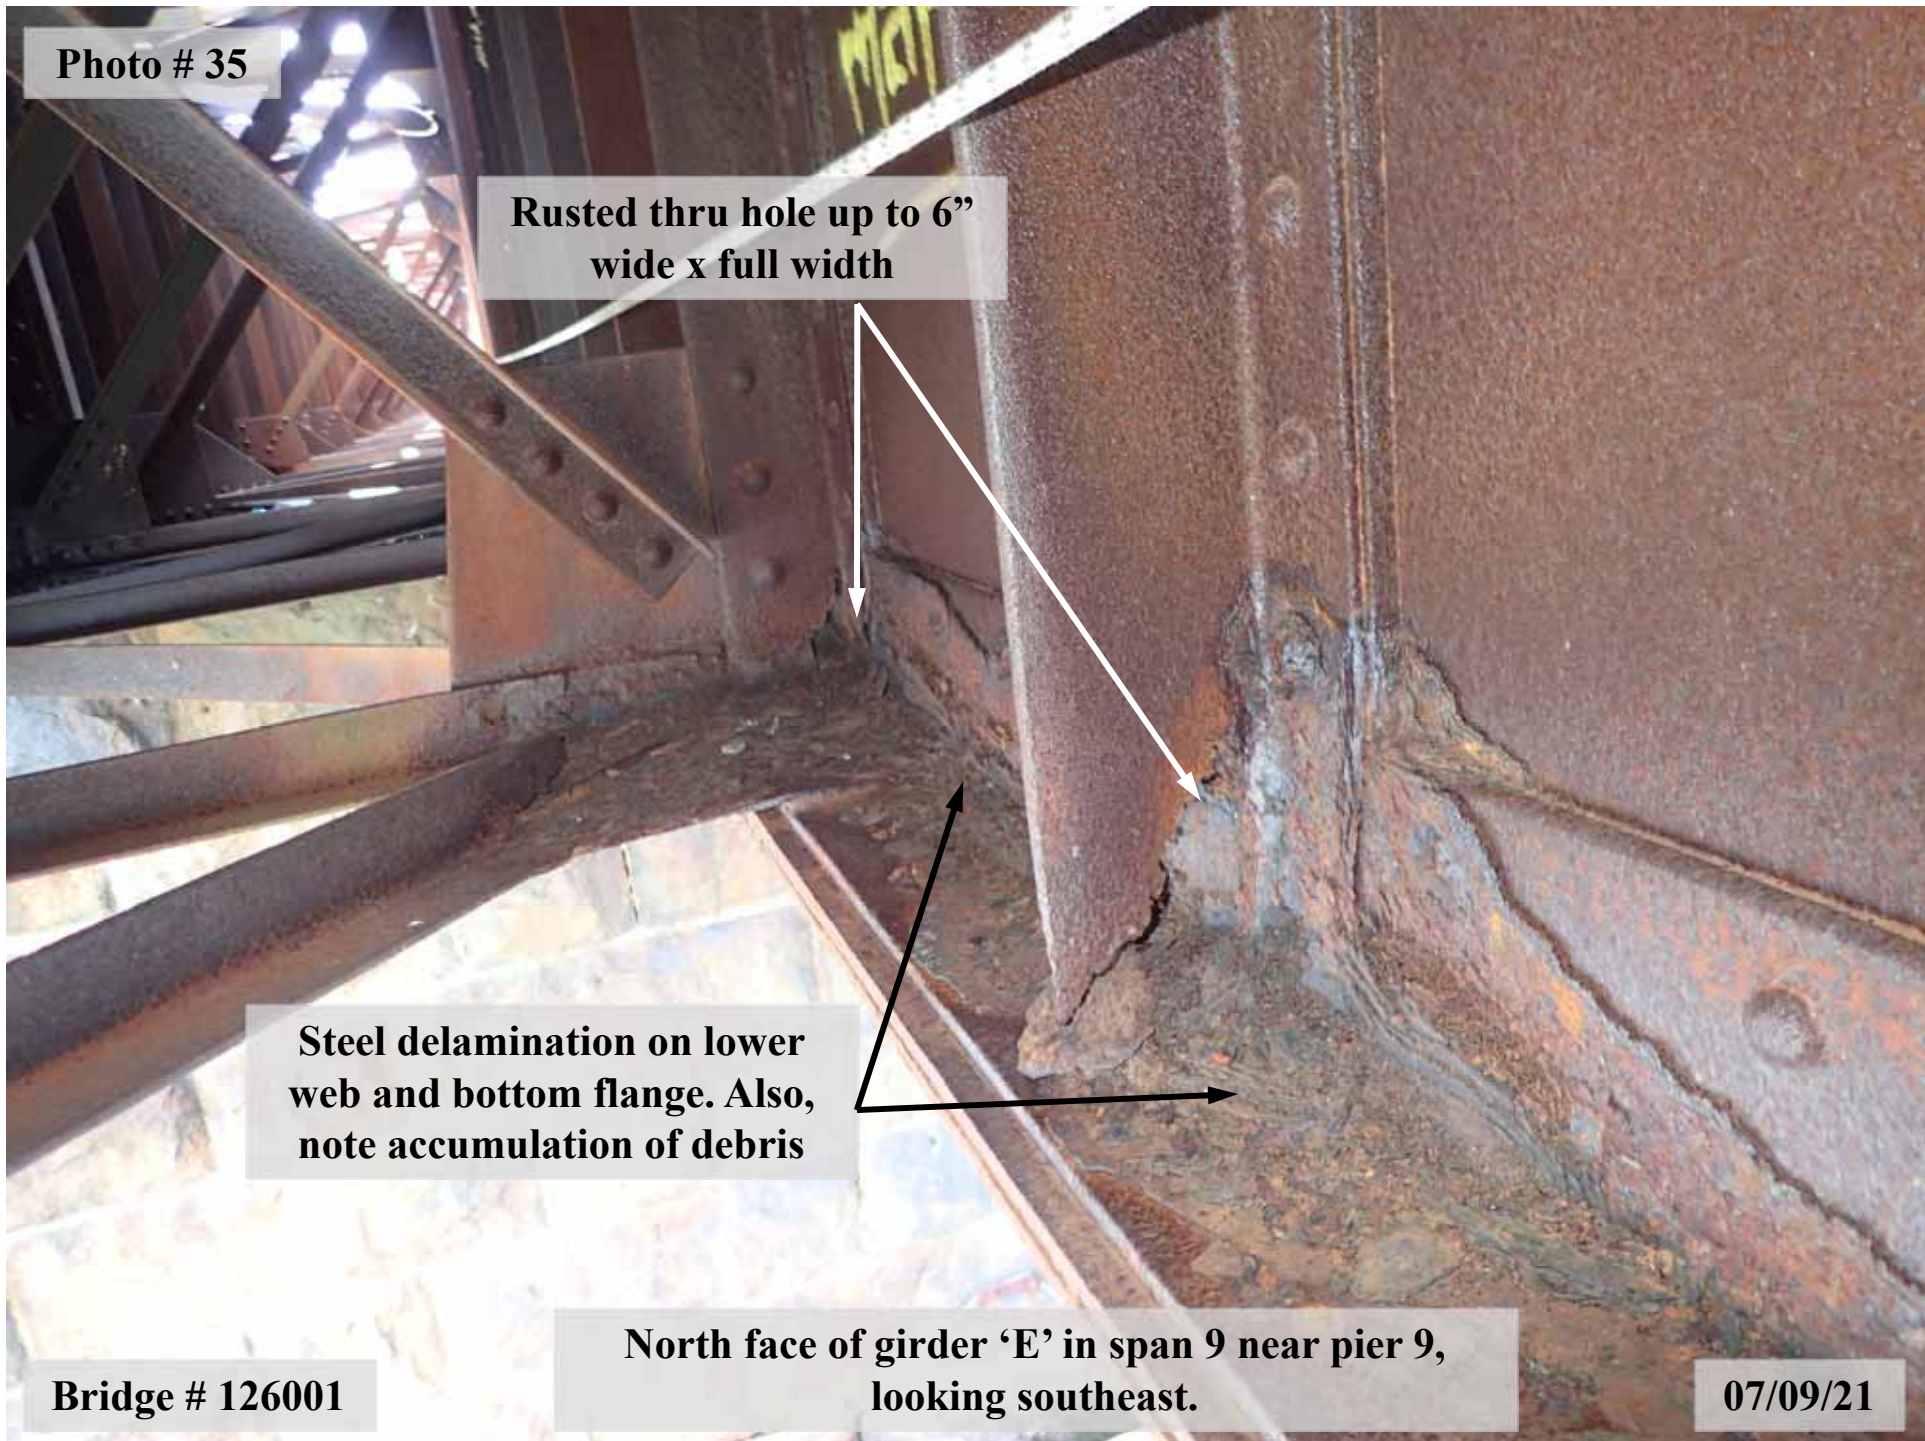
Photo # 35

**Rusted thru hole up to 6"
wide x full width**

**Steel delamination on lower
web and bottom flange. Also,
note accumulation of debris**

**North face of girder 'E' in span 9 near pier 9,
looking southeast.**
