CITY OF PROVIDENCE, RHODE ISLAND

**RFP Title: URBAN DESIGN CONSULTING SERVICES RELATING TO CROOK POINT BRIDGE
PRESERVATION**

Addendum #: 1

A potential respondent has asked for supporting pictures referenced in the bid materials. This addendum adds those pictures.

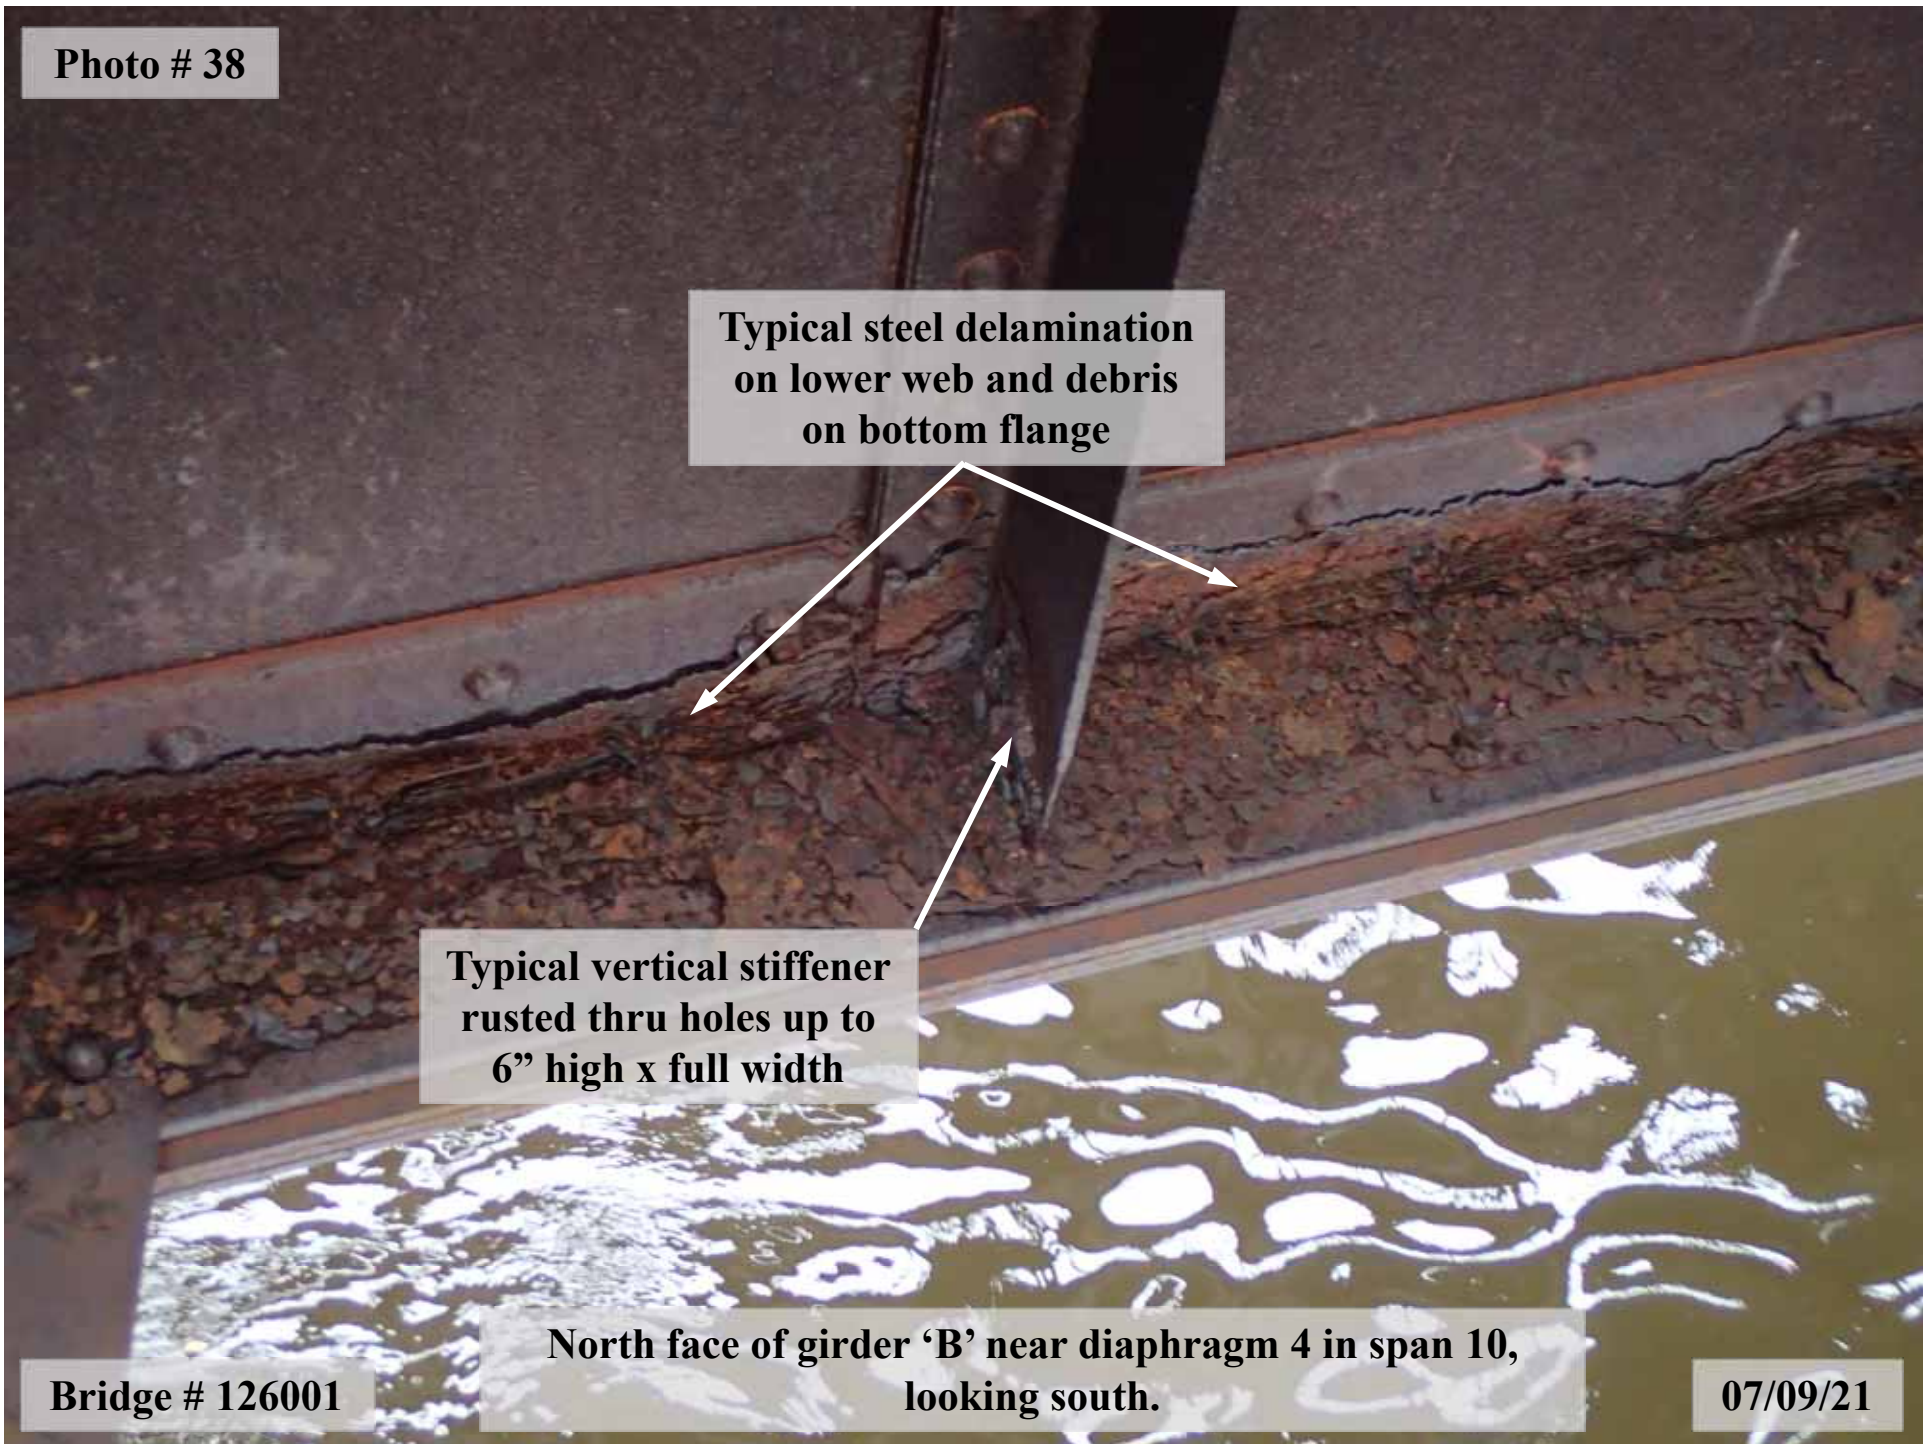
Photo # 38

**Typical steel delamination
on lower web and debris
on bottom flange**

**Typical vertical stiffener
rusted thru holes up to
6" high x full width**

**North face of girder 'B' near diaphragm 4 in span 10,
looking south.**

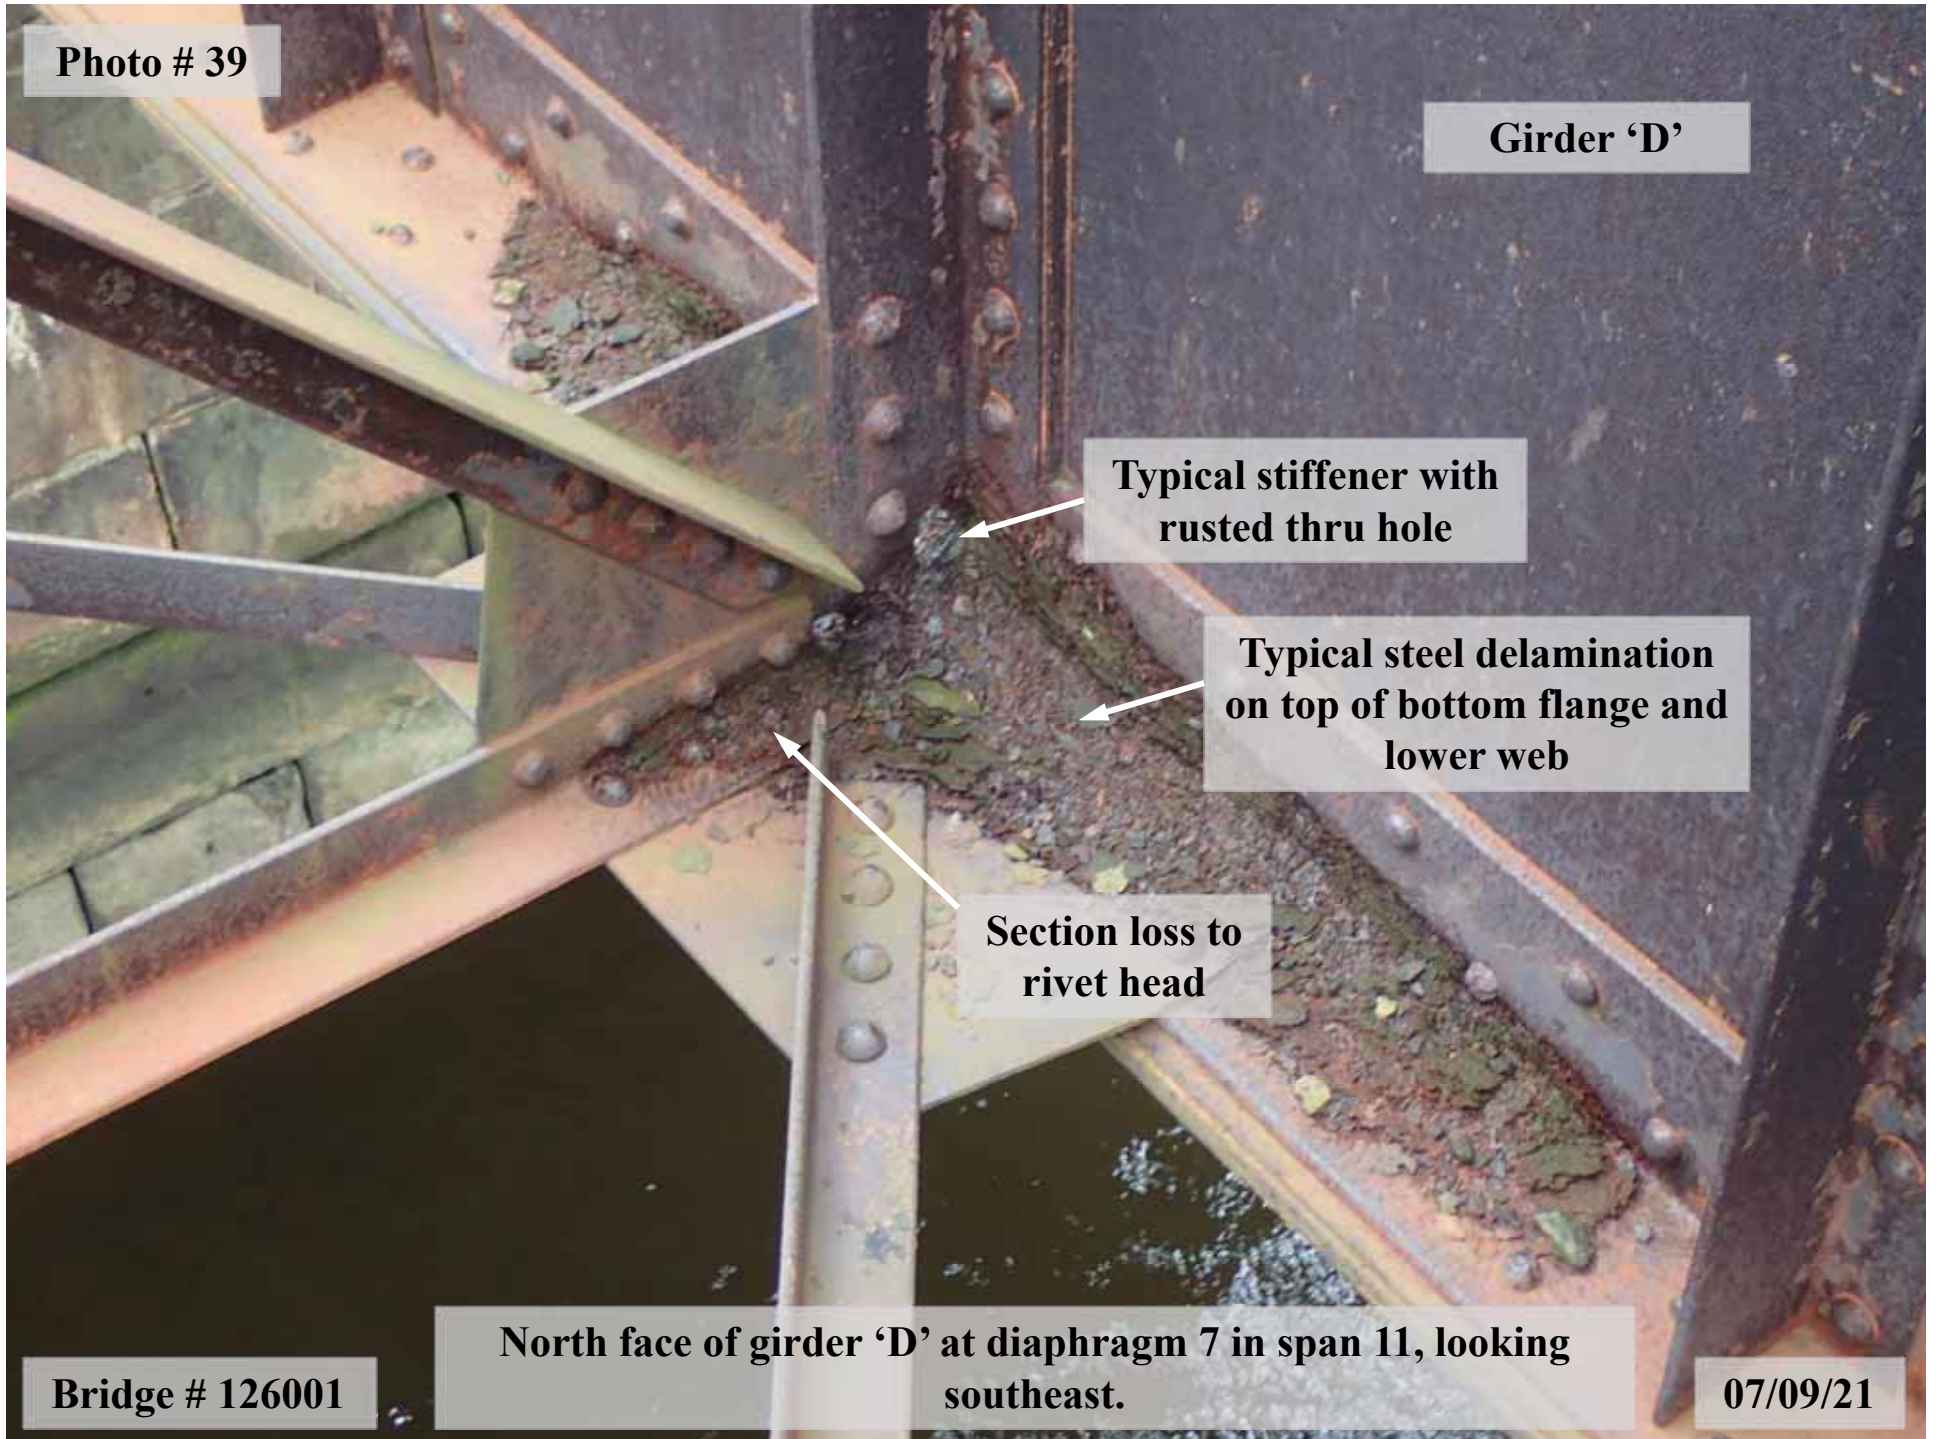
Photo # 39

**Typical stiffener with
rusted thru hole**

**Typical steel delamination
on top of bottom flange and
lower web**

**Section loss to
rivet head**

**North face of girder 'D' at diaphragm 7 in span 11, looking
southeast.**

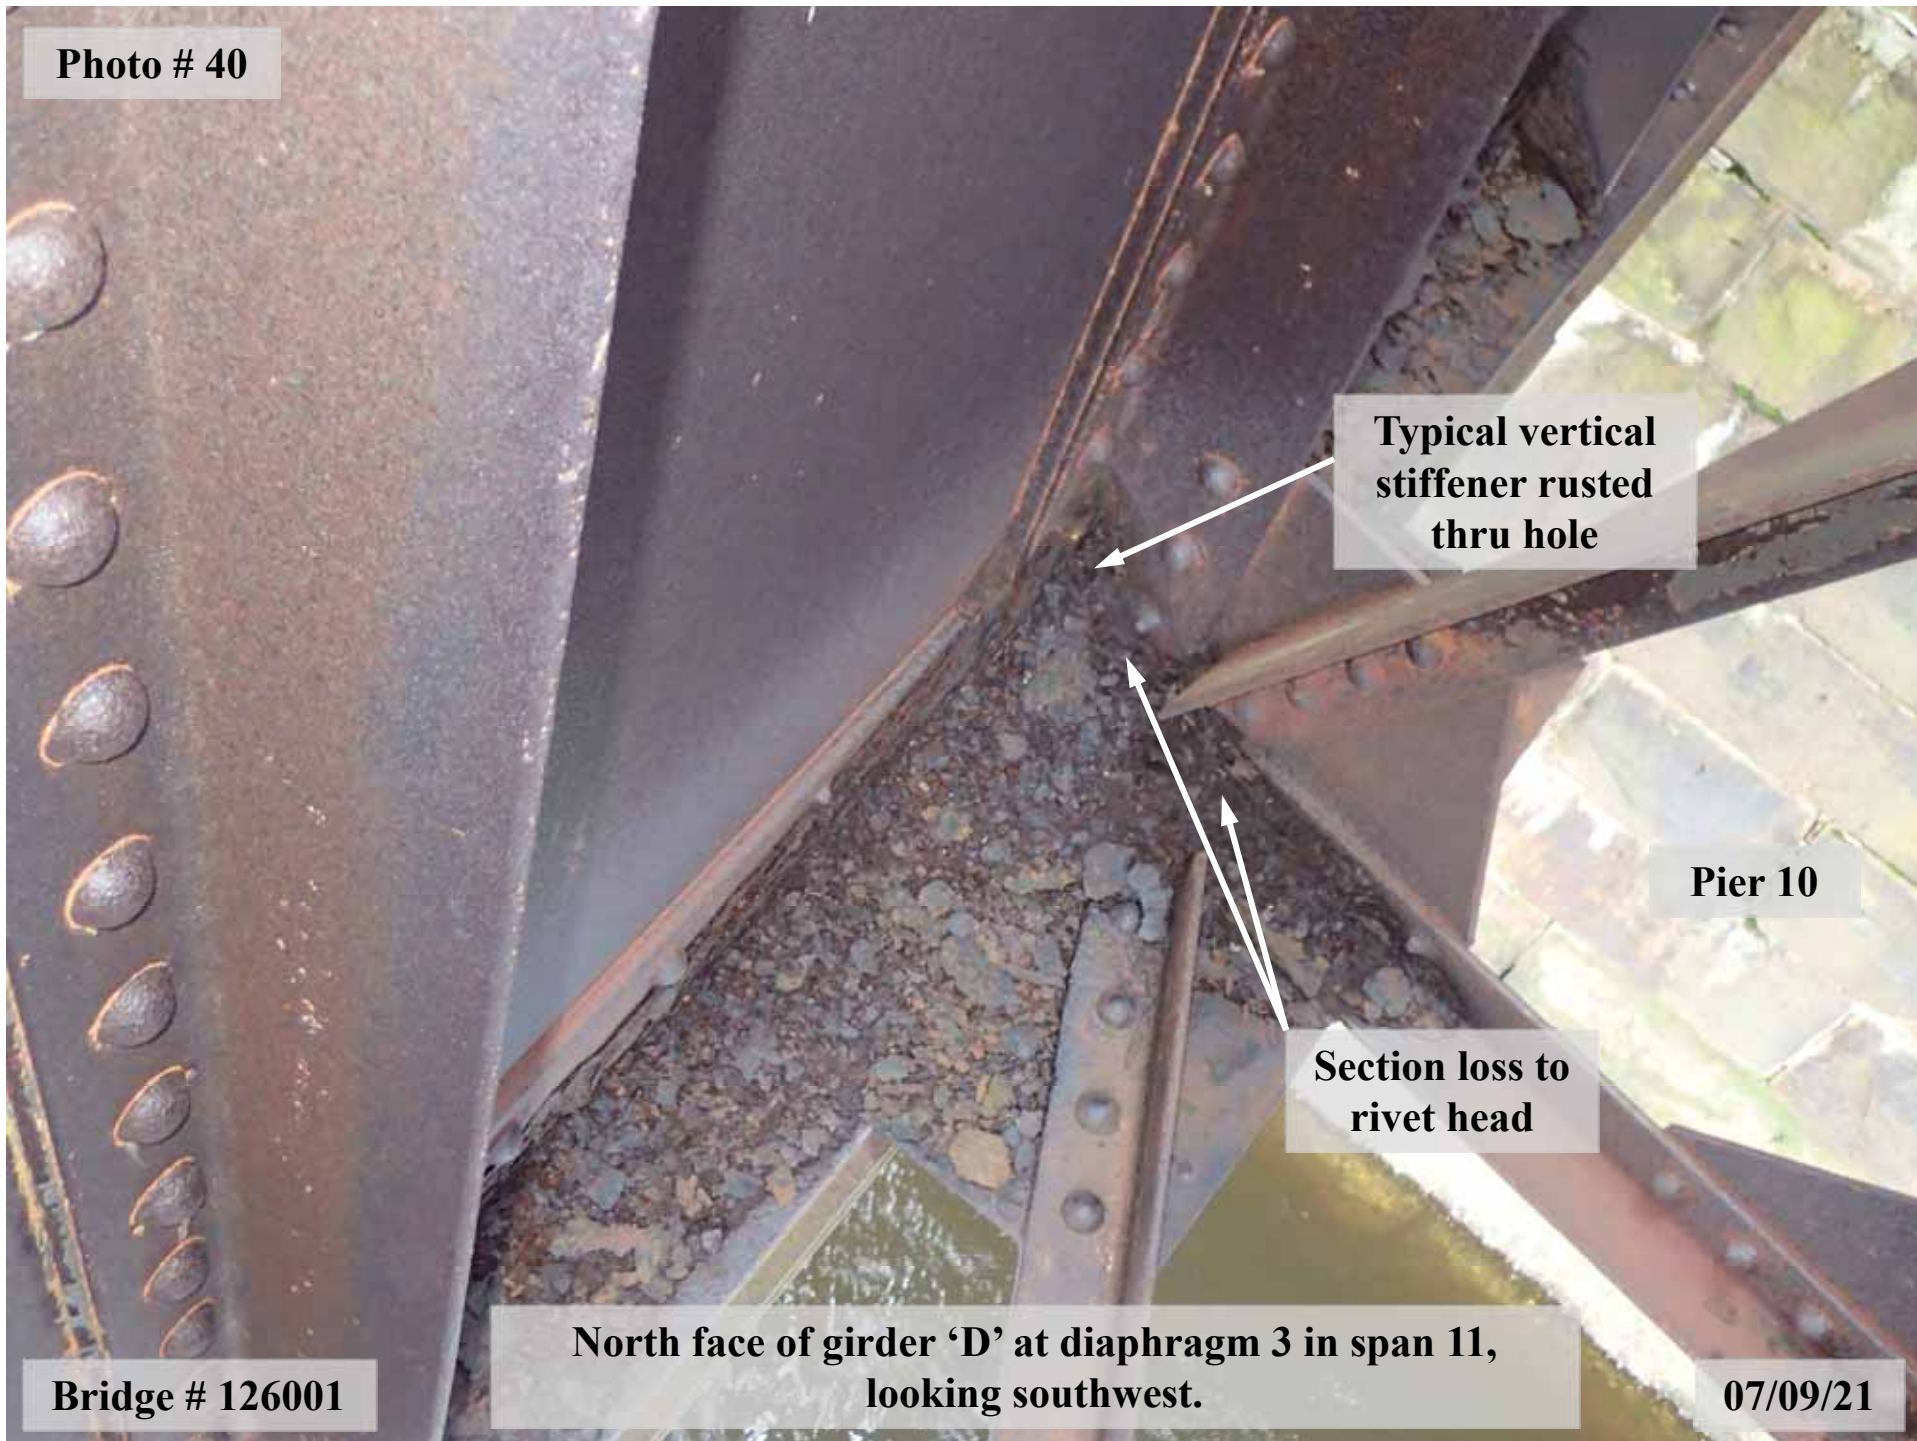
Photo # 40

**Typical vertical
stiffener rusted
thru hole**

**Section loss to
rivet head**

**North face of girder 'D' at diaphragm 3 in span 11,
looking southwest.**

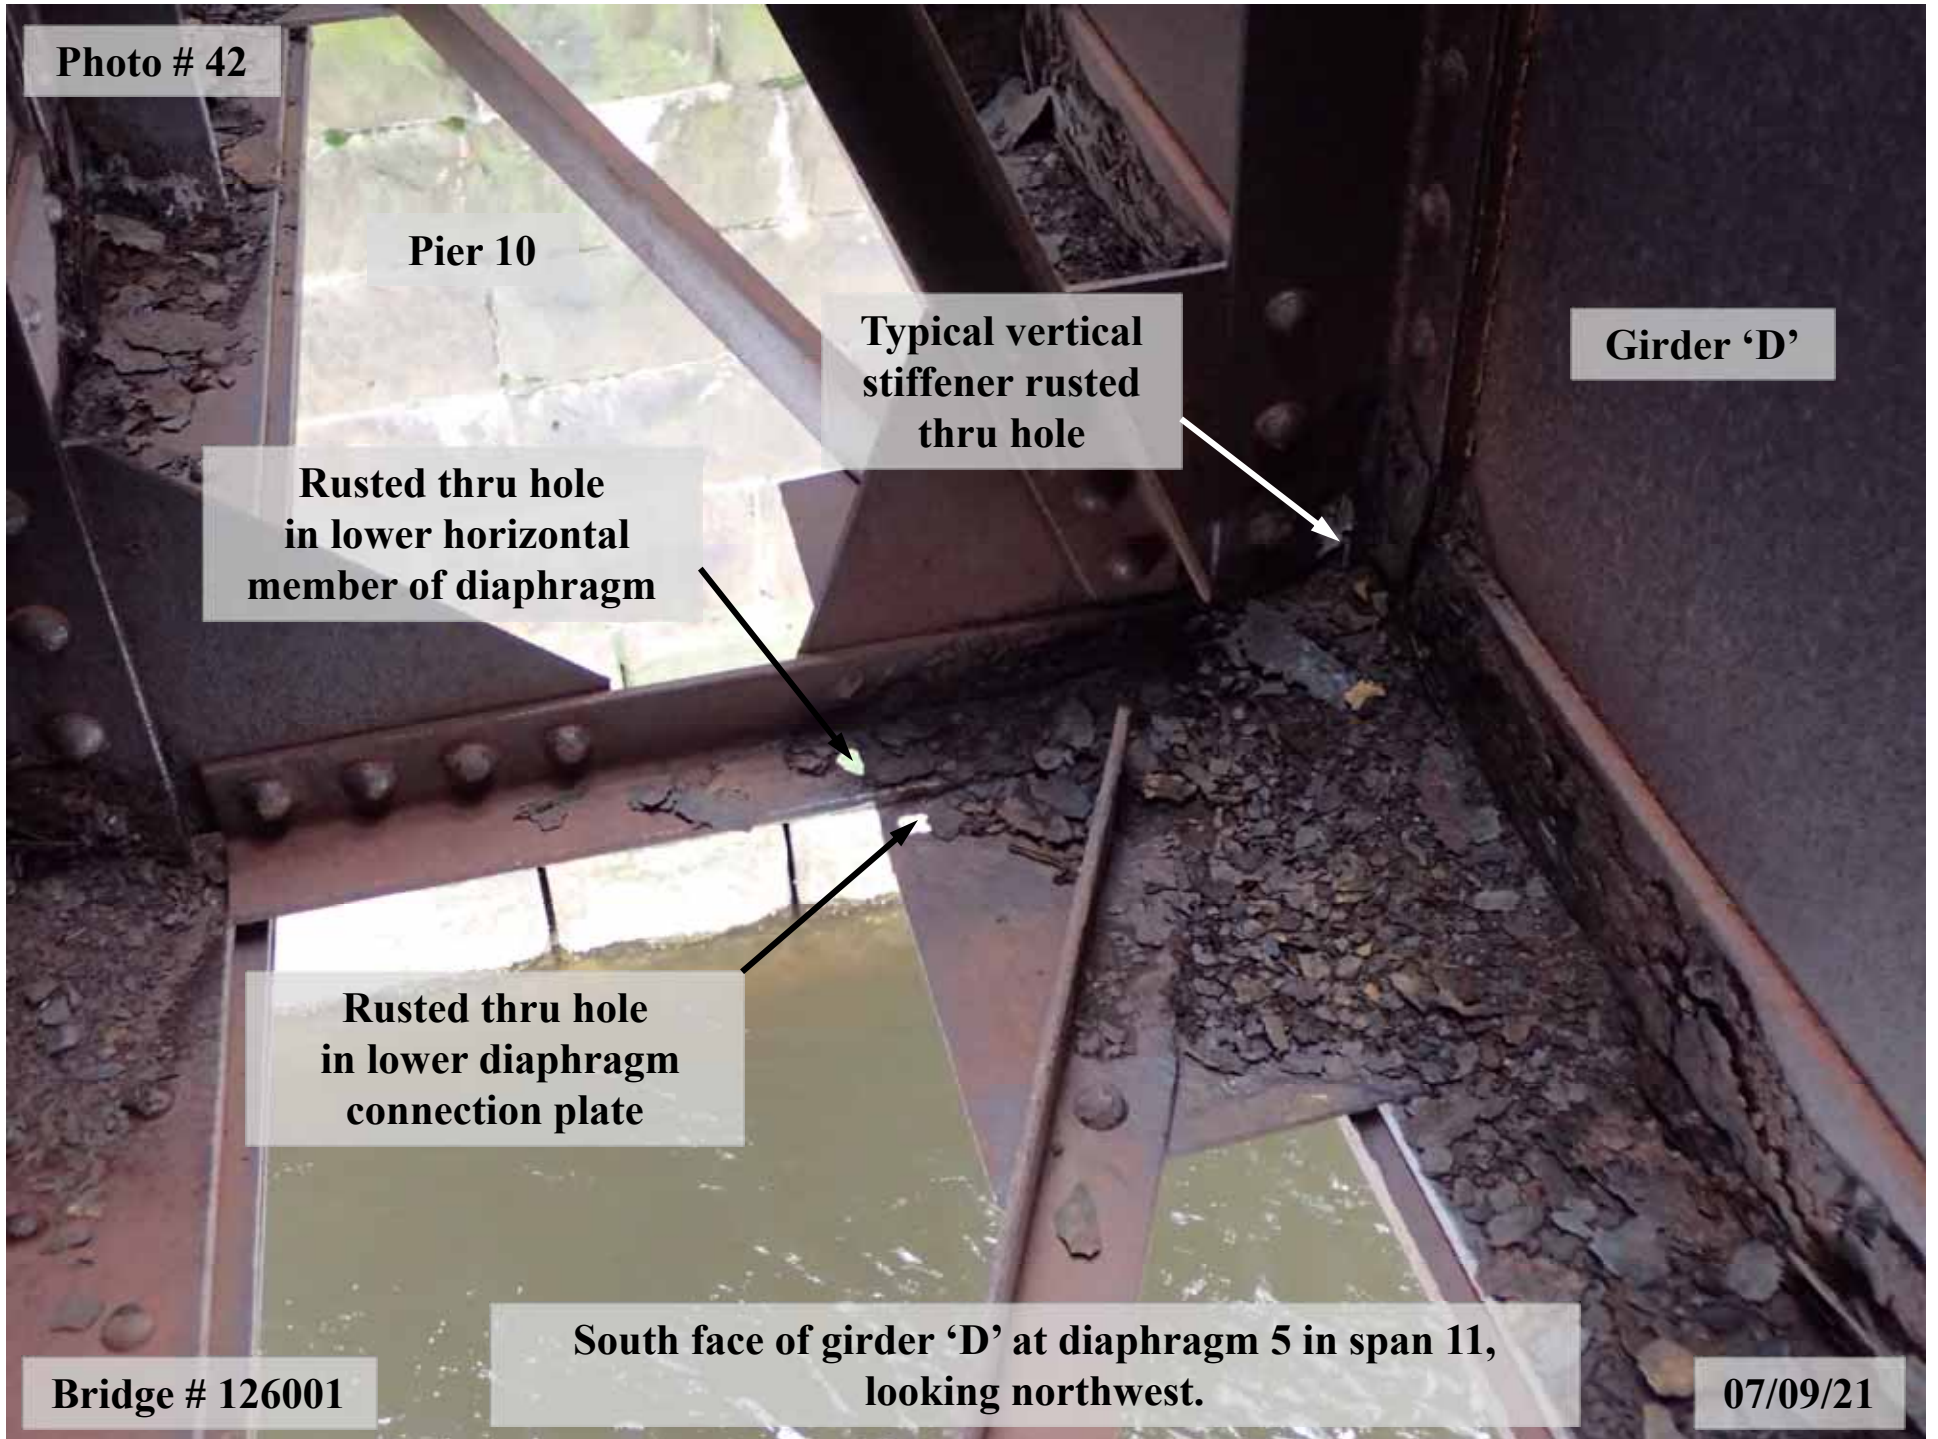
Photo # 42

Typical vertical stiffener rusted thru hole

Rusted thru hole in lower horizontal member of diaphragm

Rusted thru hole in lower diaphragm connection plate

South face of girder 'D' at diaphragm 5 in span 11, looking northwest.

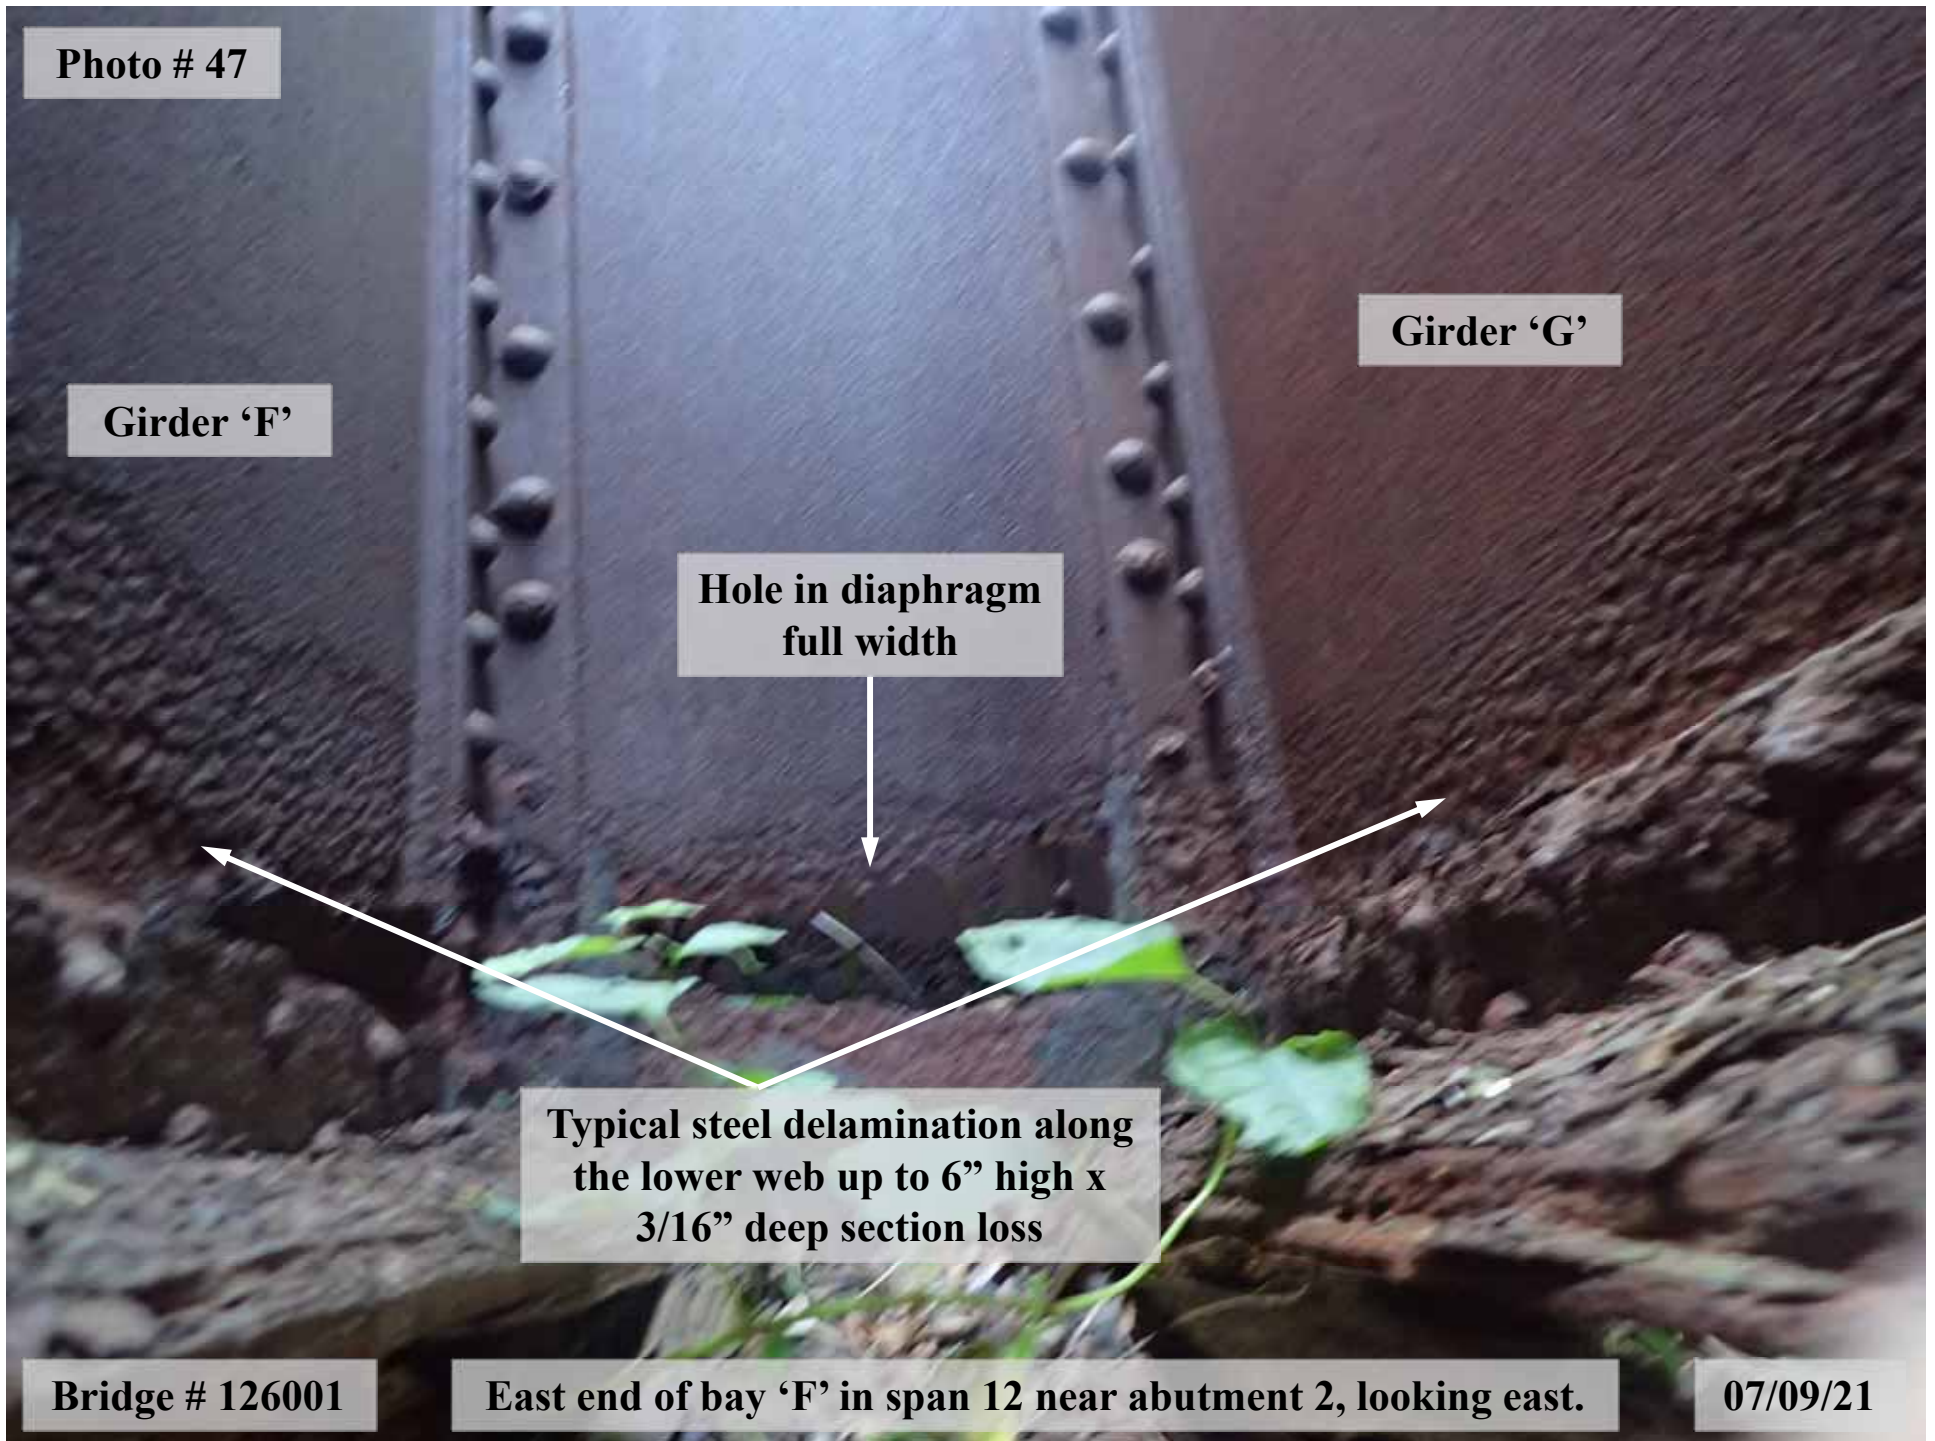
Photo # 47

**Hole in diaphragm
full width**

**Typical steel delamination along
the lower web up to 6" high x
3/16" deep section loss**

East end of bay 'F' in span 12 near abutment 2, looking east.

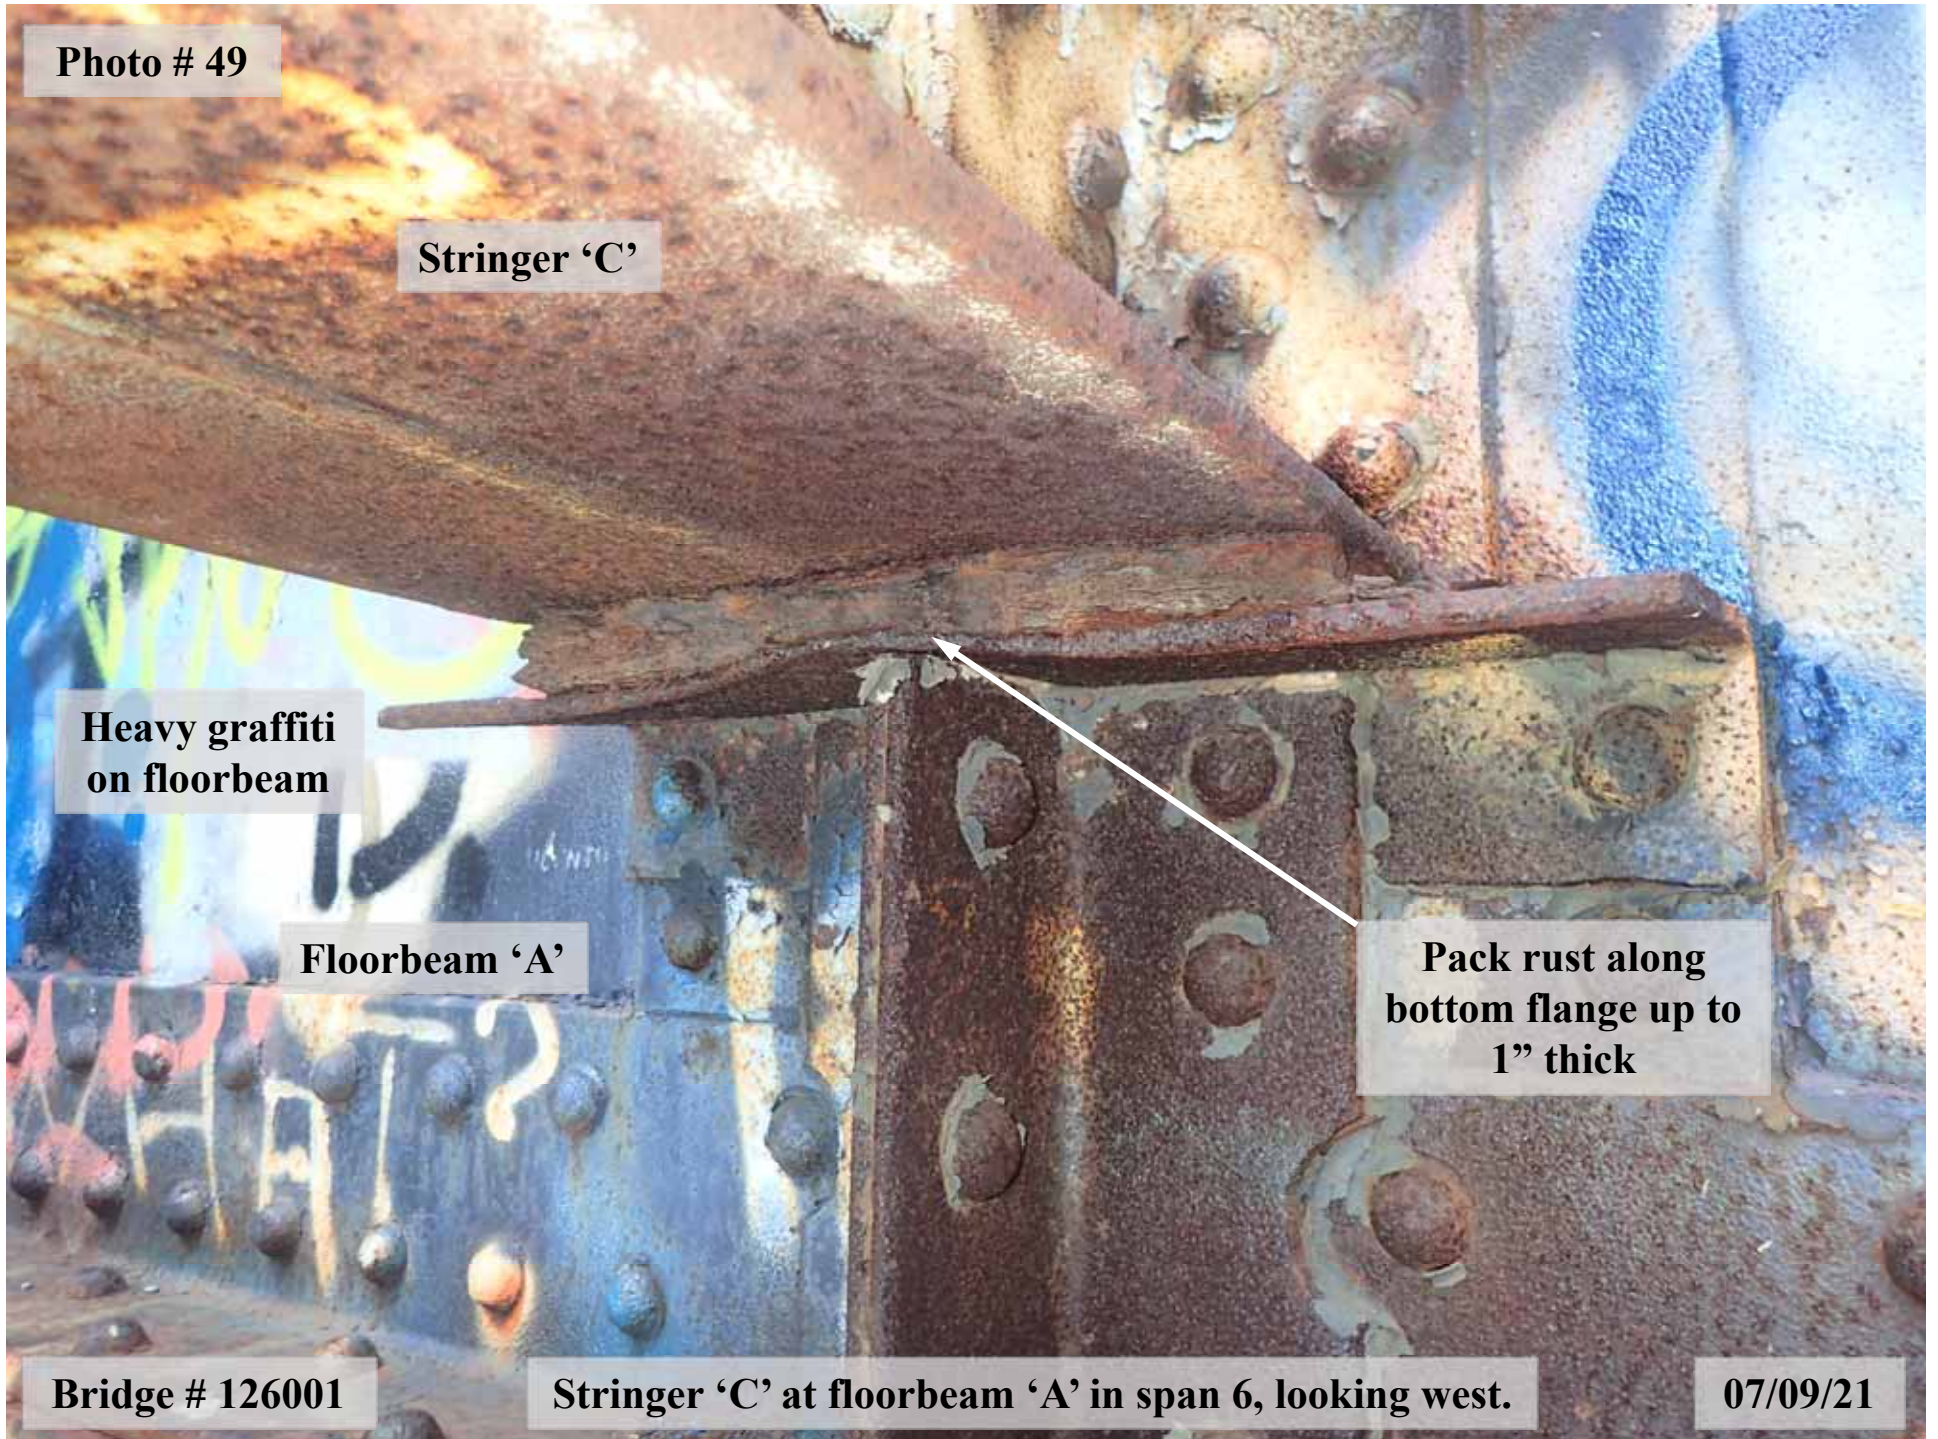
Photo # 49

**Heavy graffiti
on floorbeam**

**Pack rust along
bottom flange up to
1" thick**

Stringer 'C' at floorbeam 'A' in span 6, looking west.

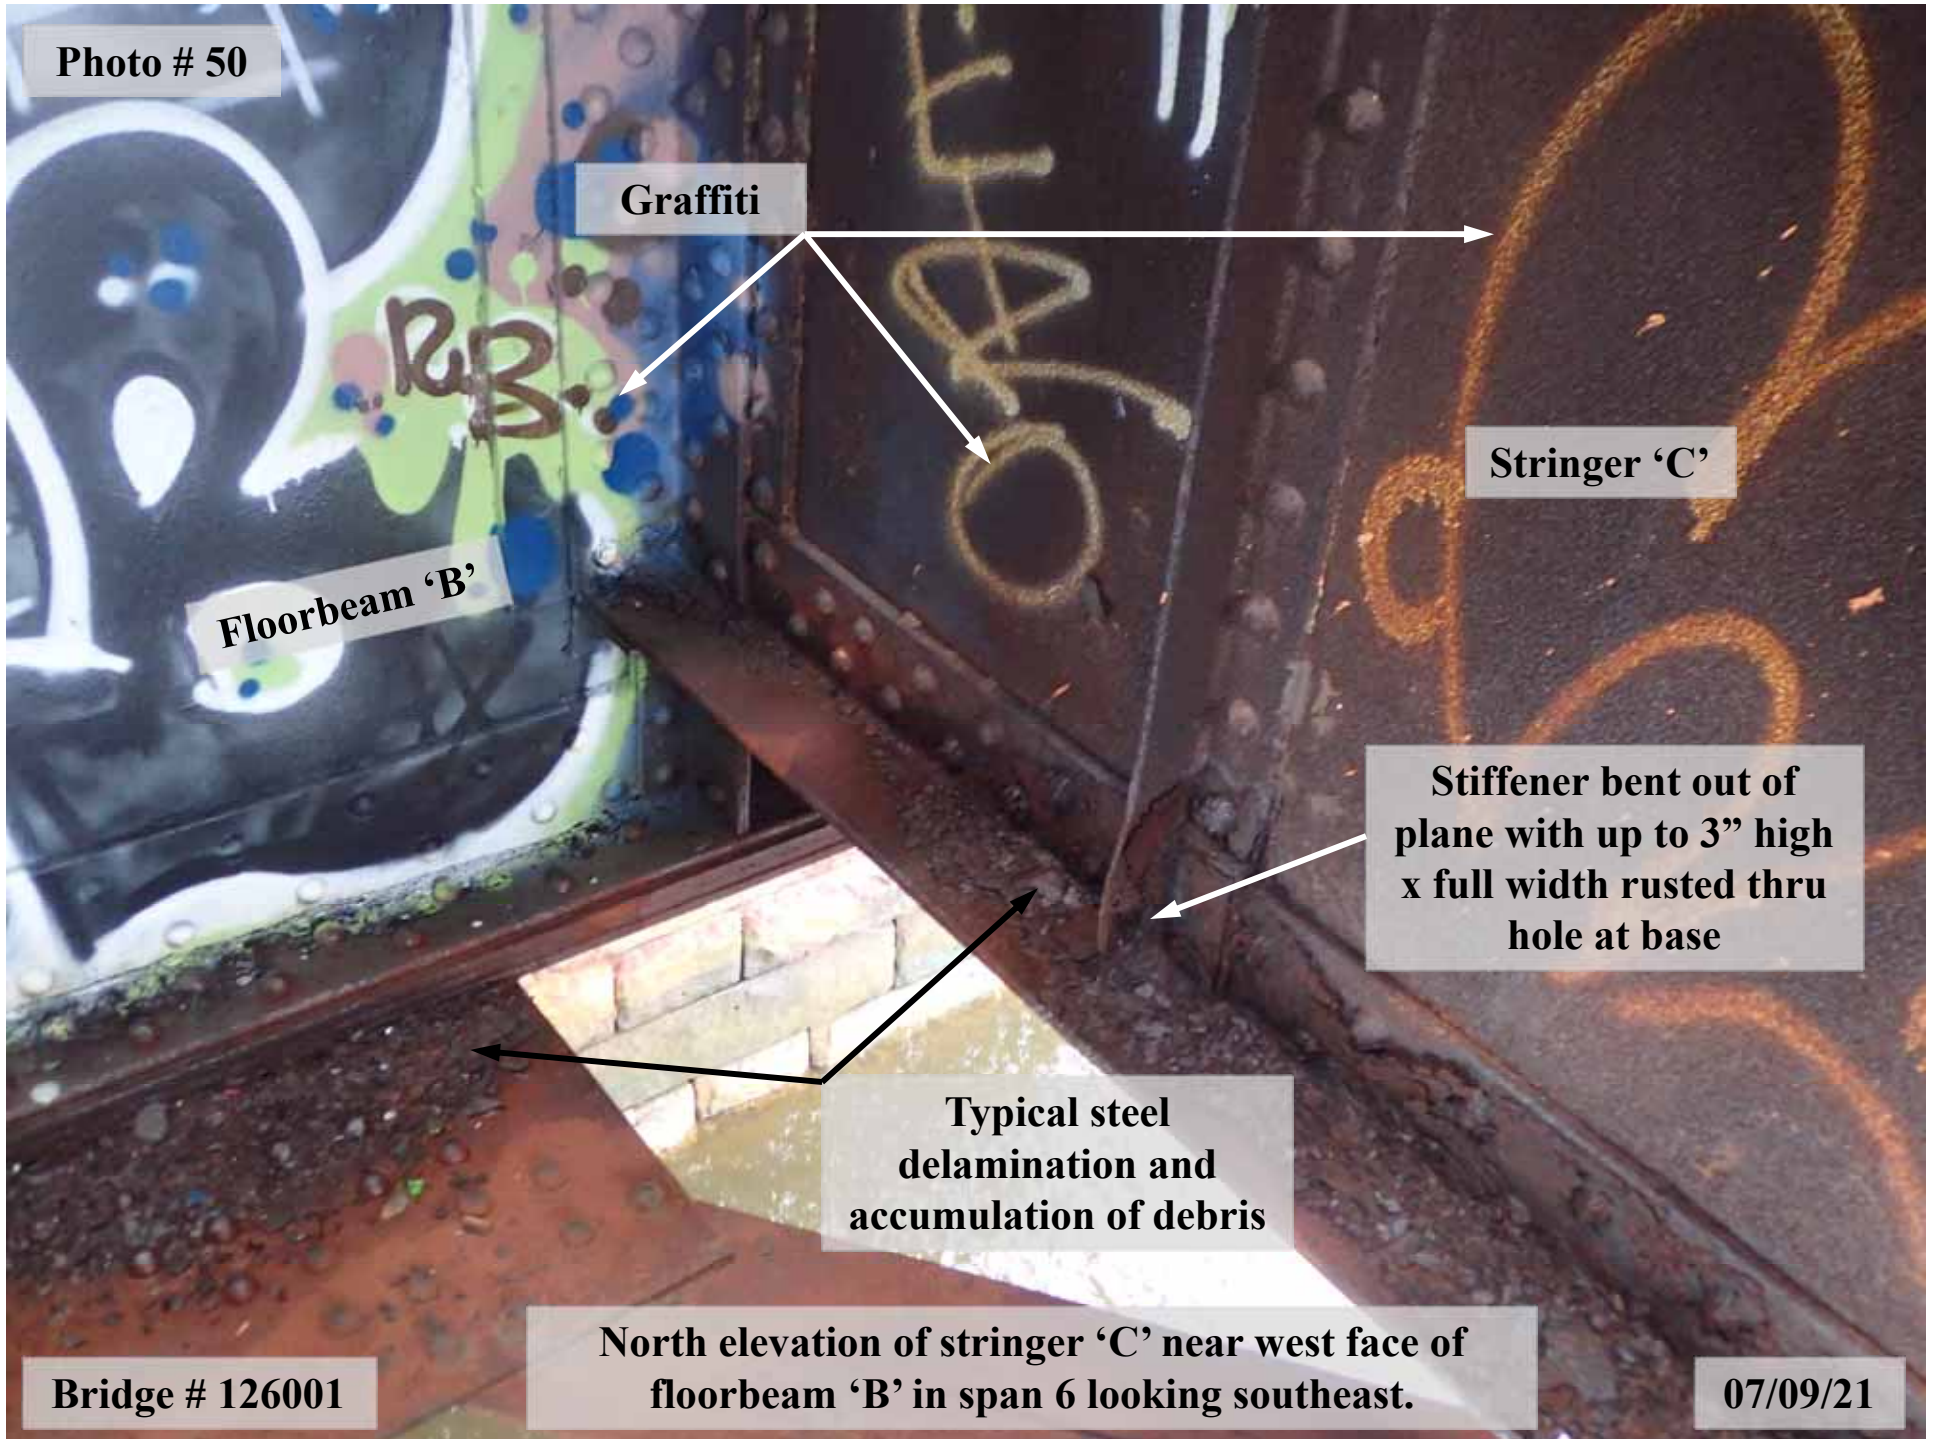
Photo # 50

Stiffener bent out of plane with up to 3" high x full width rusted thru hole at base

Typical steel delamination and accumulation of debris

North elevation of stringer 'C' near west face of floorbeam 'B' in span 6 looking southeast.

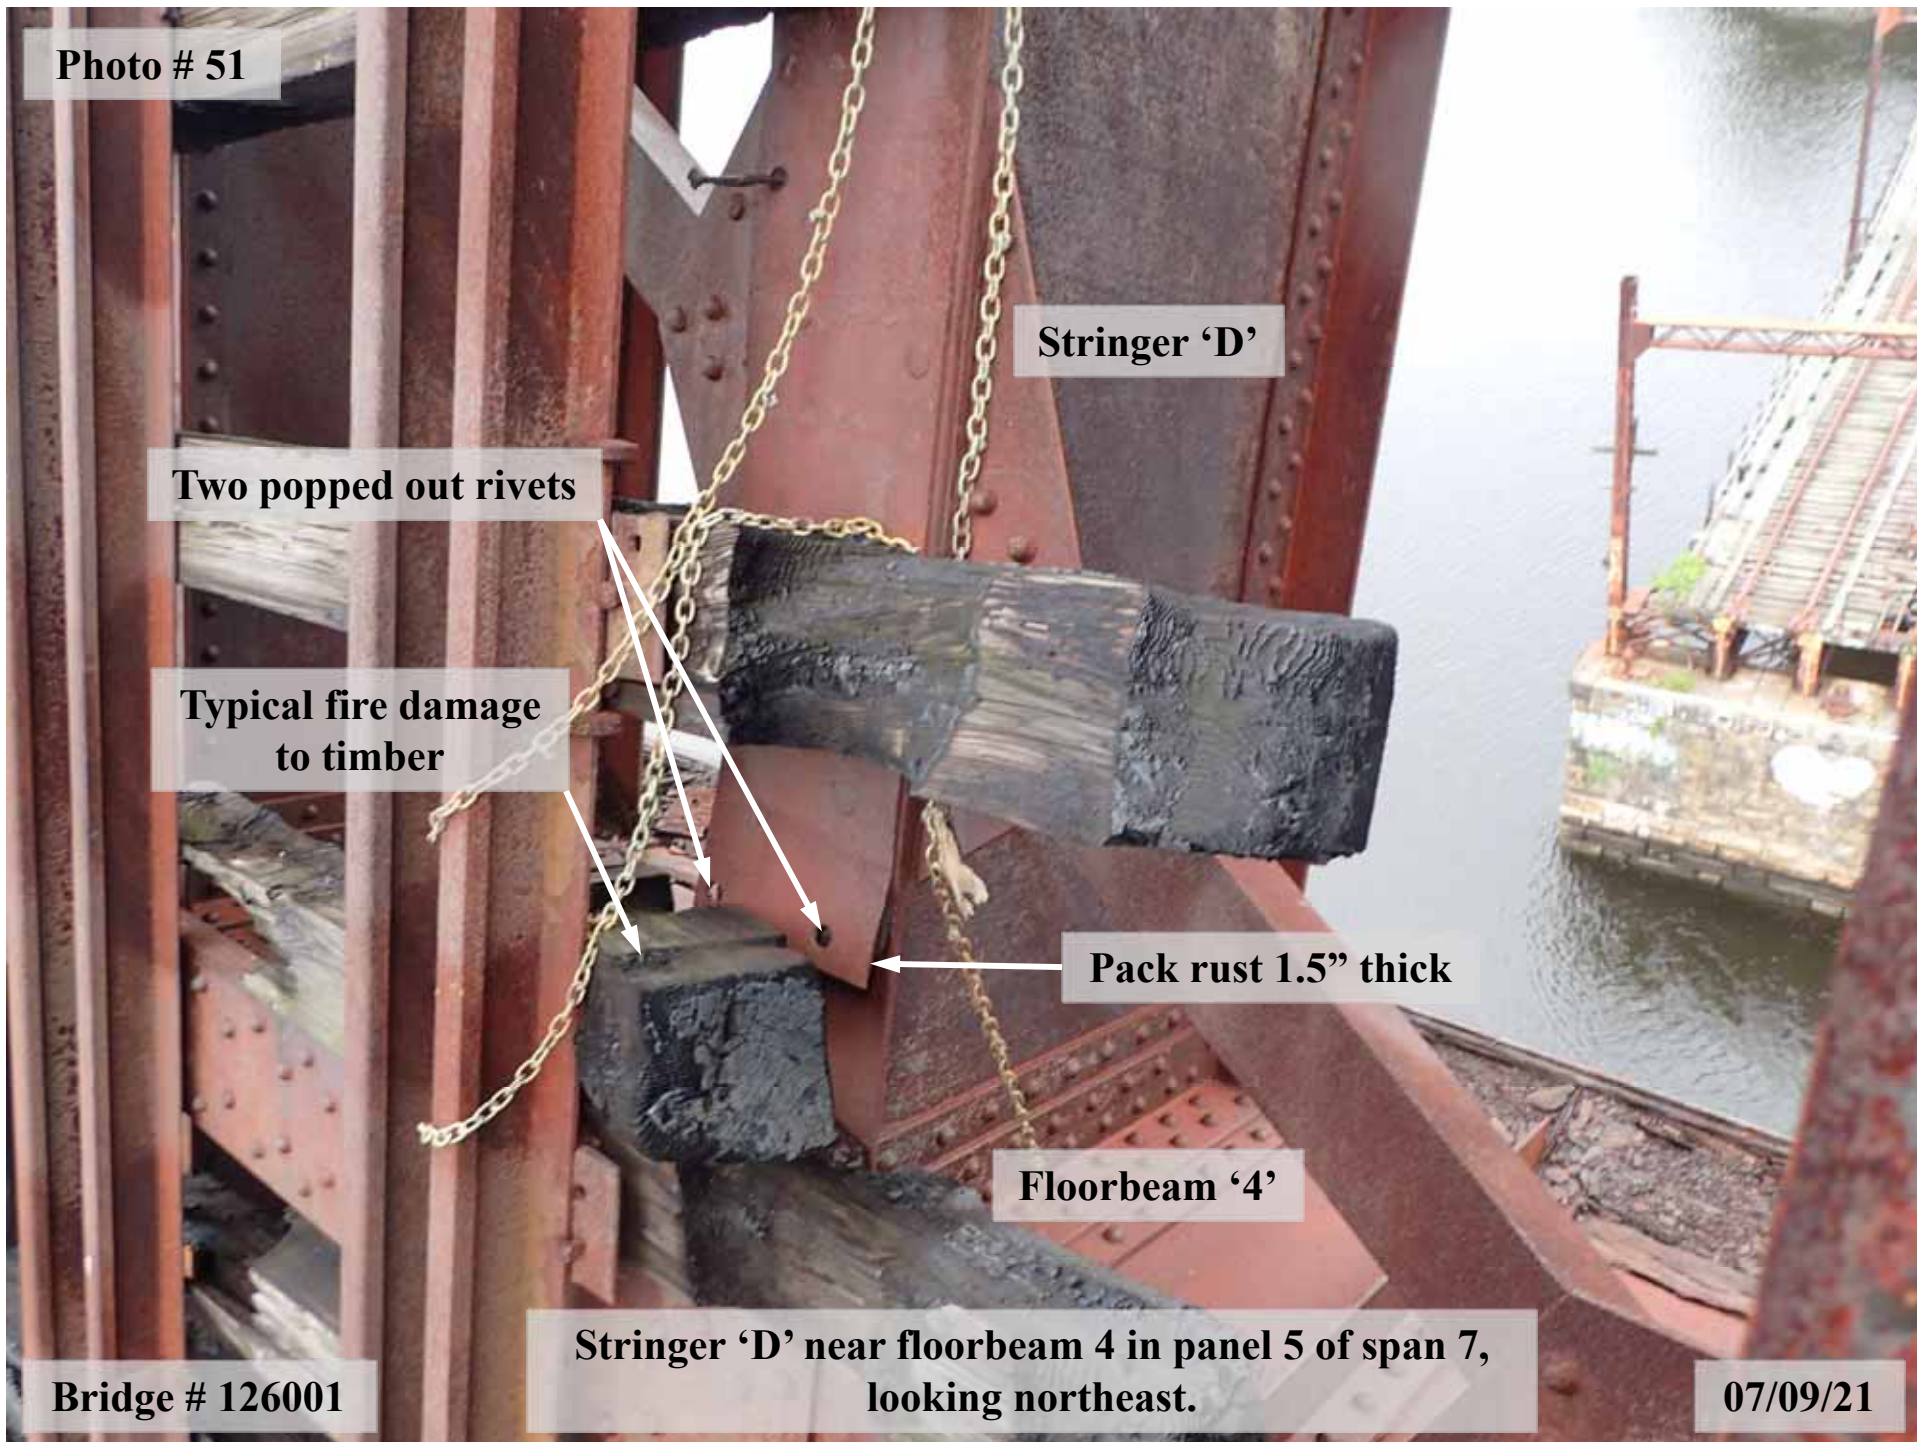
Photo # 51

Two popped out rivets

Typical fire damage to timber

Pack rust 1.5" thick

Stringer 'D' near floorbeam 4 in panel 5 of span 7, looking northeast.
