CITY OF PROVIDENCE, RHODE ISLAND

**RFP Title: URBAN DESIGN CONSULTING SERVICES RELATING TO CROOK POINT BRIDGE
PRESERVATION**

Addendum #: 1

A potential respondent has asked for supporting pictures referenced in the bid materials. This addendum adds those pictures.

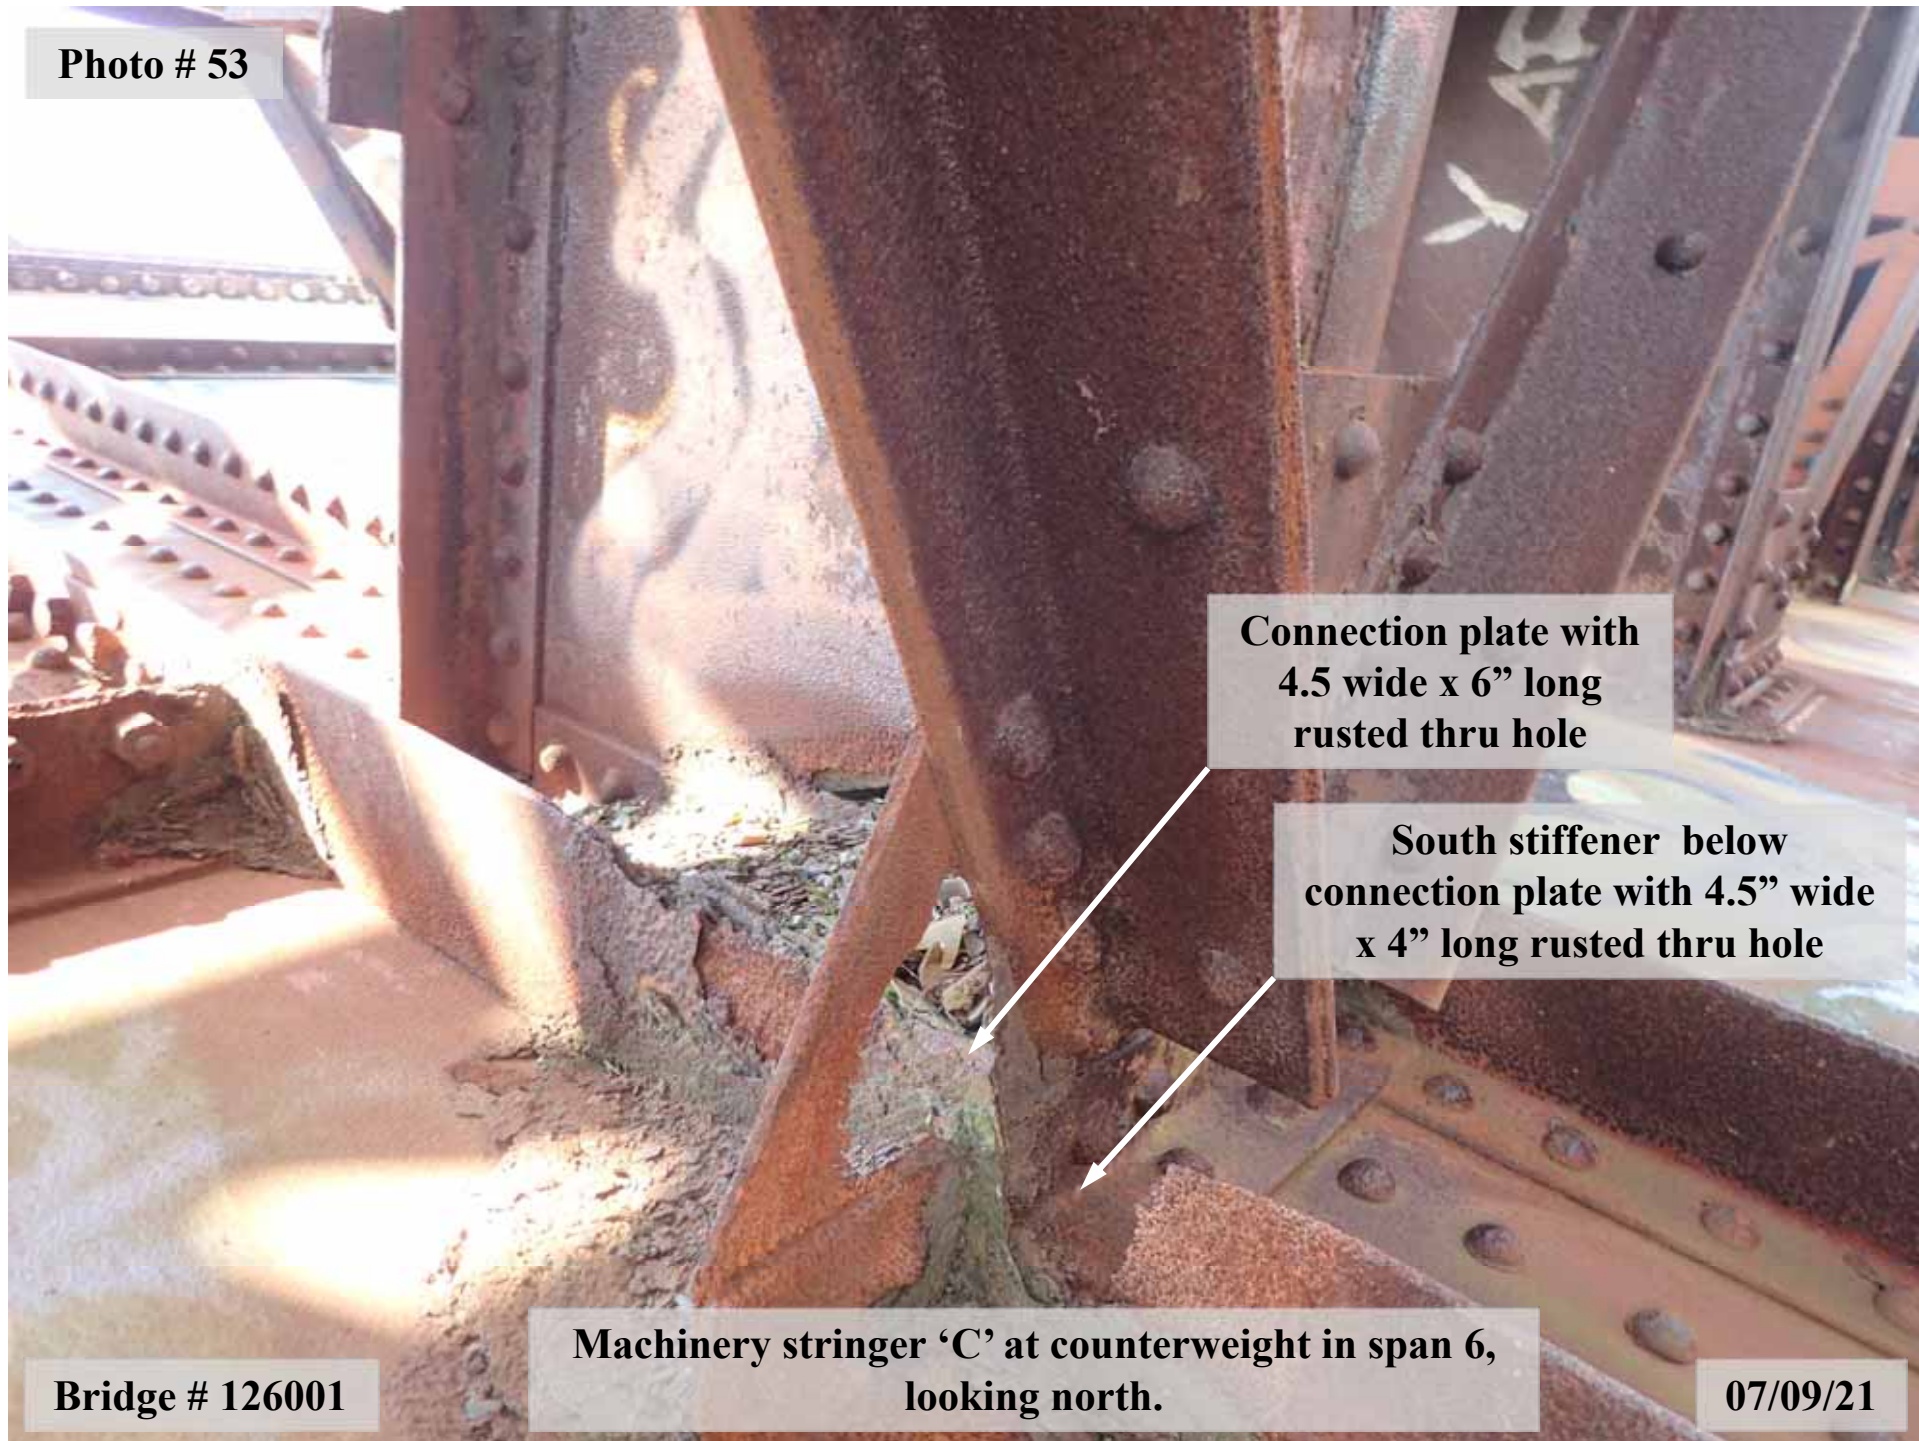
Photo # 53

**Connection plate with
4.5 wide x 6" long
rusted thru hole**

**South stiffener below
connection plate with 4.5" wide
x 4" long rusted thru hole**

**Machinery stringer 'C' at counterweight in span 6,
looking north.**

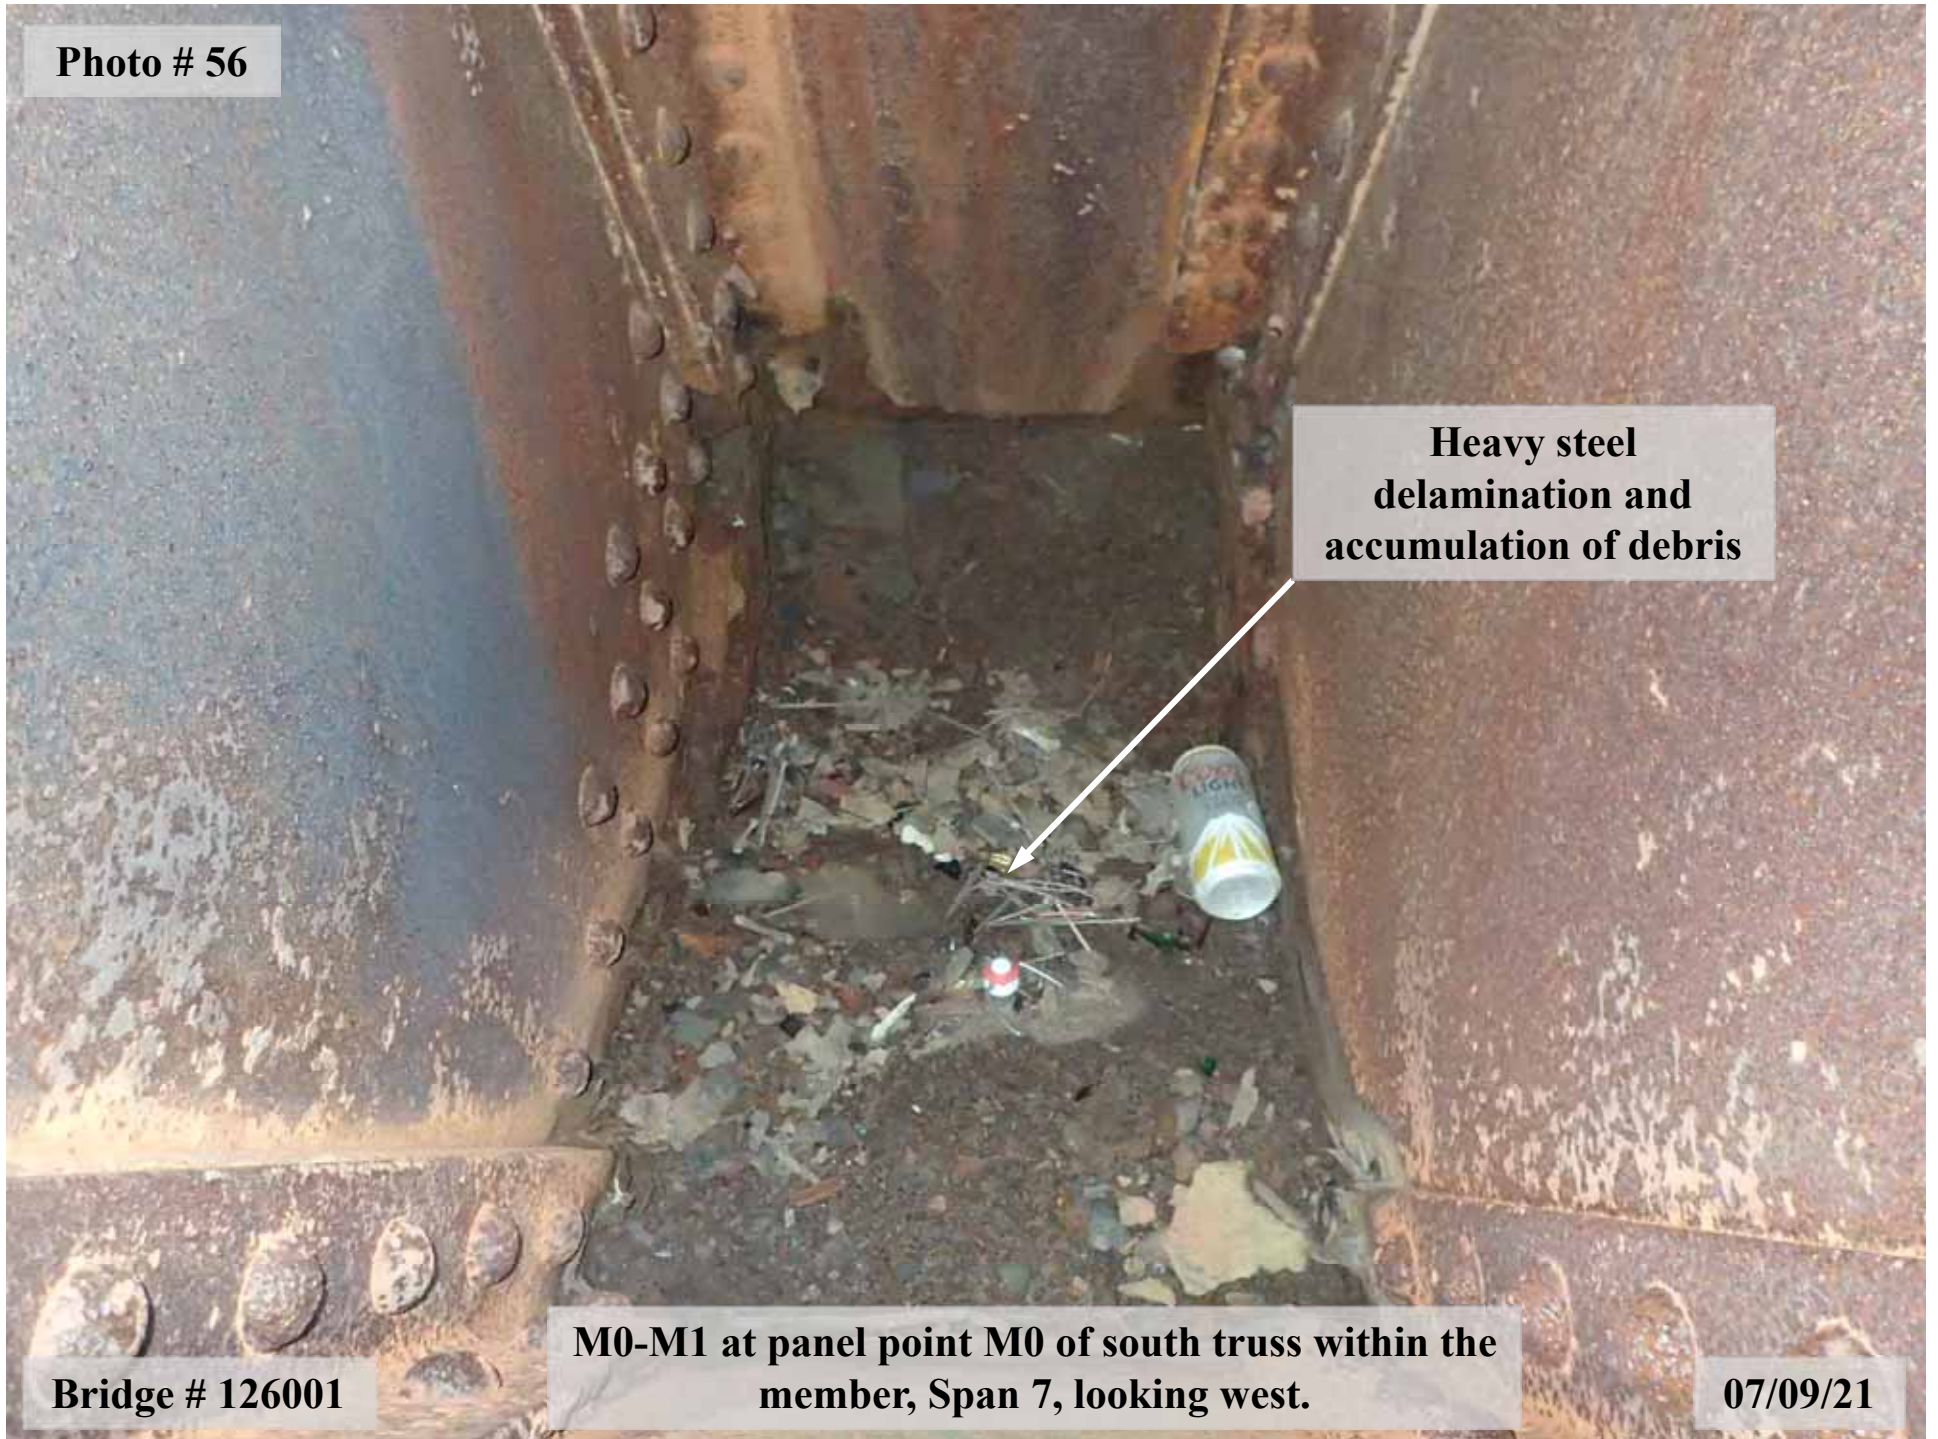
Photo # 56

**Heavy steel
delamination and
accumulation of debris**

**M0-M1 at panel point M0 of south truss within the
member, Span 7, looking west.**

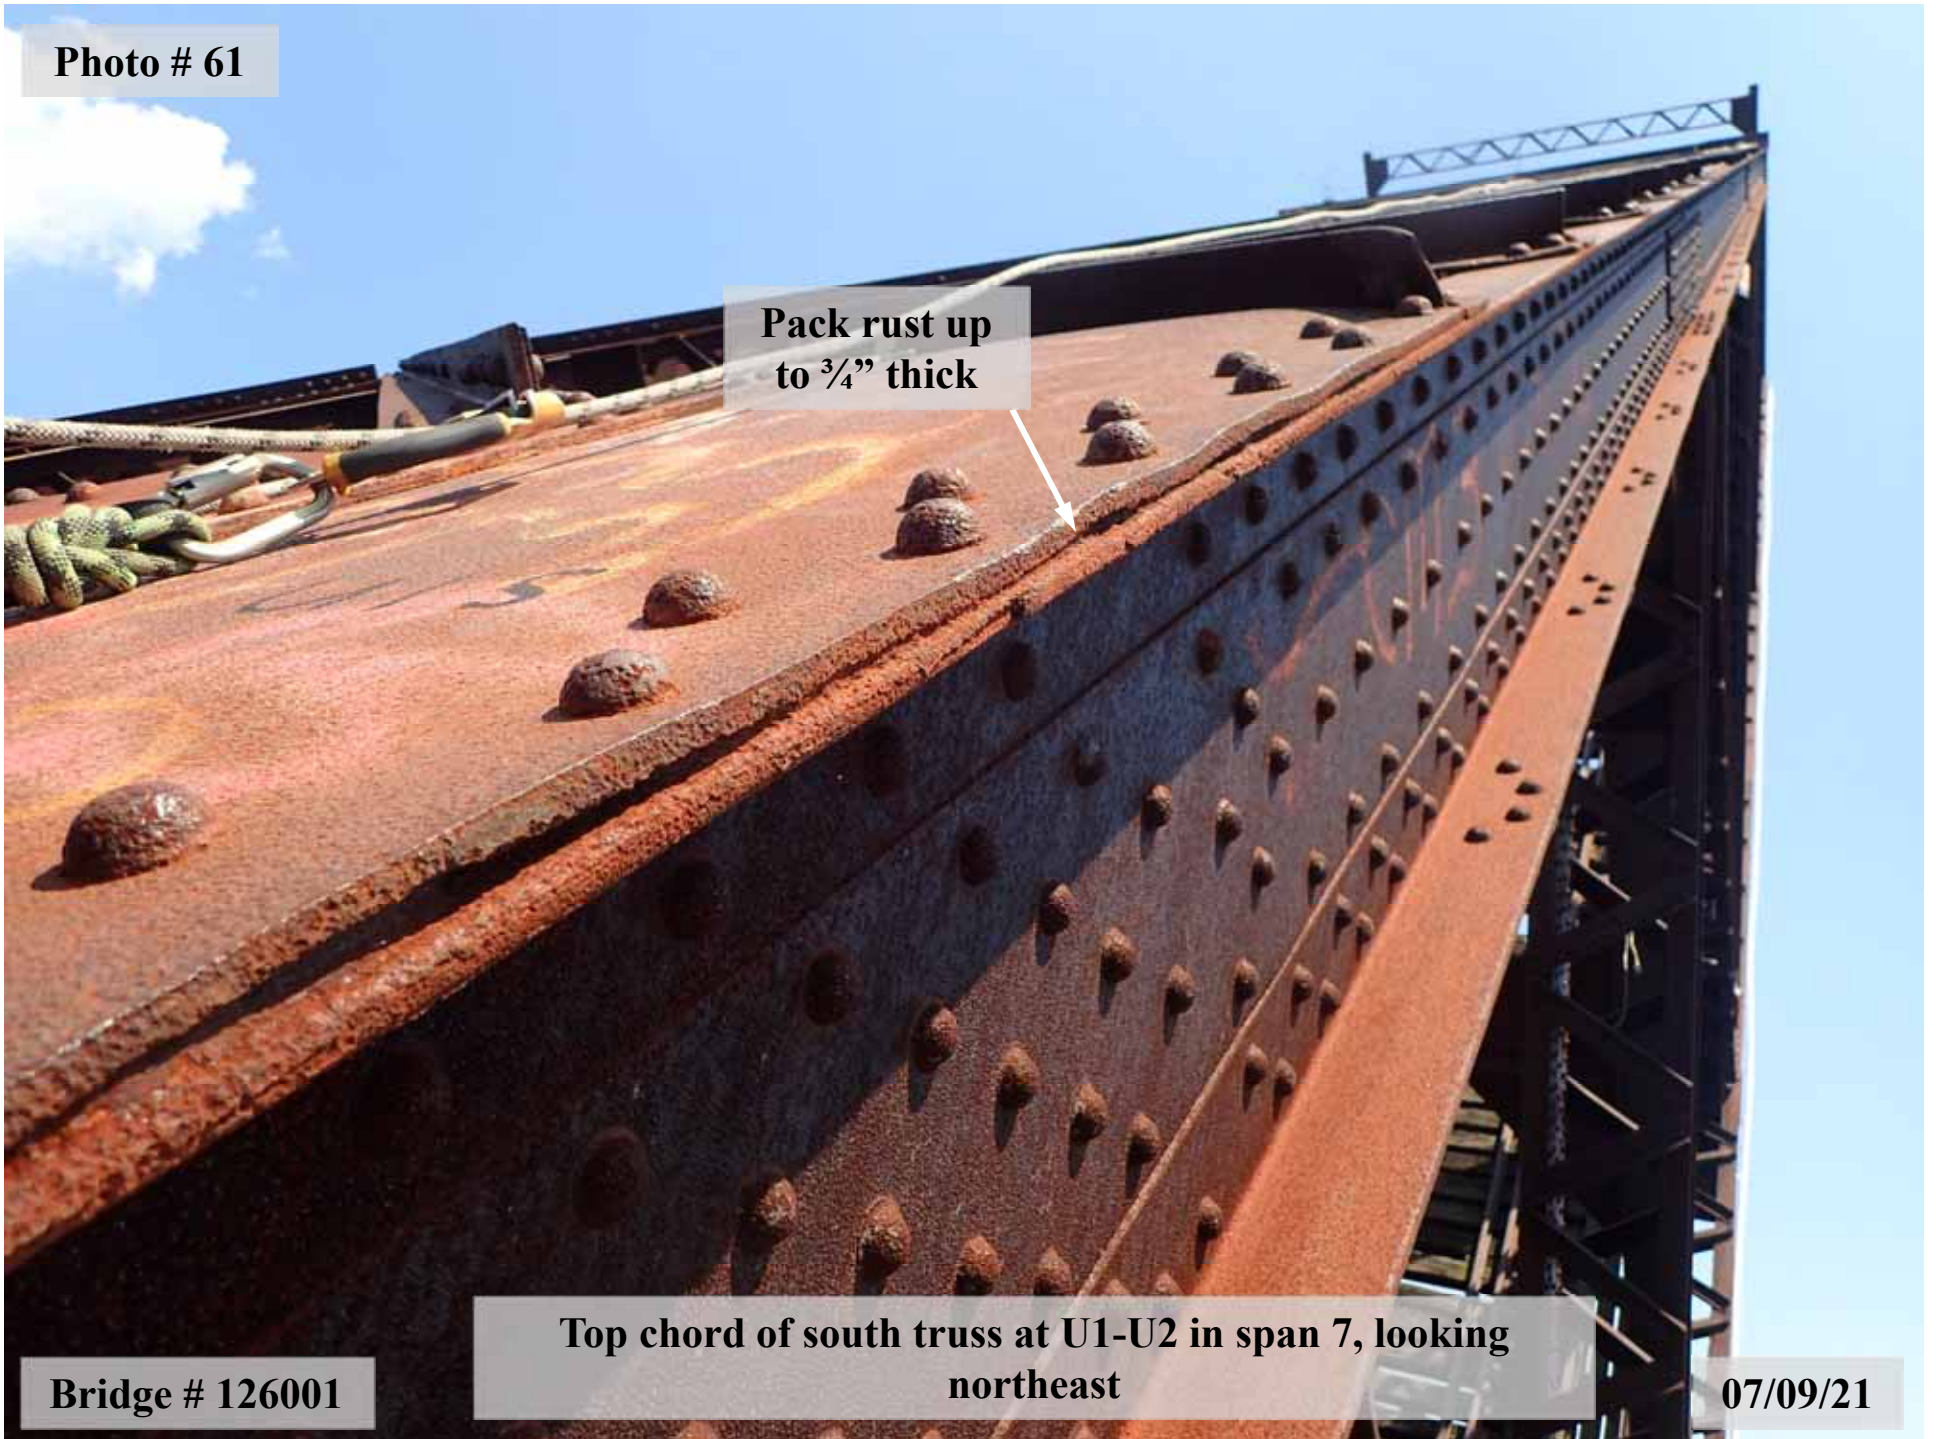
Photo # 61

**Pack rust up
to 3/4" thick**

**Top chord of south truss at U1-U2 in span 7, looking
northeast**

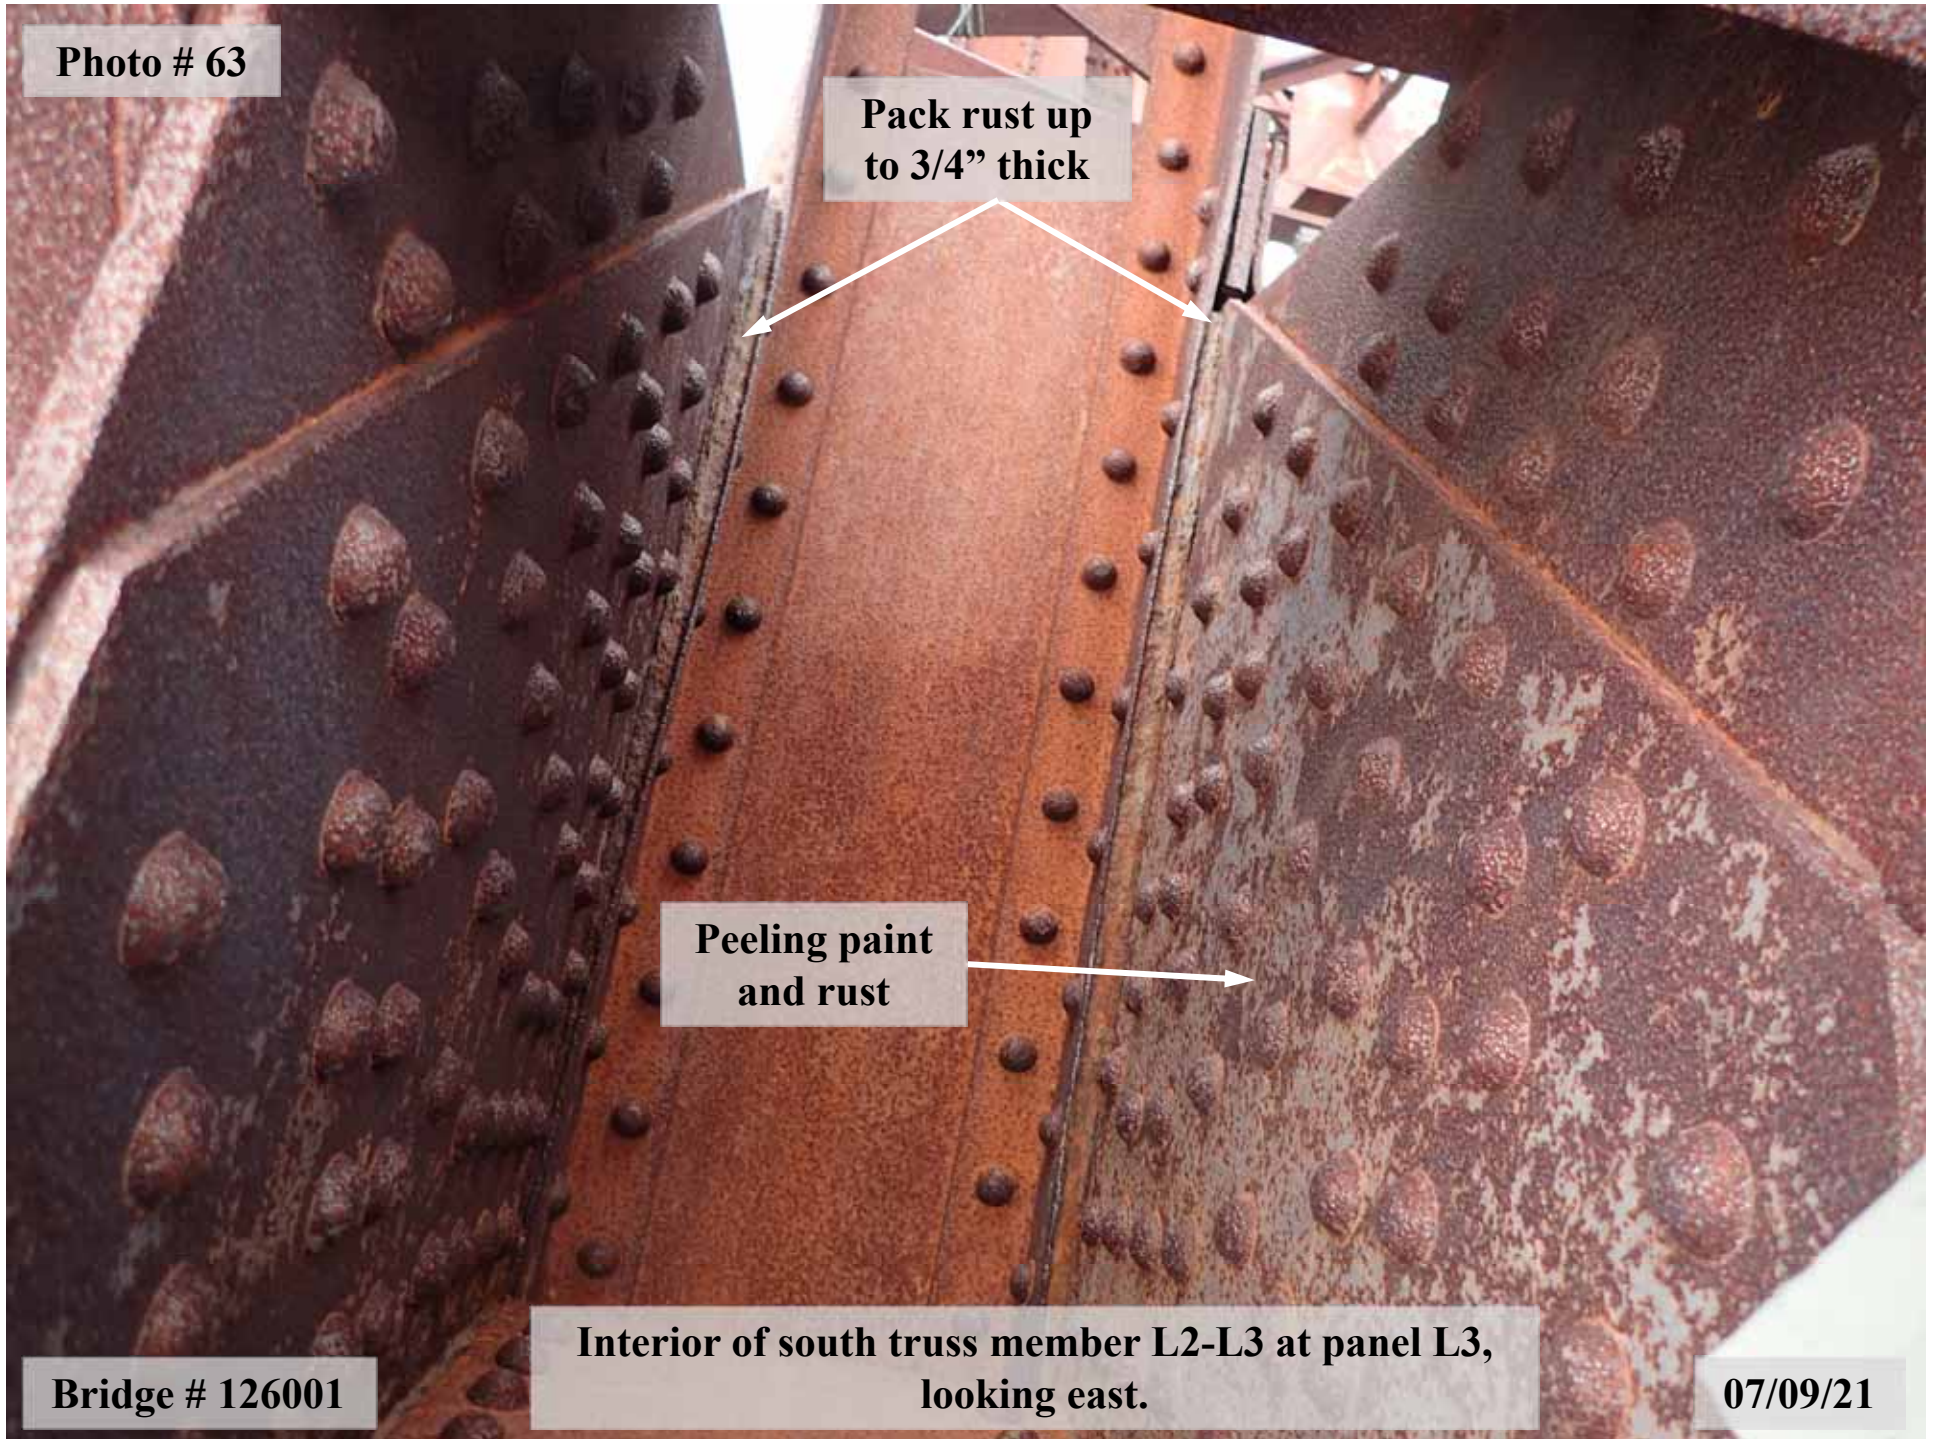
Photo # 63

**Pack rust up
to 3/4" thick**

**Peeling paint
and rust**

**Interior of south truss member L2-L3 at panel L3,
looking east.**

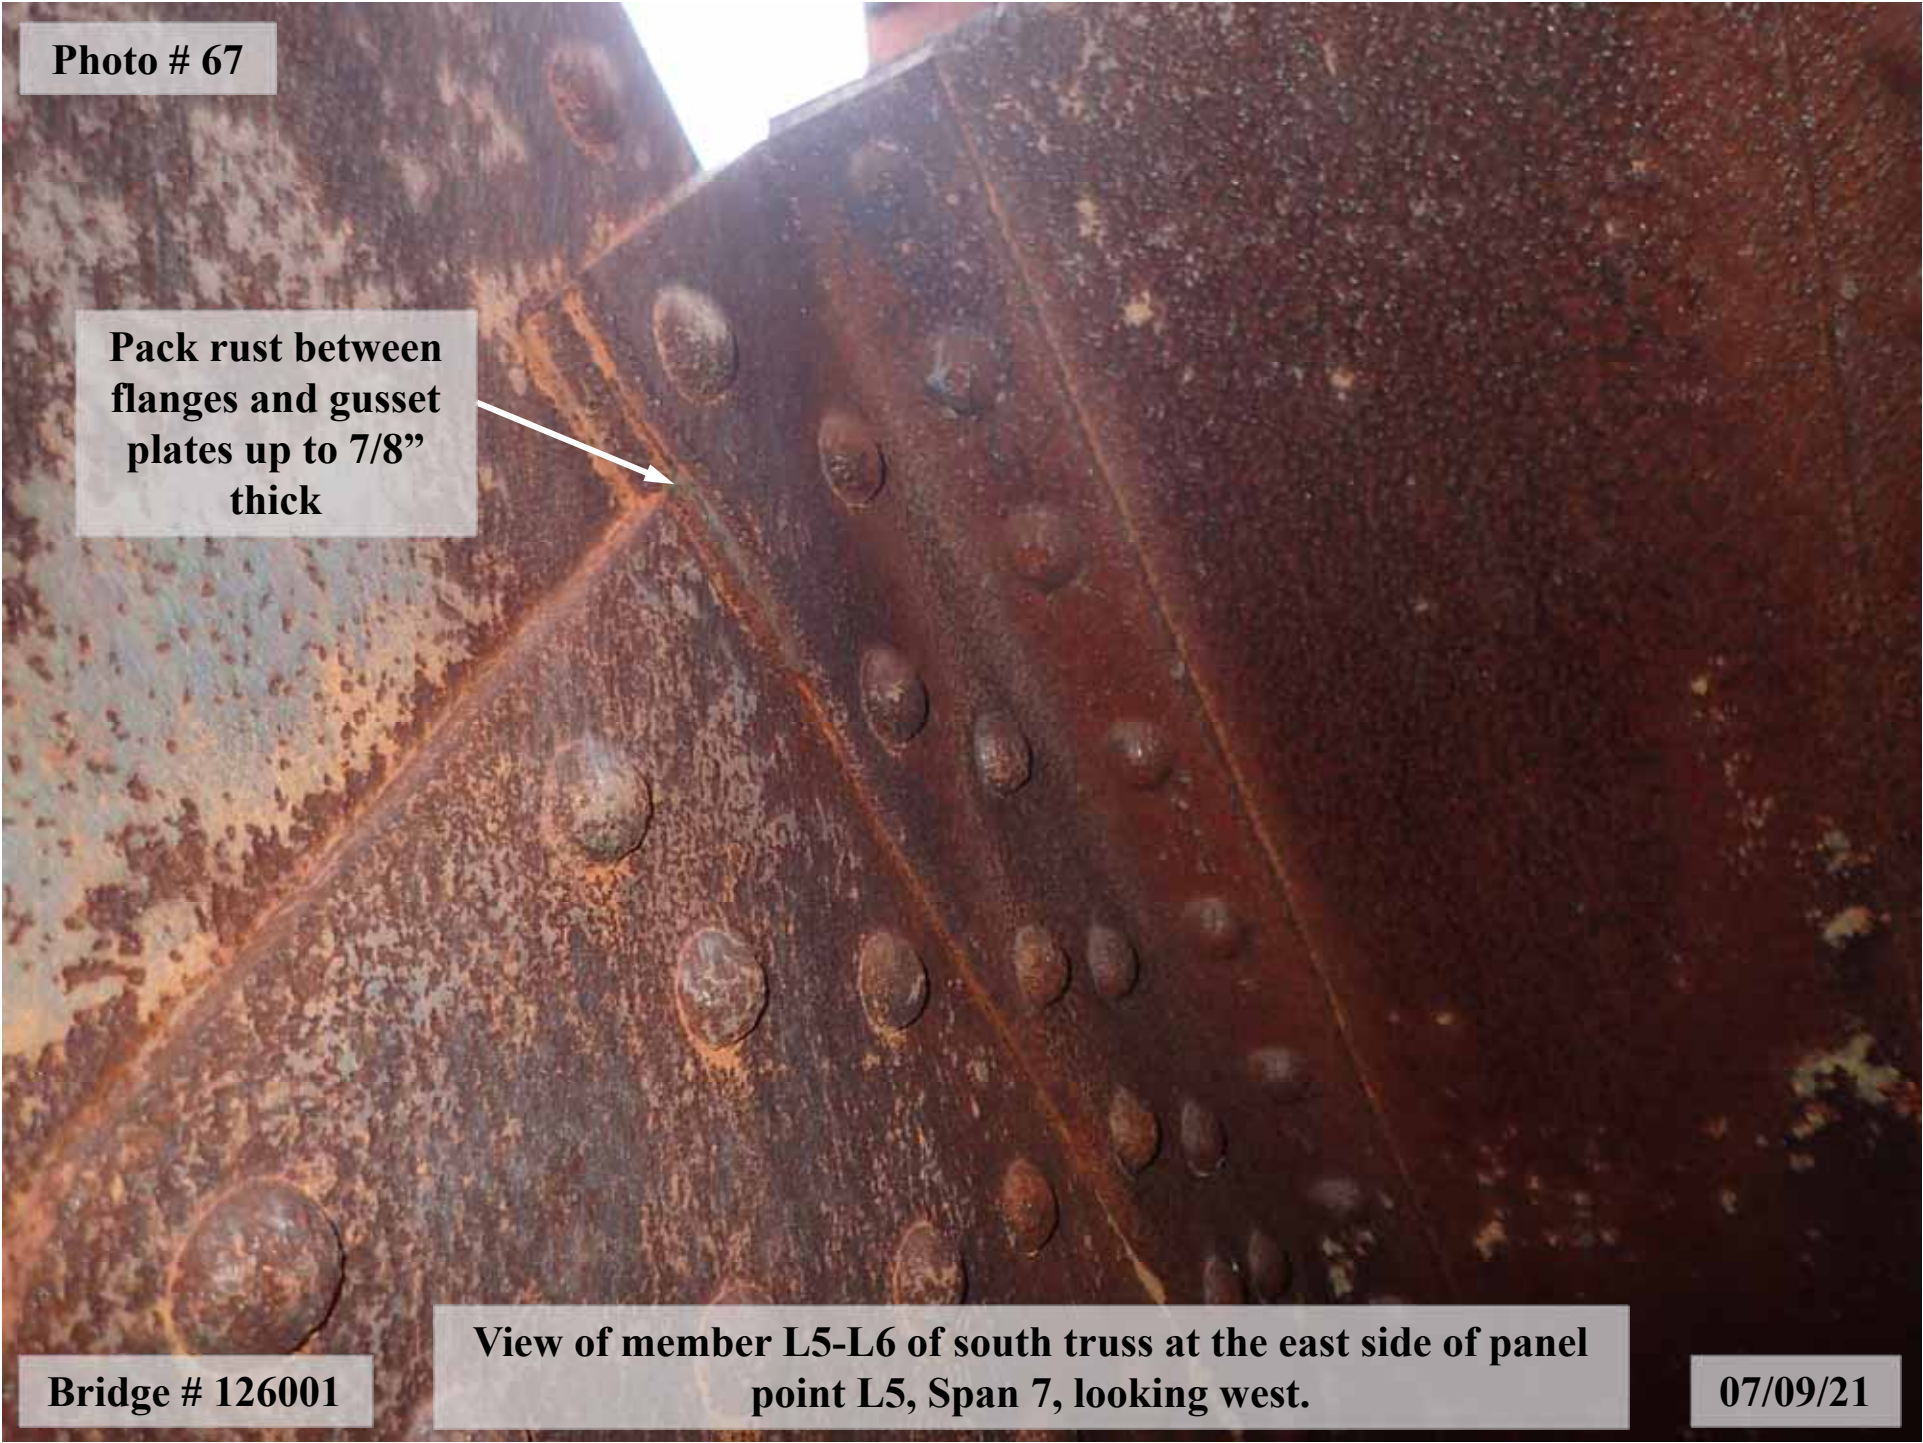
Photo # 67

**Pack rust between
flanges and gusset
plates up to 7/8"
thick**

**View of member L5-L6 of south truss at the east side of panel
point L5, Span 7, looking west.**

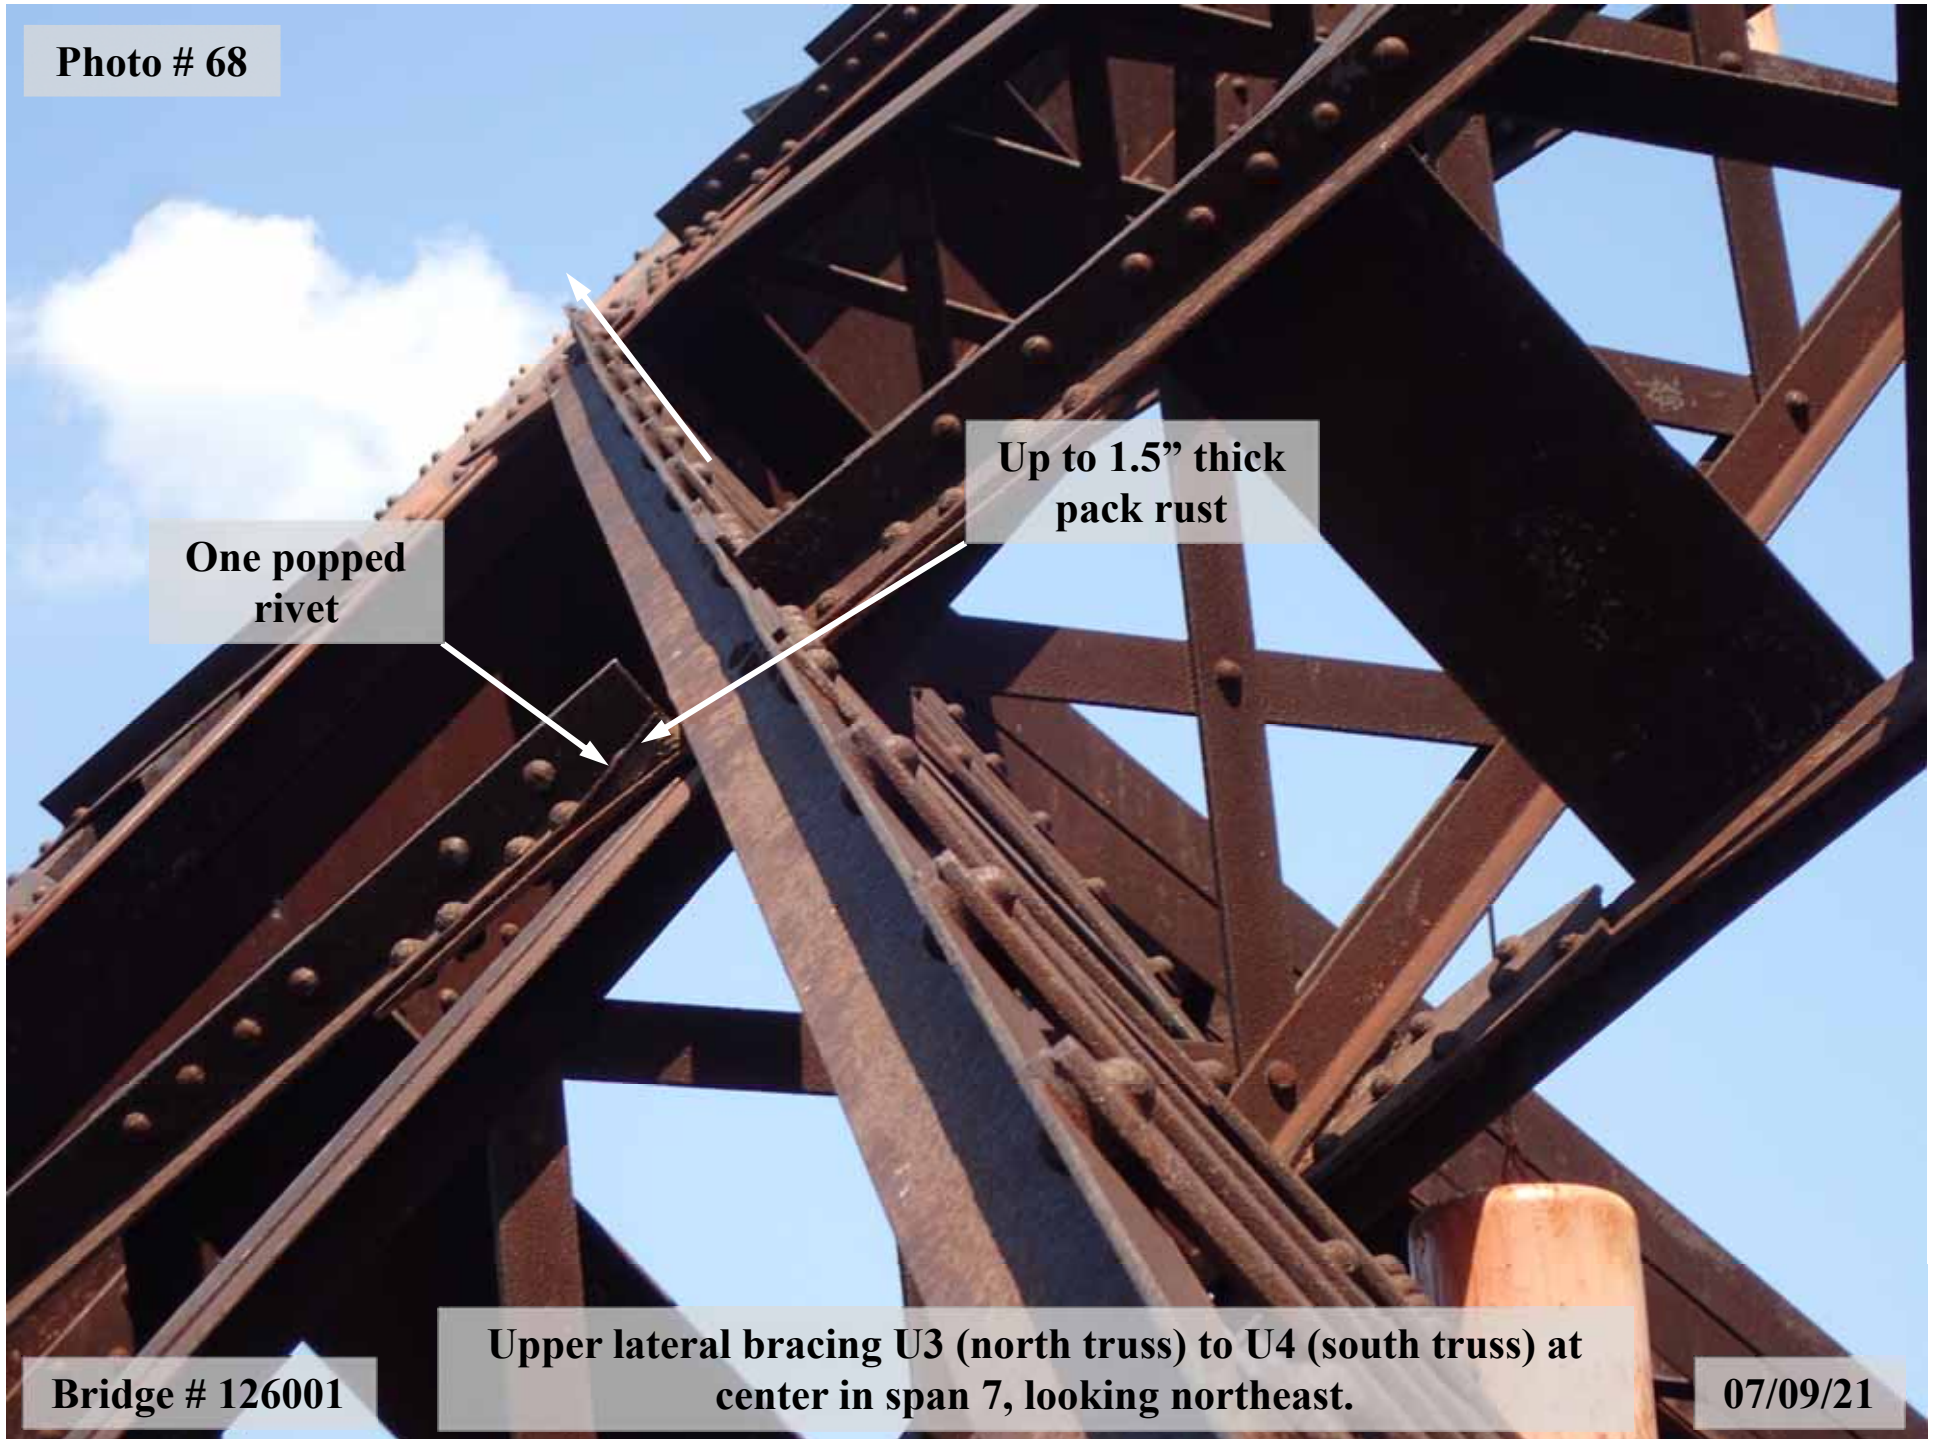
Photo # 68

**One popped
rivet**

**Up to 1.5" thick
pack rust**

**Upper lateral bracing U3 (north truss) to U4 (south truss) at
center in span 7, looking northeast.**

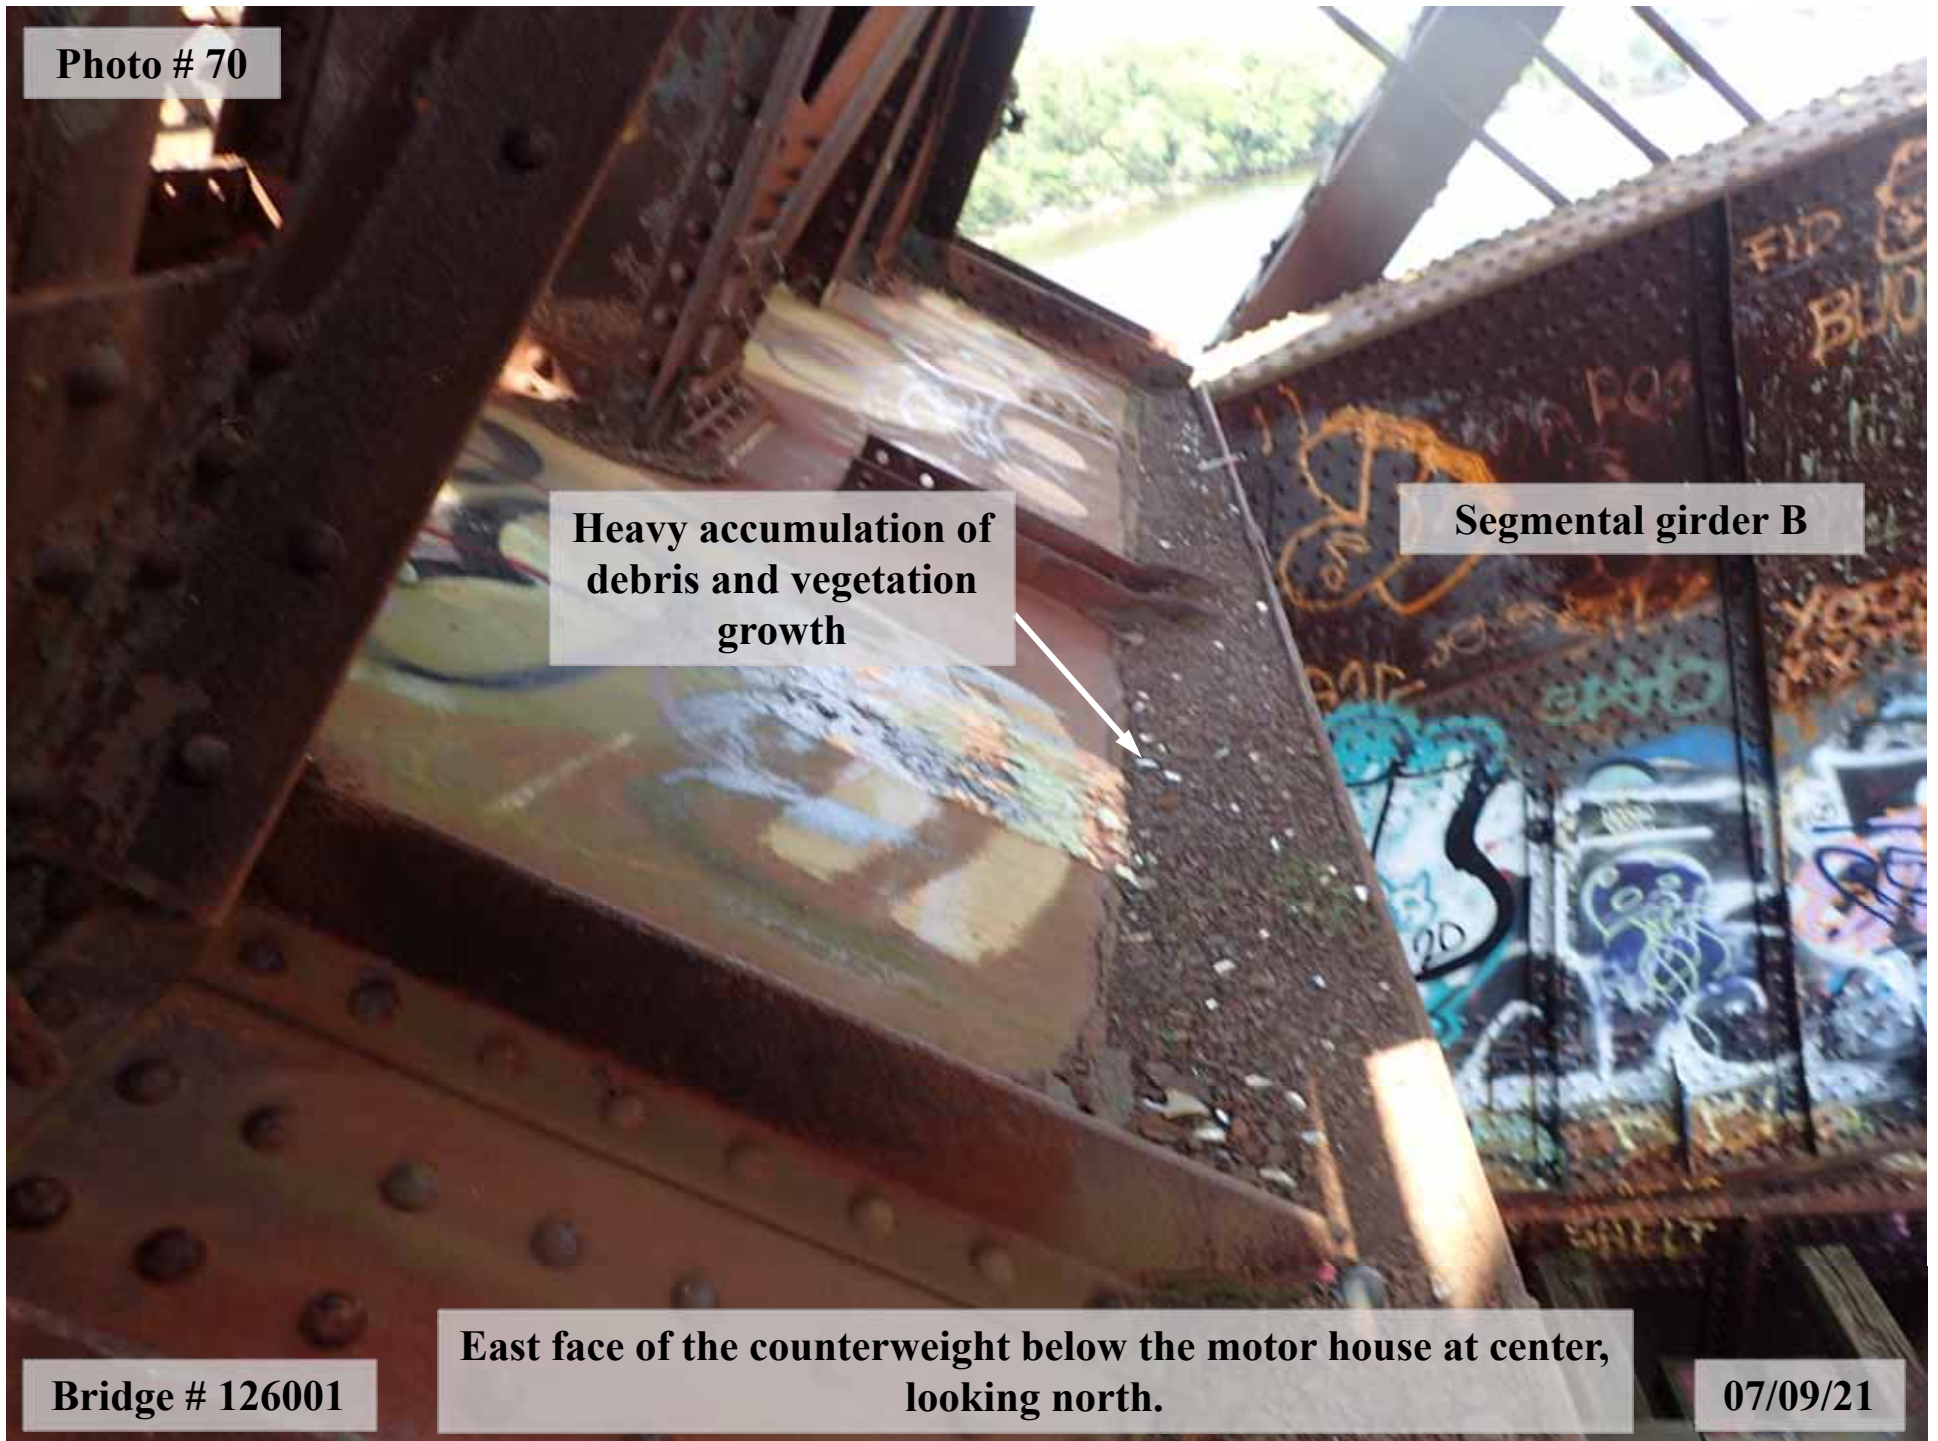
Photo # 70

**Heavy accumulation of
debris and vegetation
growth**

**East face of the counterweight below the motor house at center,
looking north.**

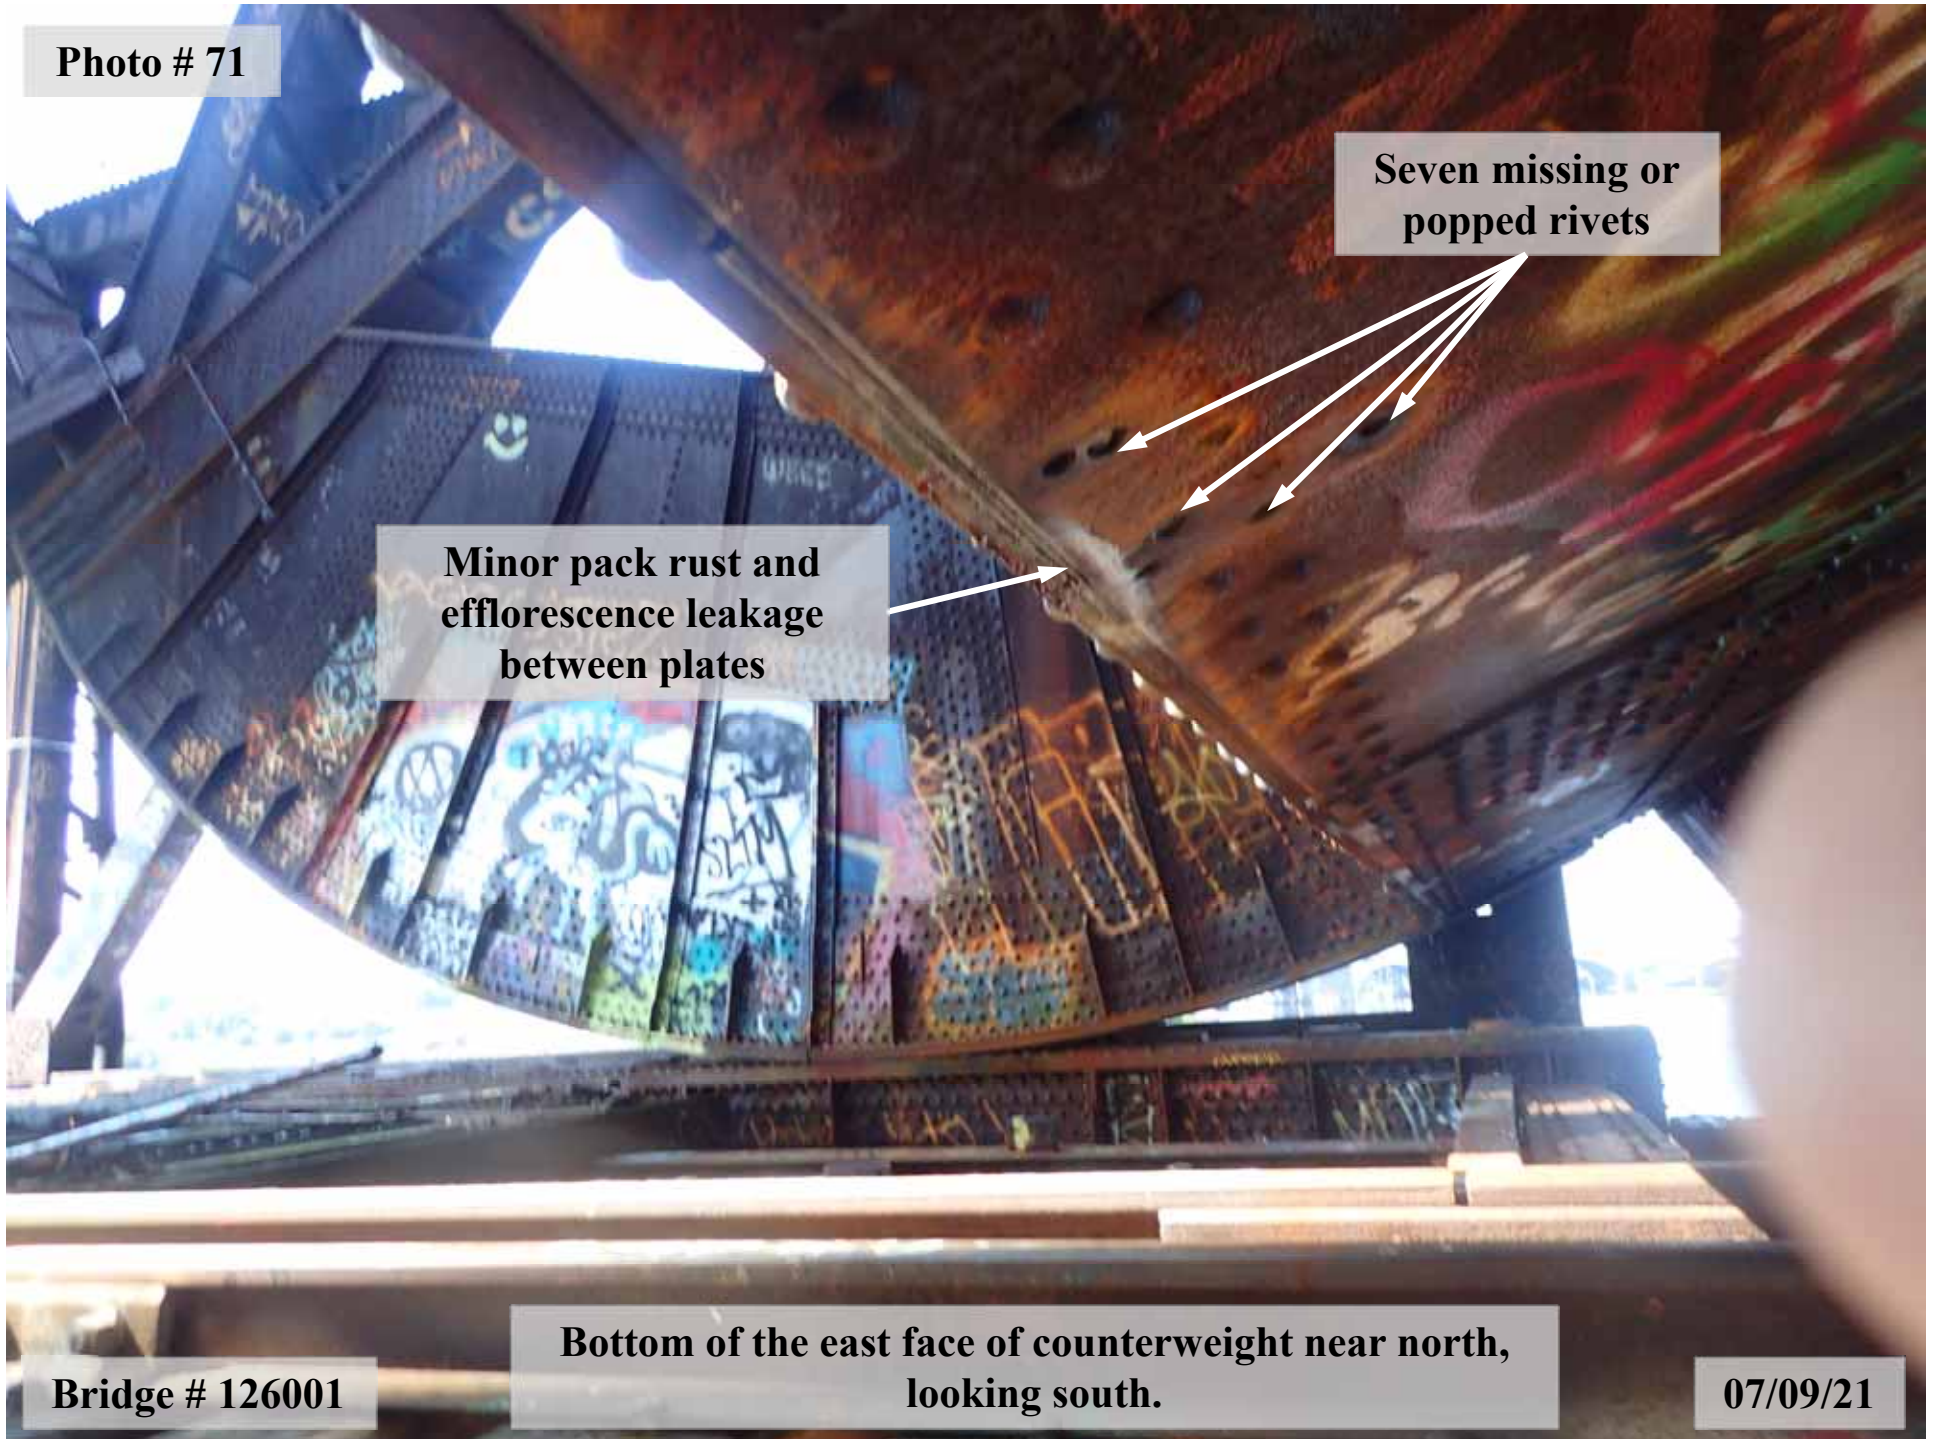
Photo # 71

**Seven missing or
popped rivets**

**Minor pack rust and
efflorescence leakage
between plates**

**Bottom of the east face of counterweight near north,
looking south.**
