CITY OF PROVIDENCE, RHODE ISLAND

**RFP Title: URBAN DESIGN CONSULTING SERVICES RELATING TO CROOK POINT BRIDGE
PRESERVATION**

Addendum #: 1

A potential respondent has asked for supporting pictures referenced in the bid materials. This addendum adds those pictures.

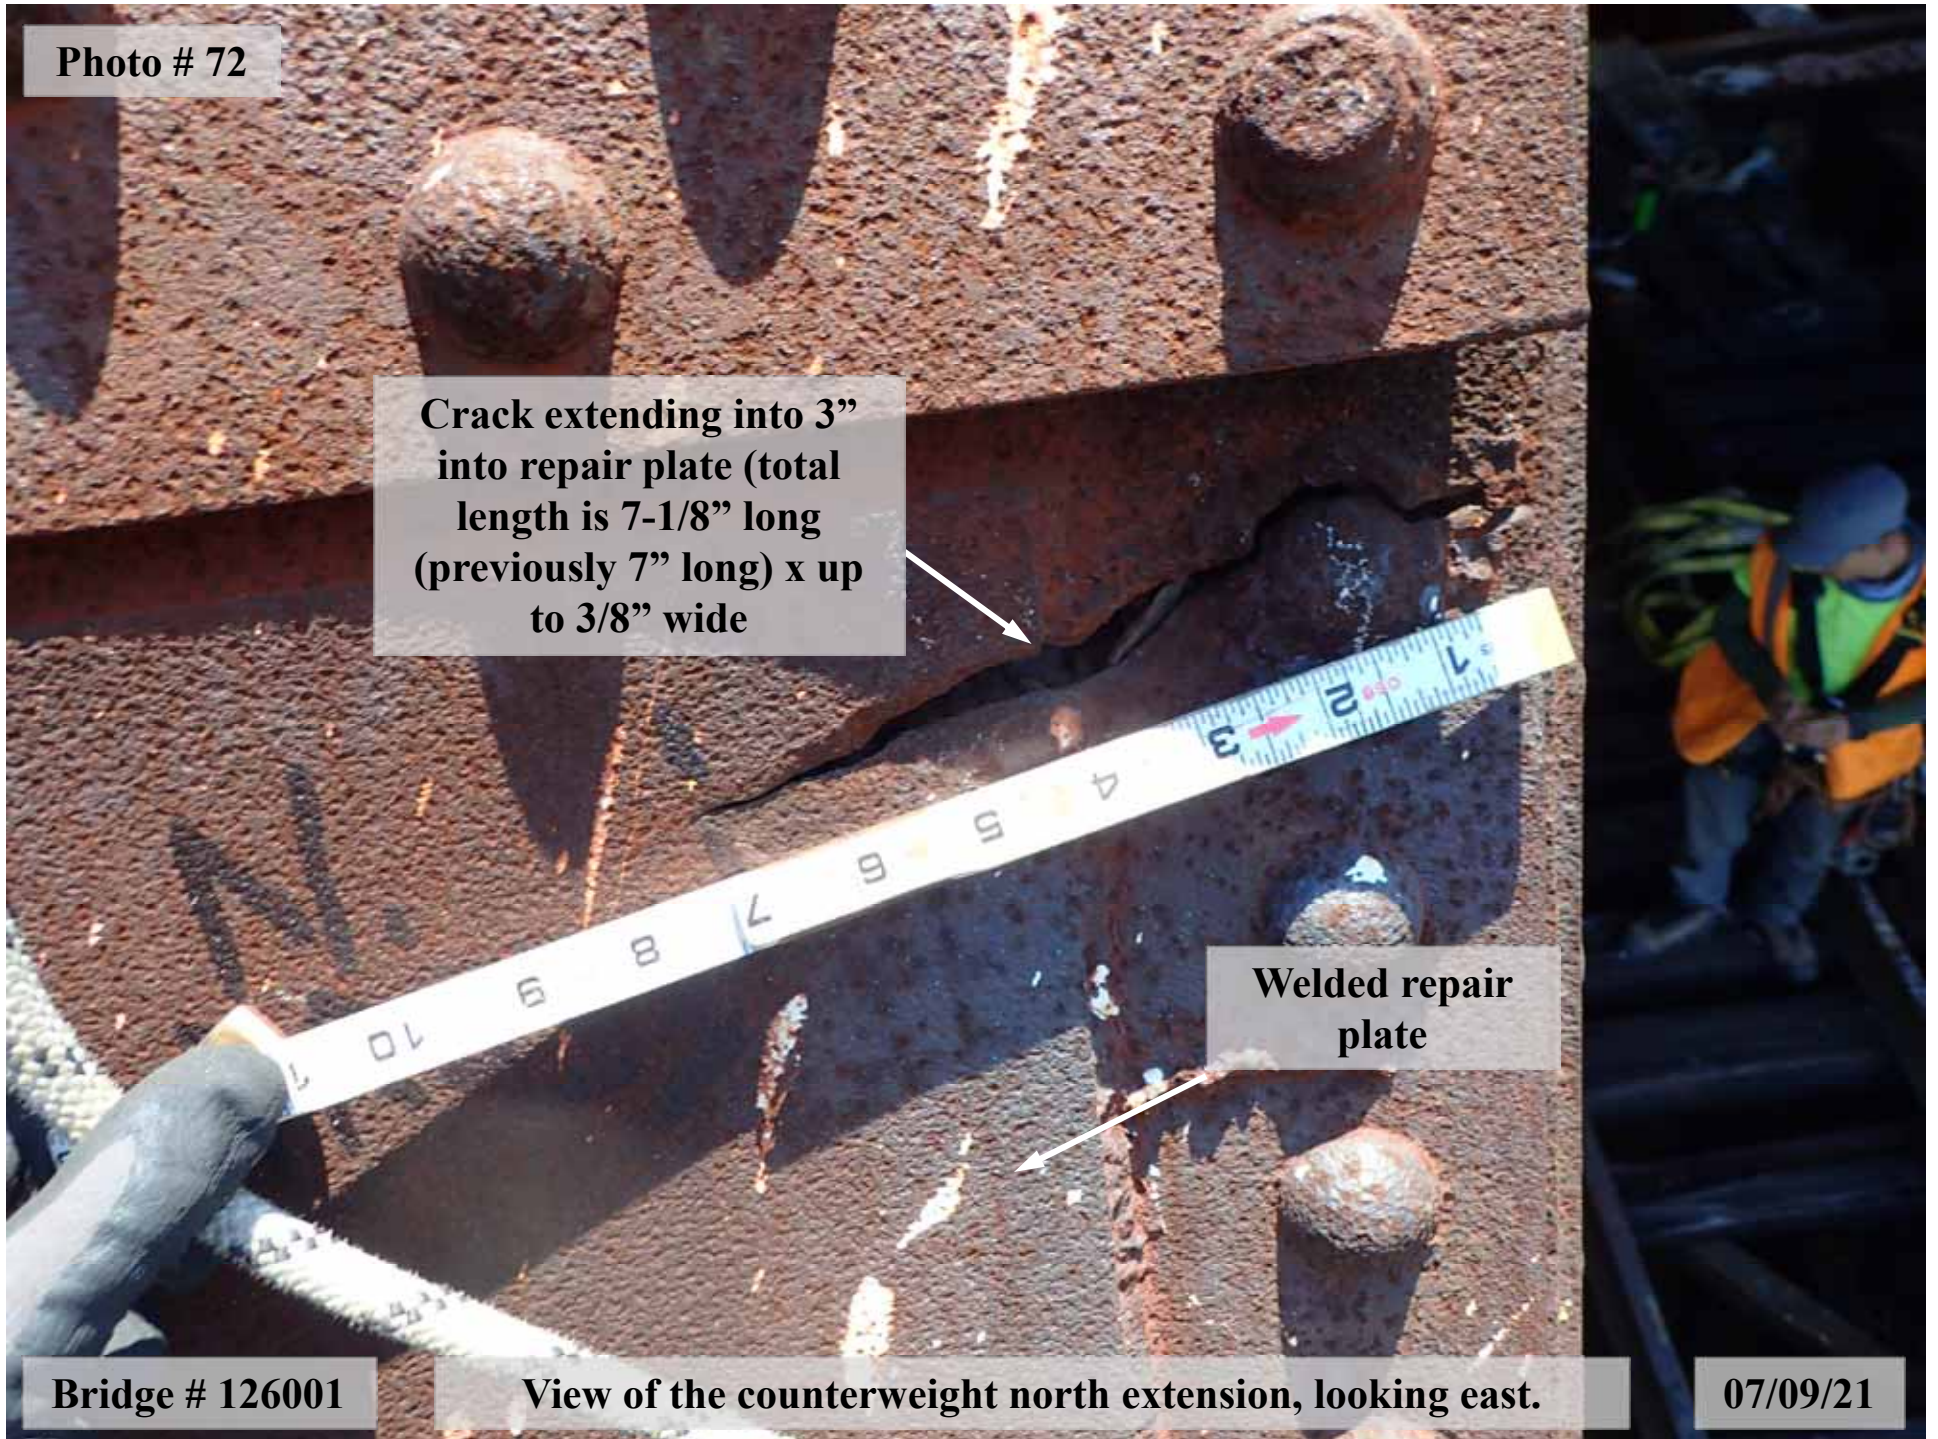
Photo # 72

Crack extending into 3"
into repair plate (total
length is 7-1/8" long
(previously 7" long) x up
to 3/8" wide

Welded repair
plate

View of the counterweight north extension, looking east.

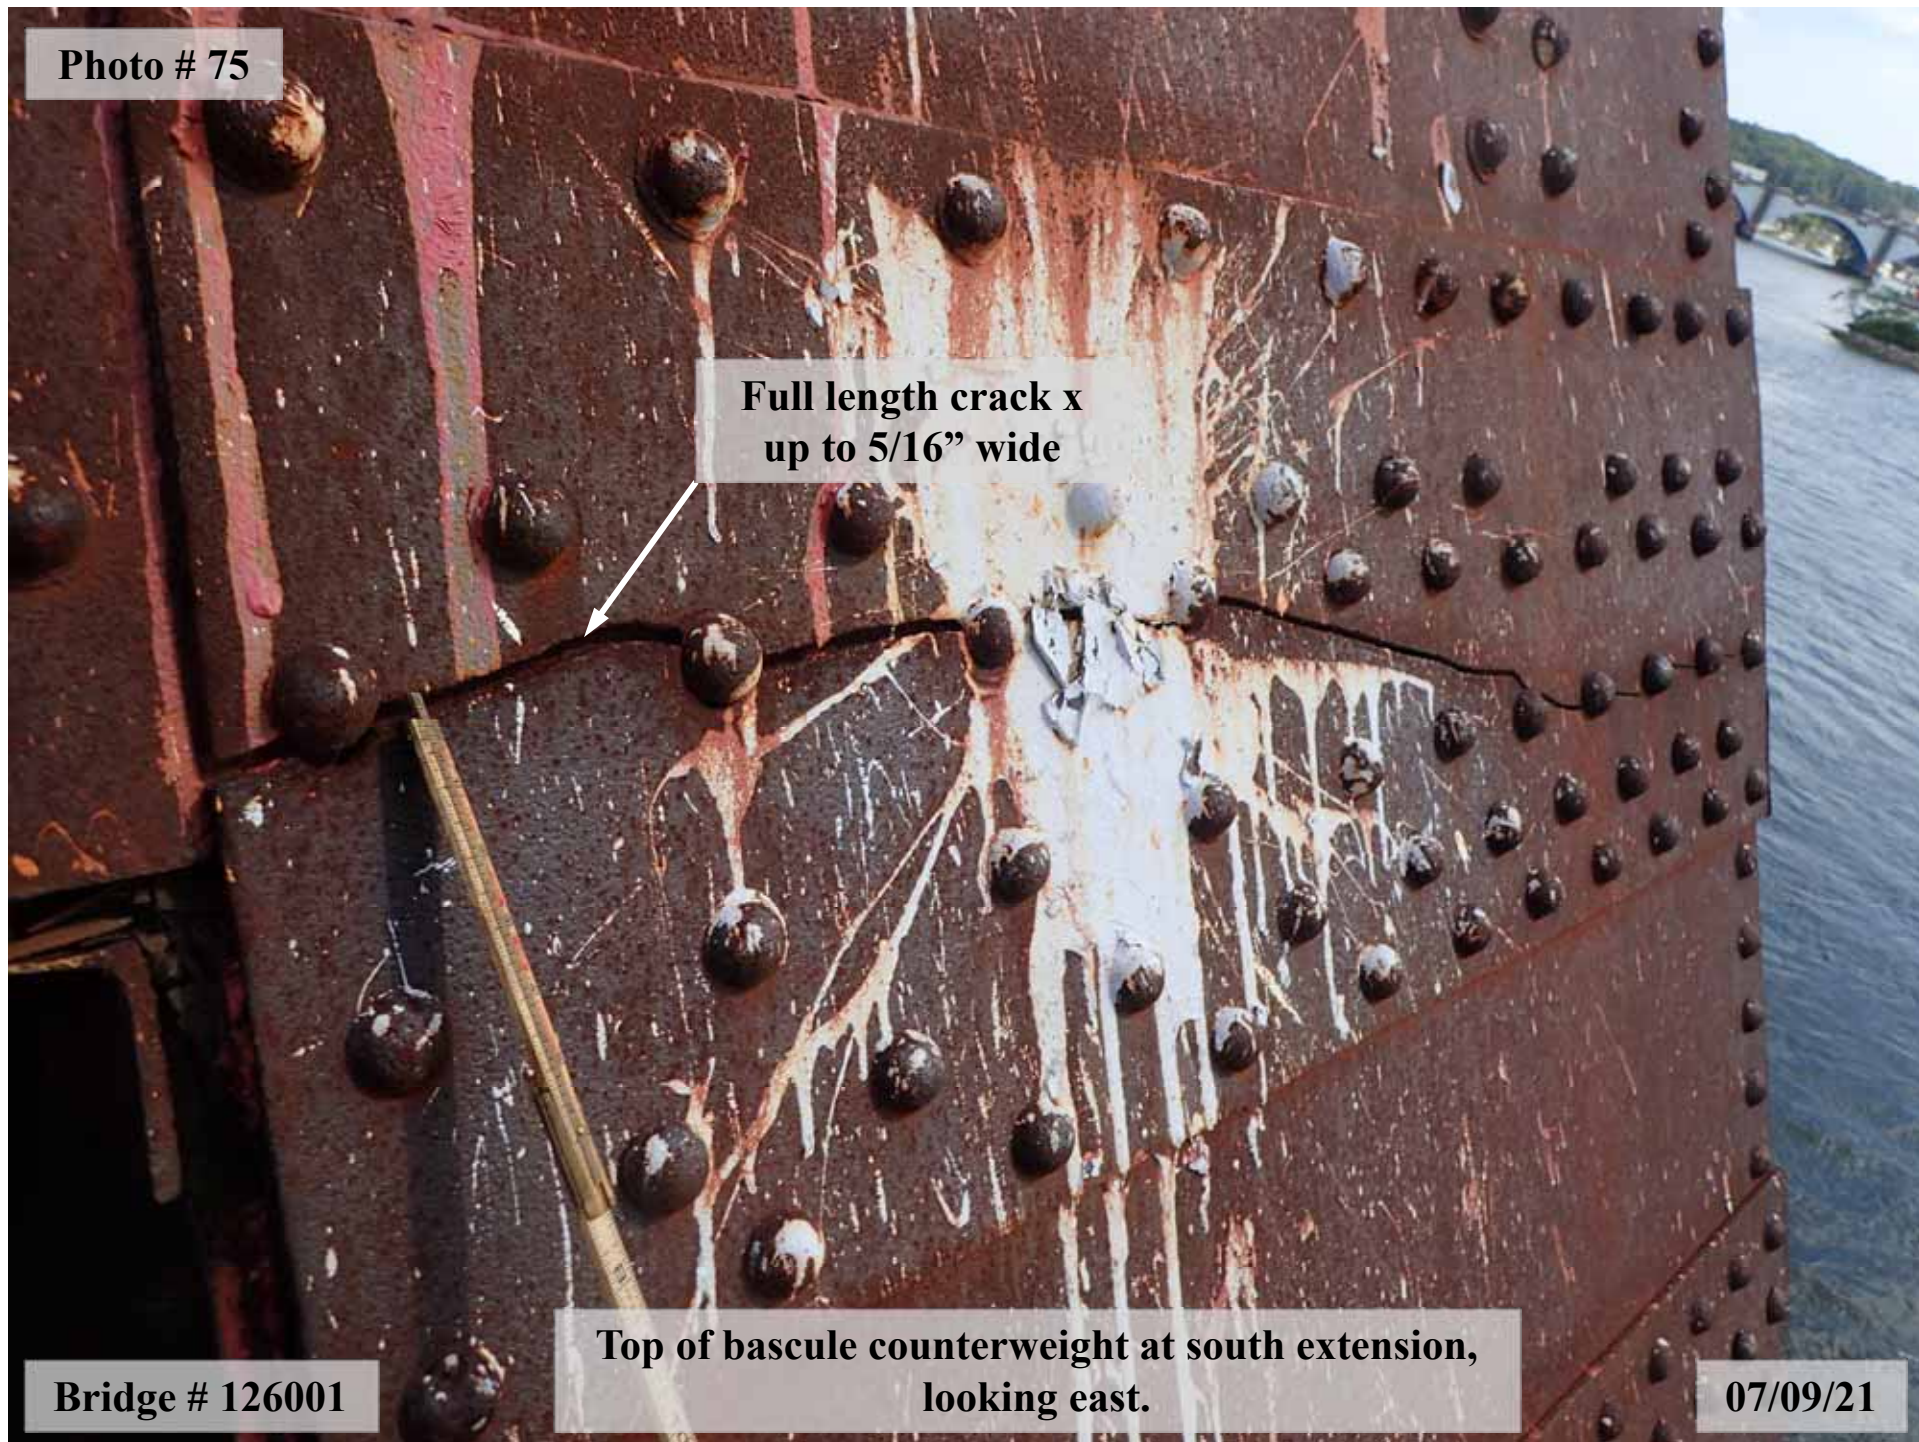
Photo # 75

**Full length crack x
up to 5/16" wide**

**Top of bascule counterweight at south extension,
looking east.**

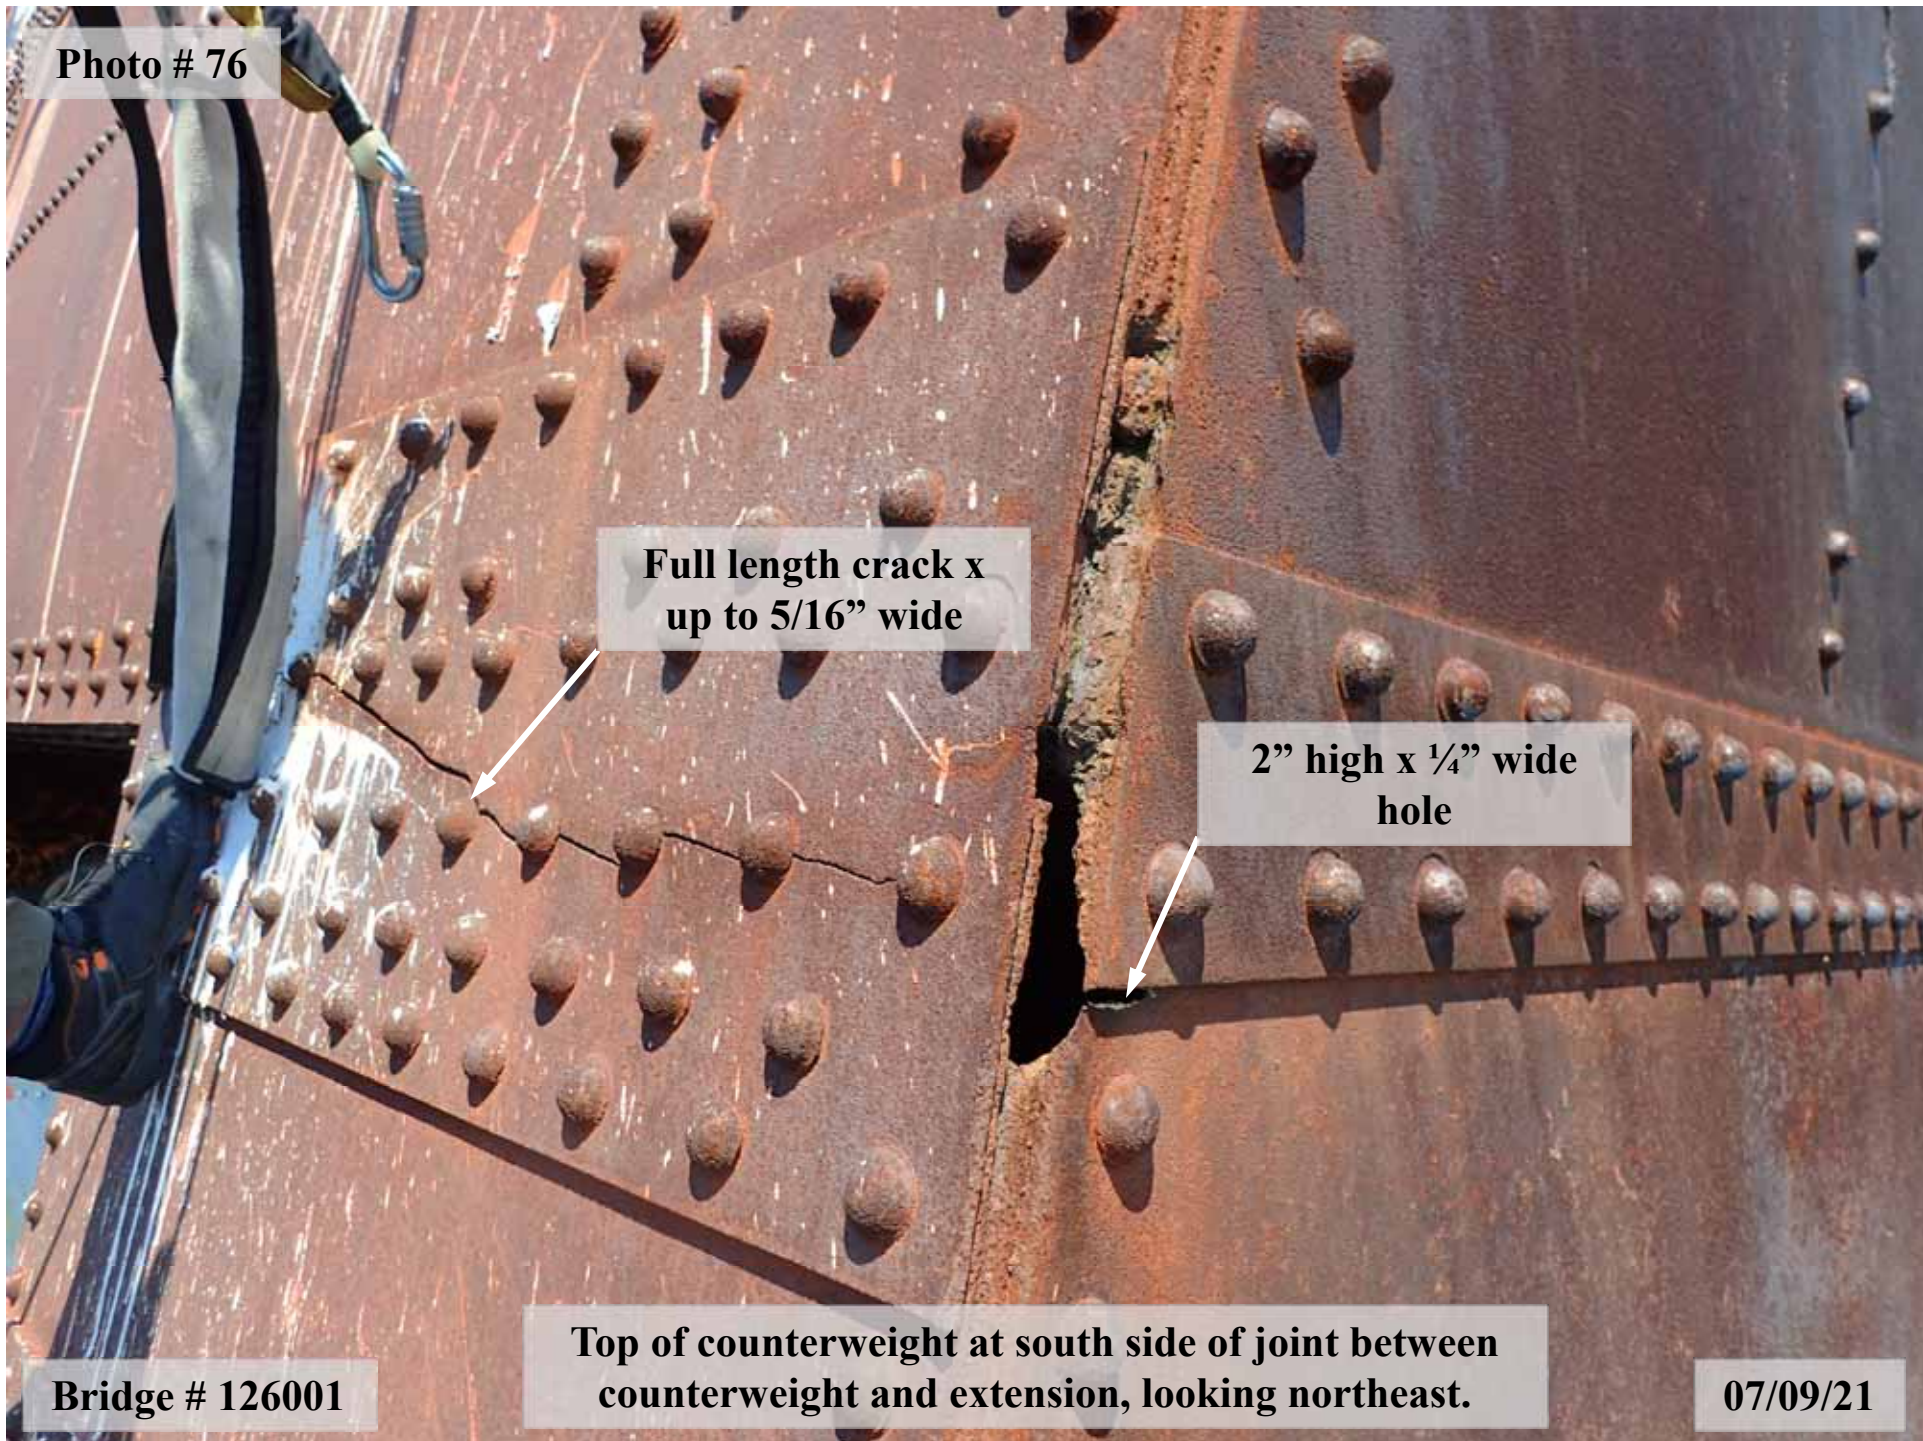
Photo # 76

**Full length crack x
up to 5/16" wide**

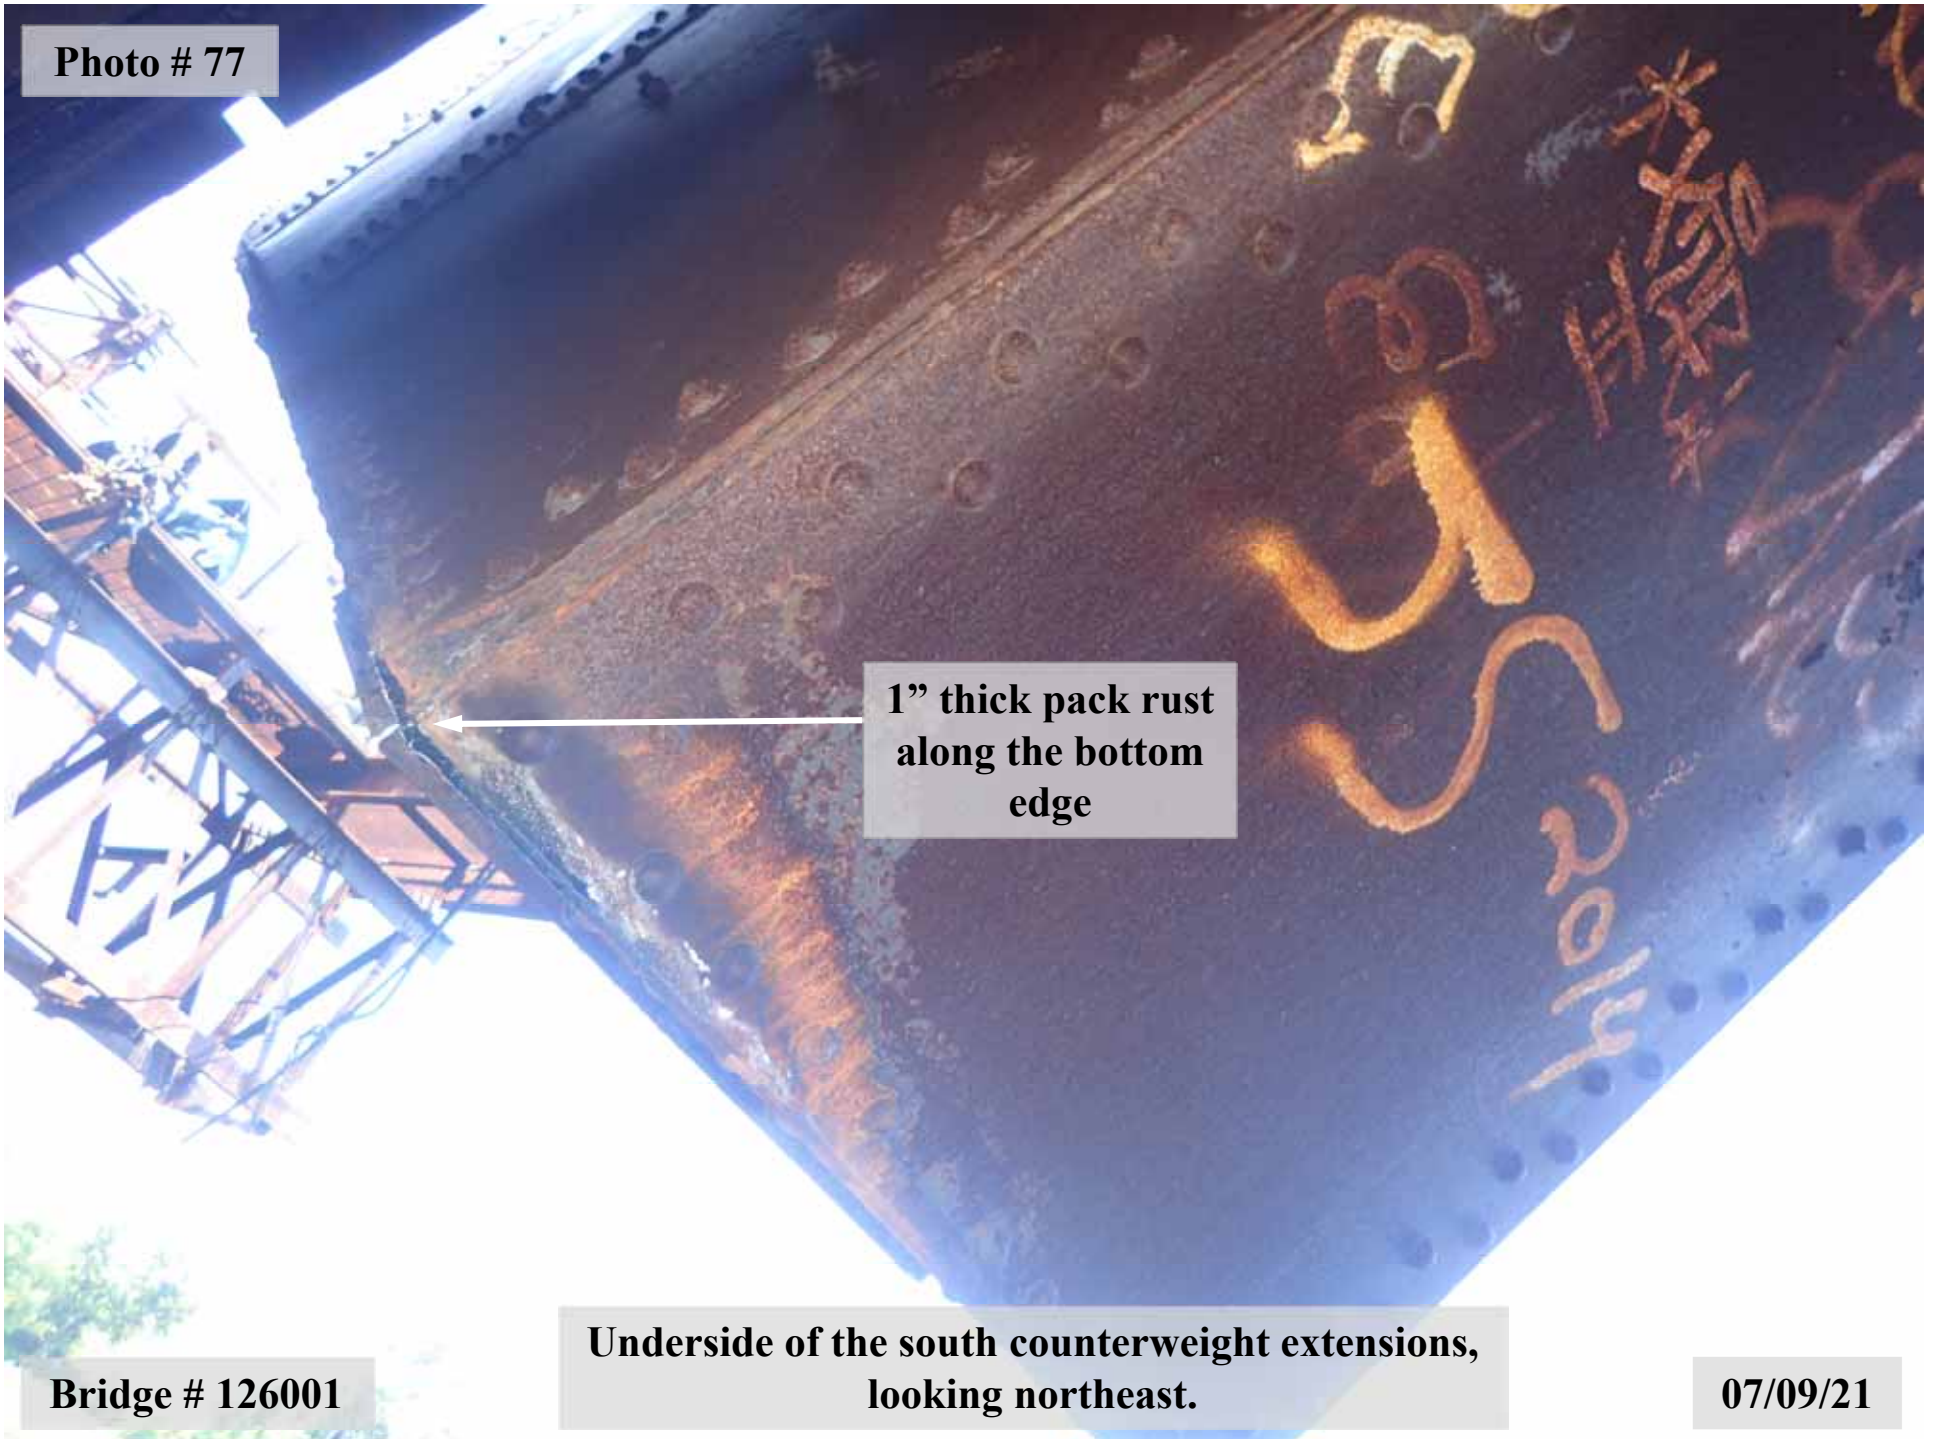
Photo # 77

**1" thick pack rust
along the bottom
edge**

**Underside of the south counterweight extensions,
looking northeast.**

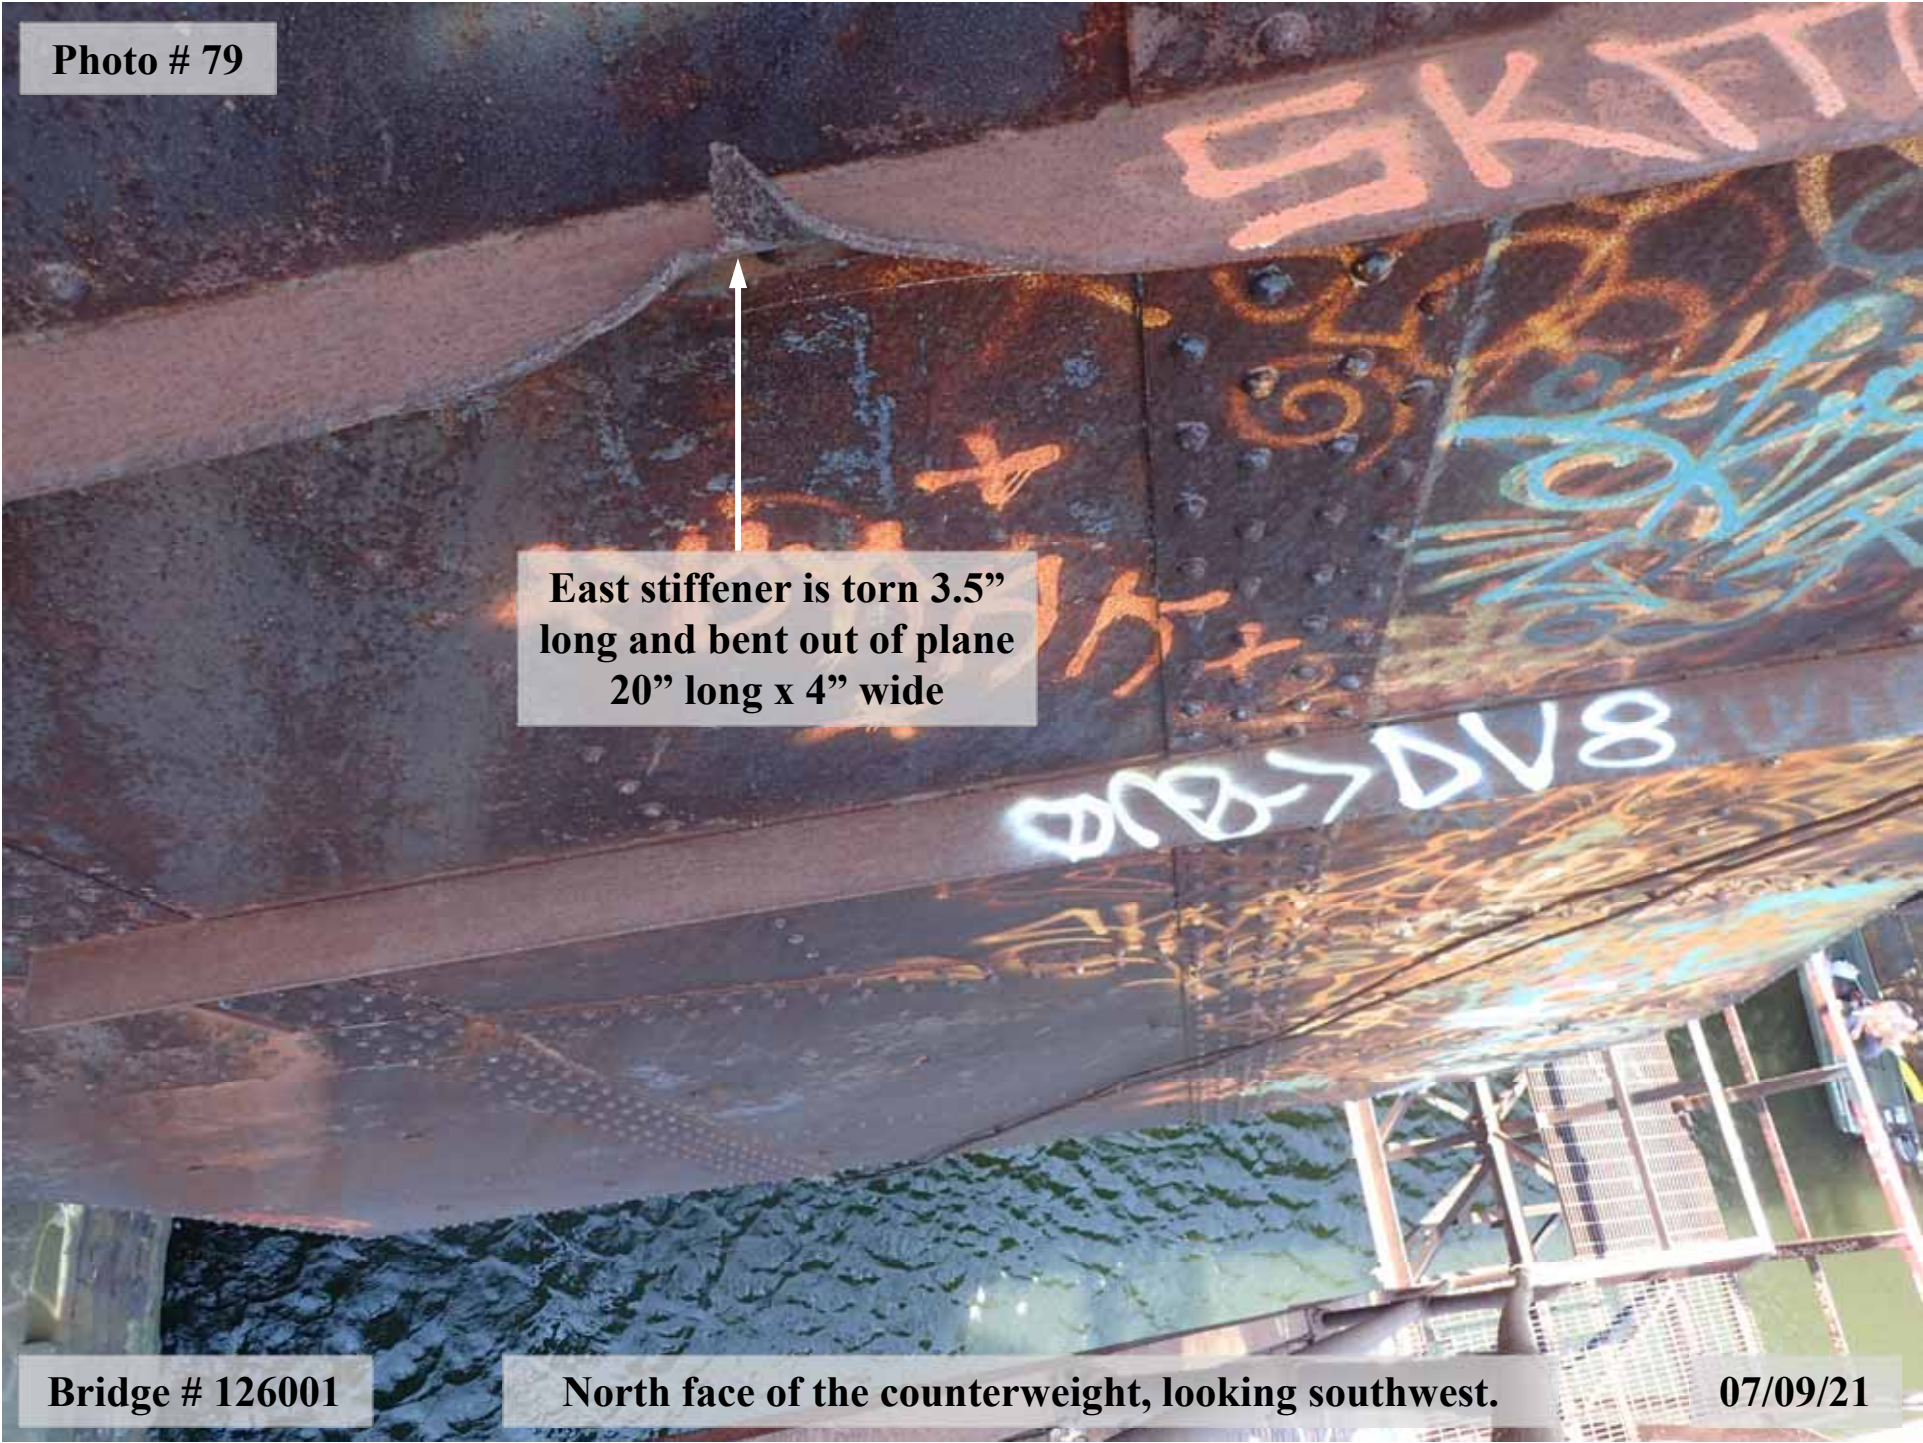
Photo # 79

**East stiffener is torn 3.5"
long and bent out of plane
20" long x 4" wide**

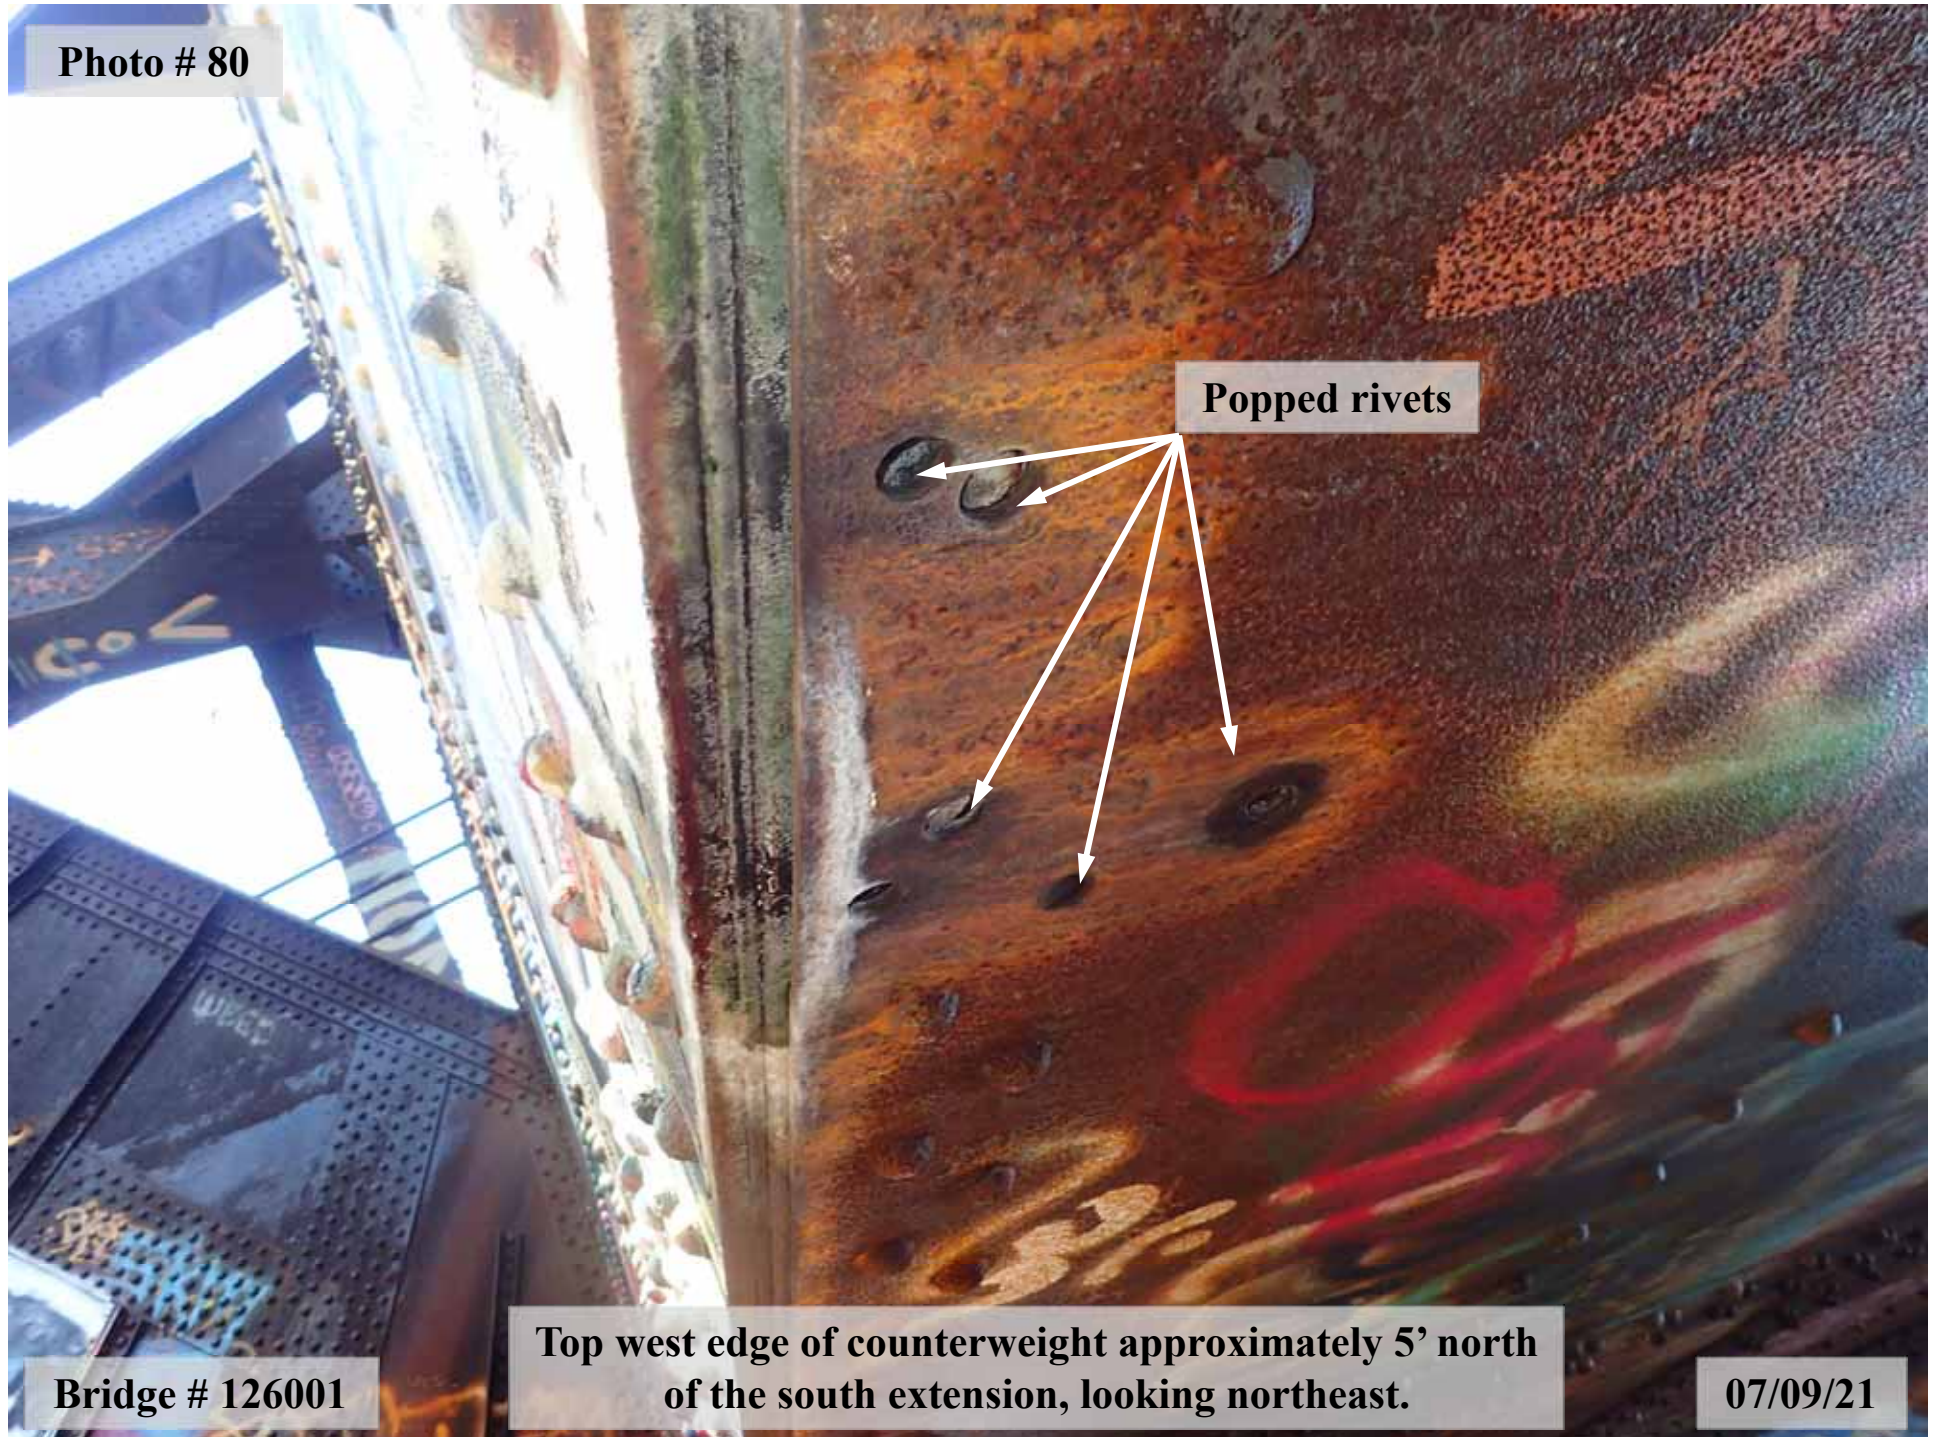
Photo # 80

Popped rivets

**Top west edge of counterweight approximately 5' north
of the south extension, looking northeast.**

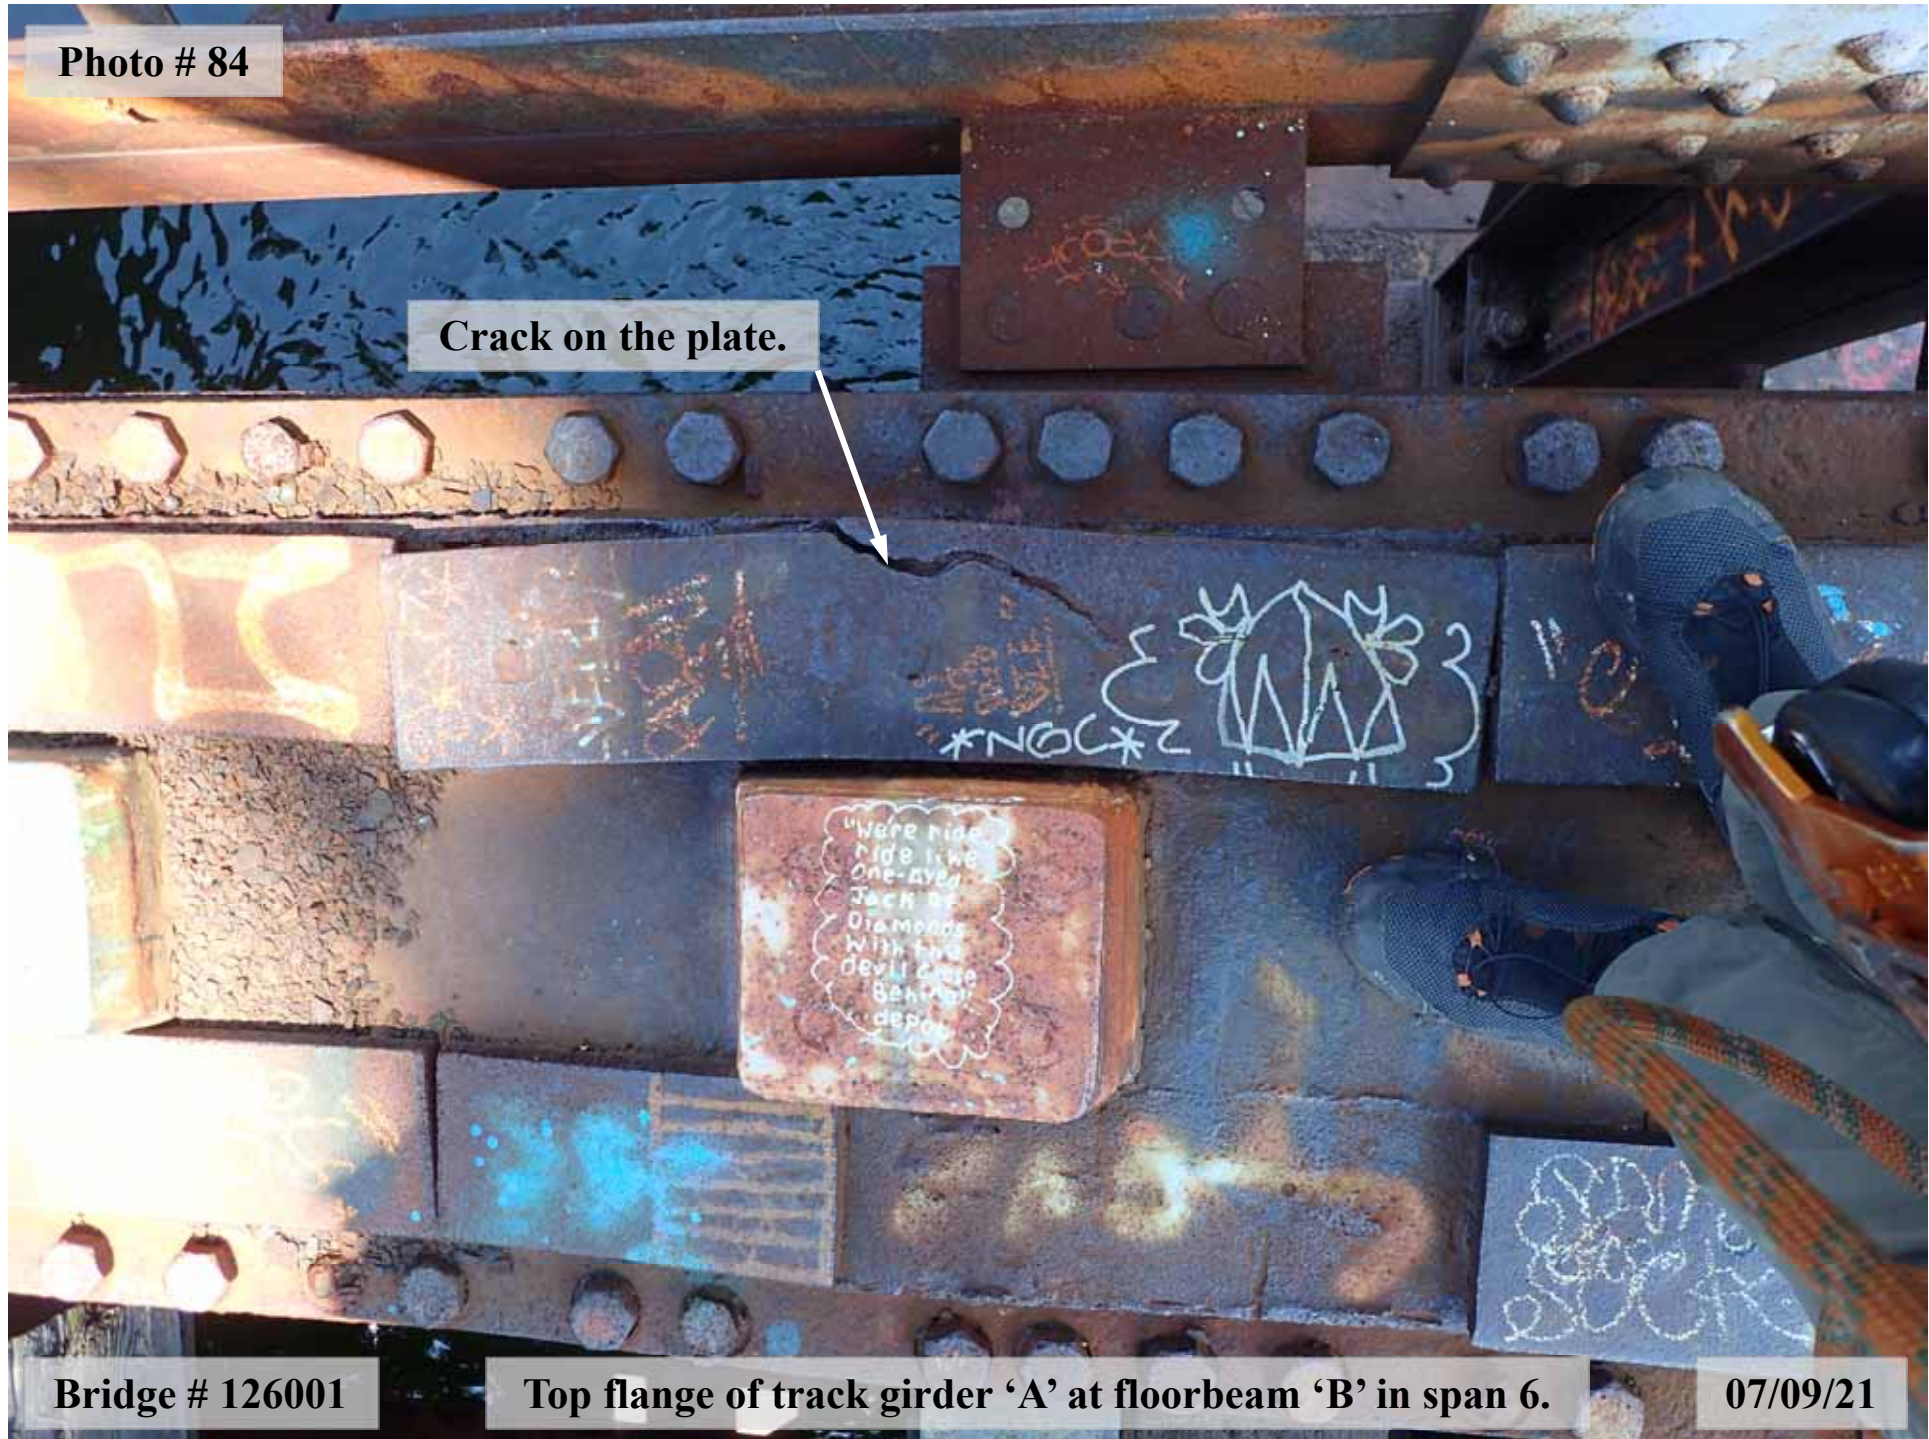
Photo # 84

Crack on the plate.

Top flange of track girder 'A' at floorbeam 'B' in span 6.

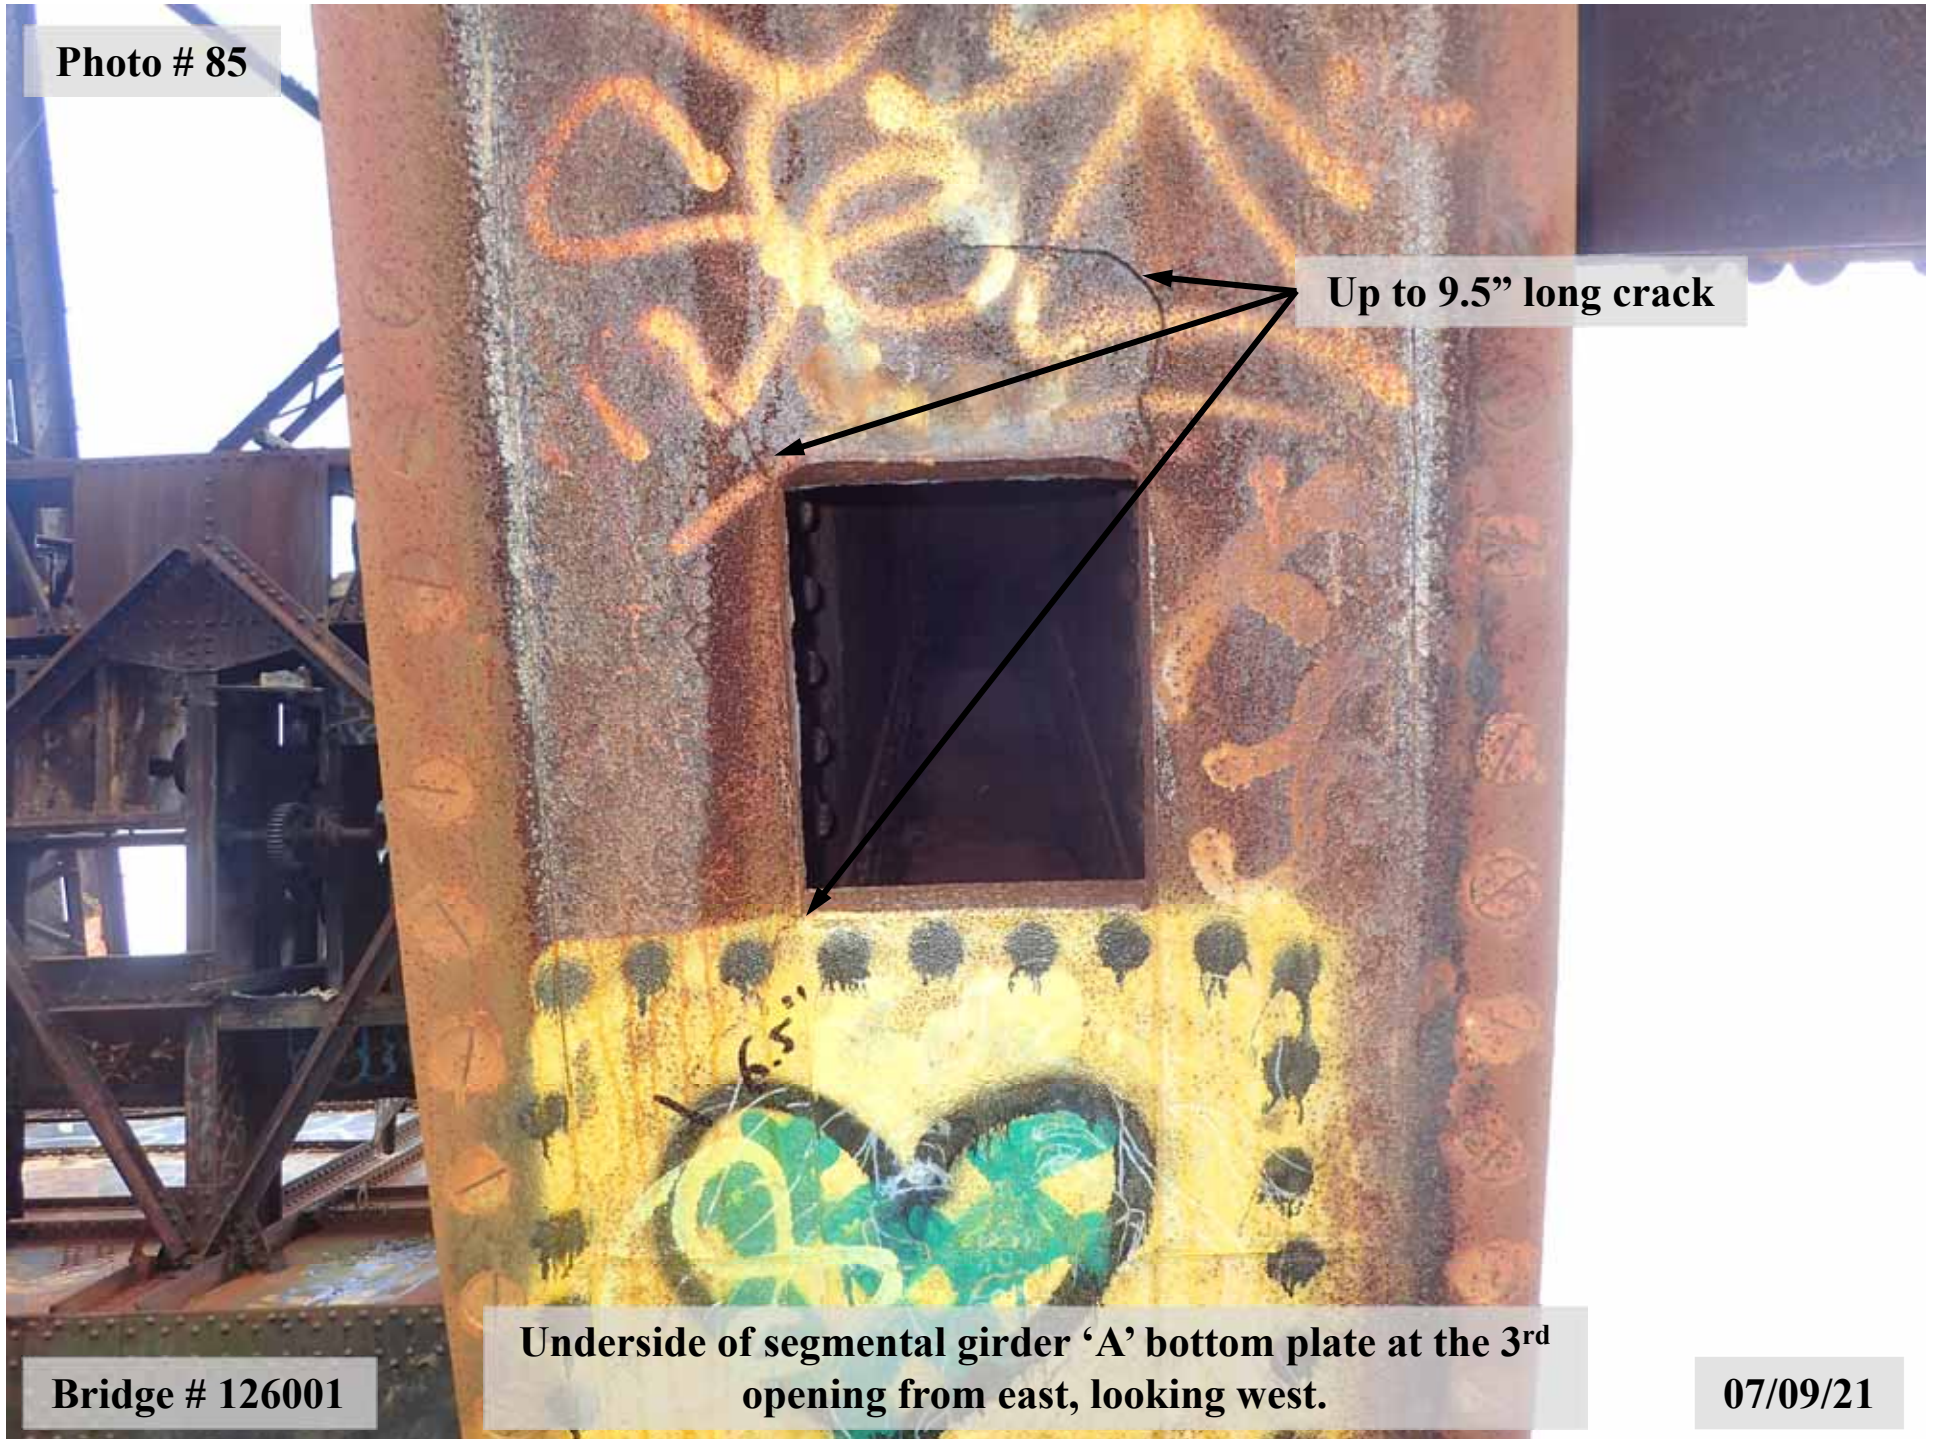
Photo # 85

Up to 9.5" long crack

Underside of segmental girder 'A' bottom plate at the 3rd opening from east, looking west.
