CITY OF PROVIDENCE, RHODE ISLAND

**RFP Title: URBAN DESIGN CONSULTING SERVICES RELATING TO CROOK POINT BRIDGE
PRESERVATION**

Addendum #: 1

A potential respondent has asked for supporting pictures referenced in the bid materials. This addendum adds those pictures.

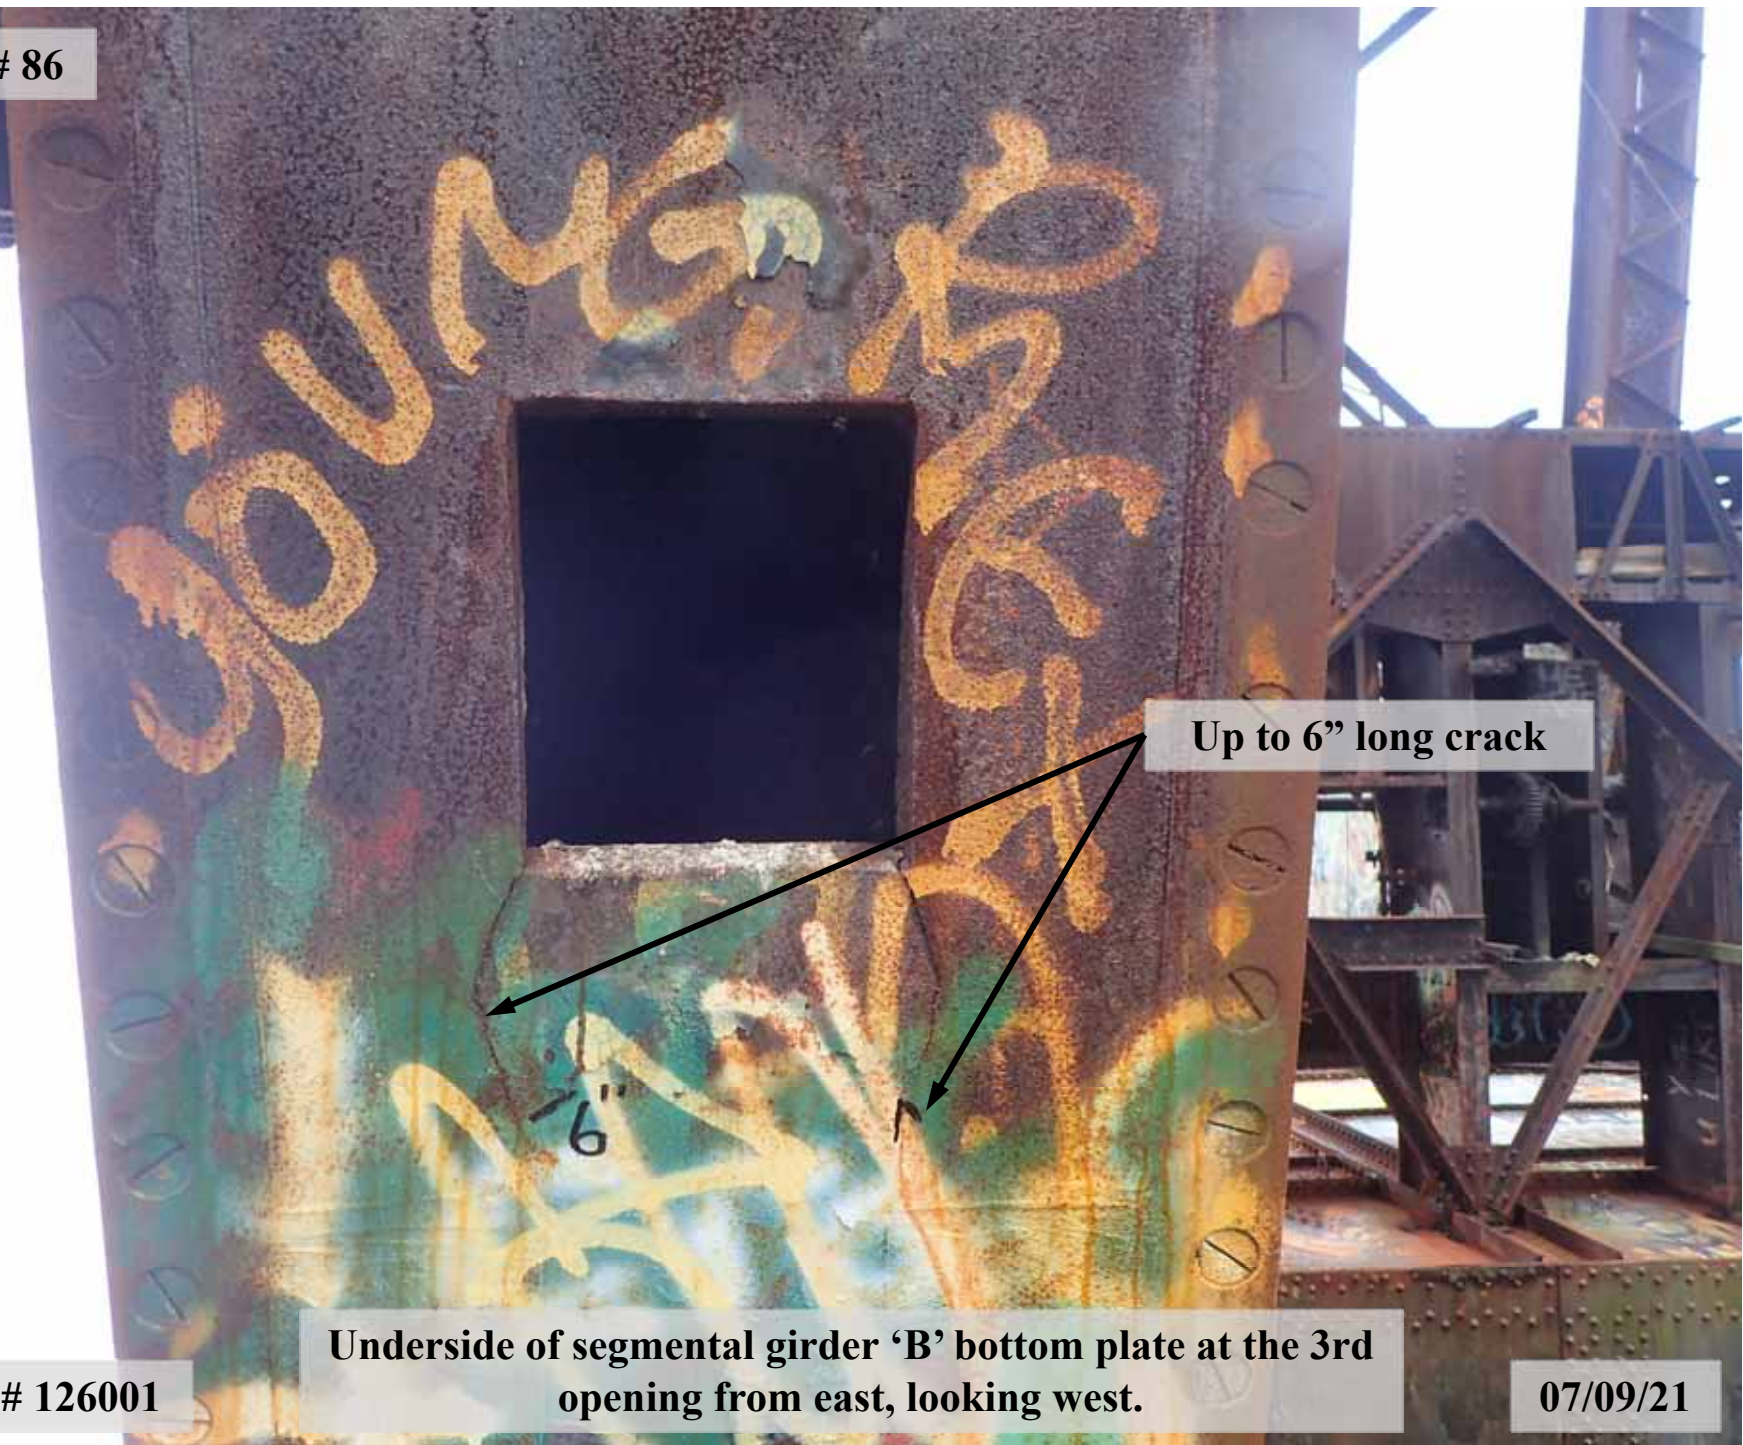
Photo # 86

Up to 6" long crack

Underside of segmental girder 'B' bottom plate at the 3rd opening from east, looking west.

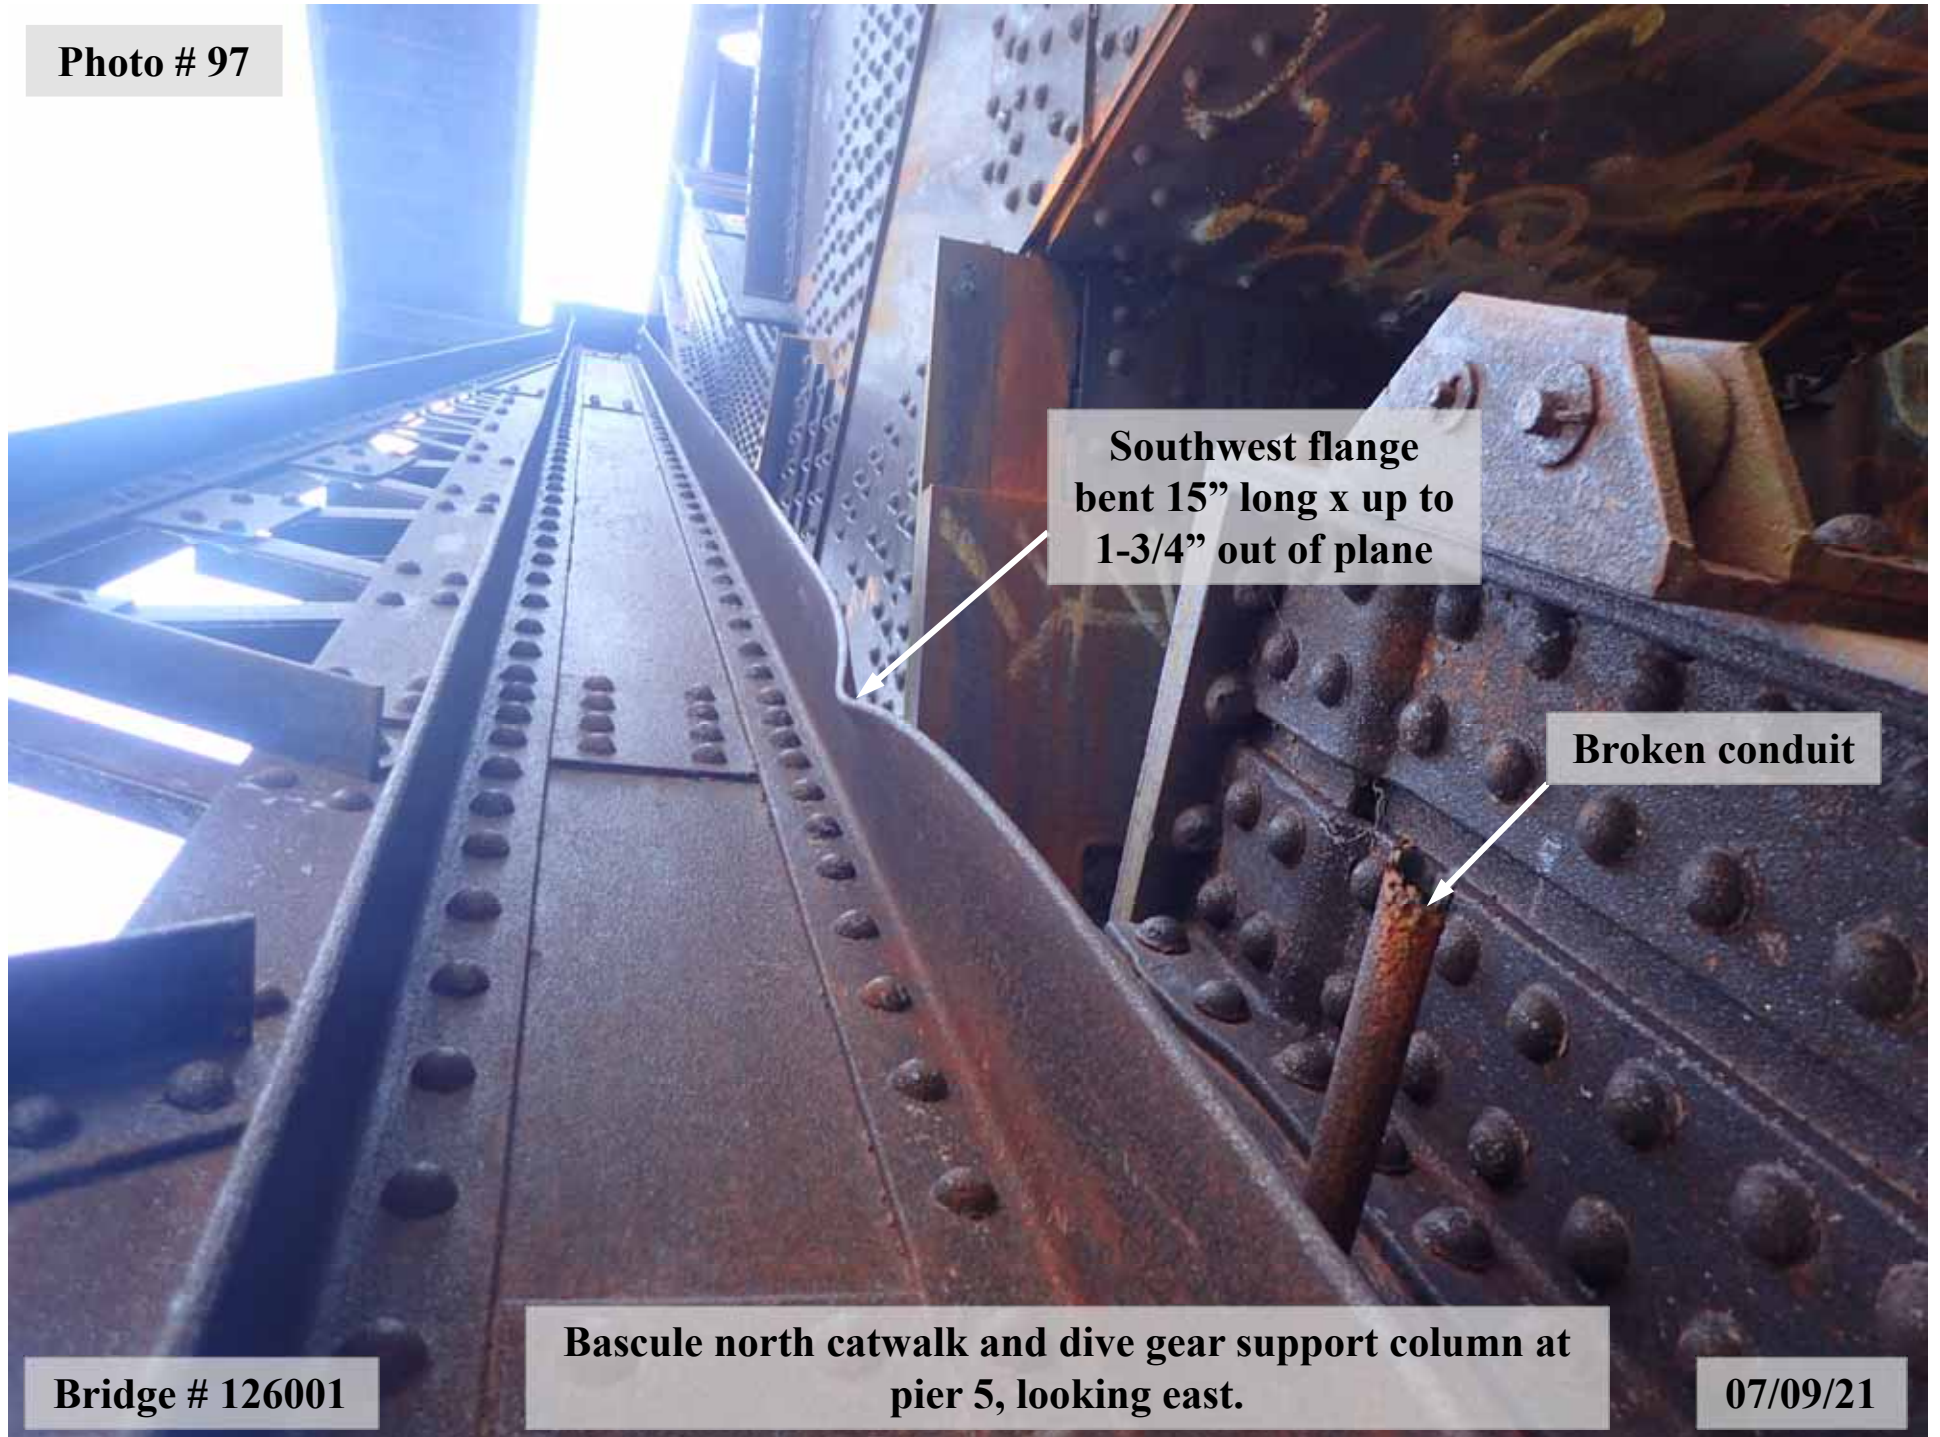
Photo # 97

**Southwest flange
bent 15" long x up to
1-3/4" out of plane**

Broken conduit

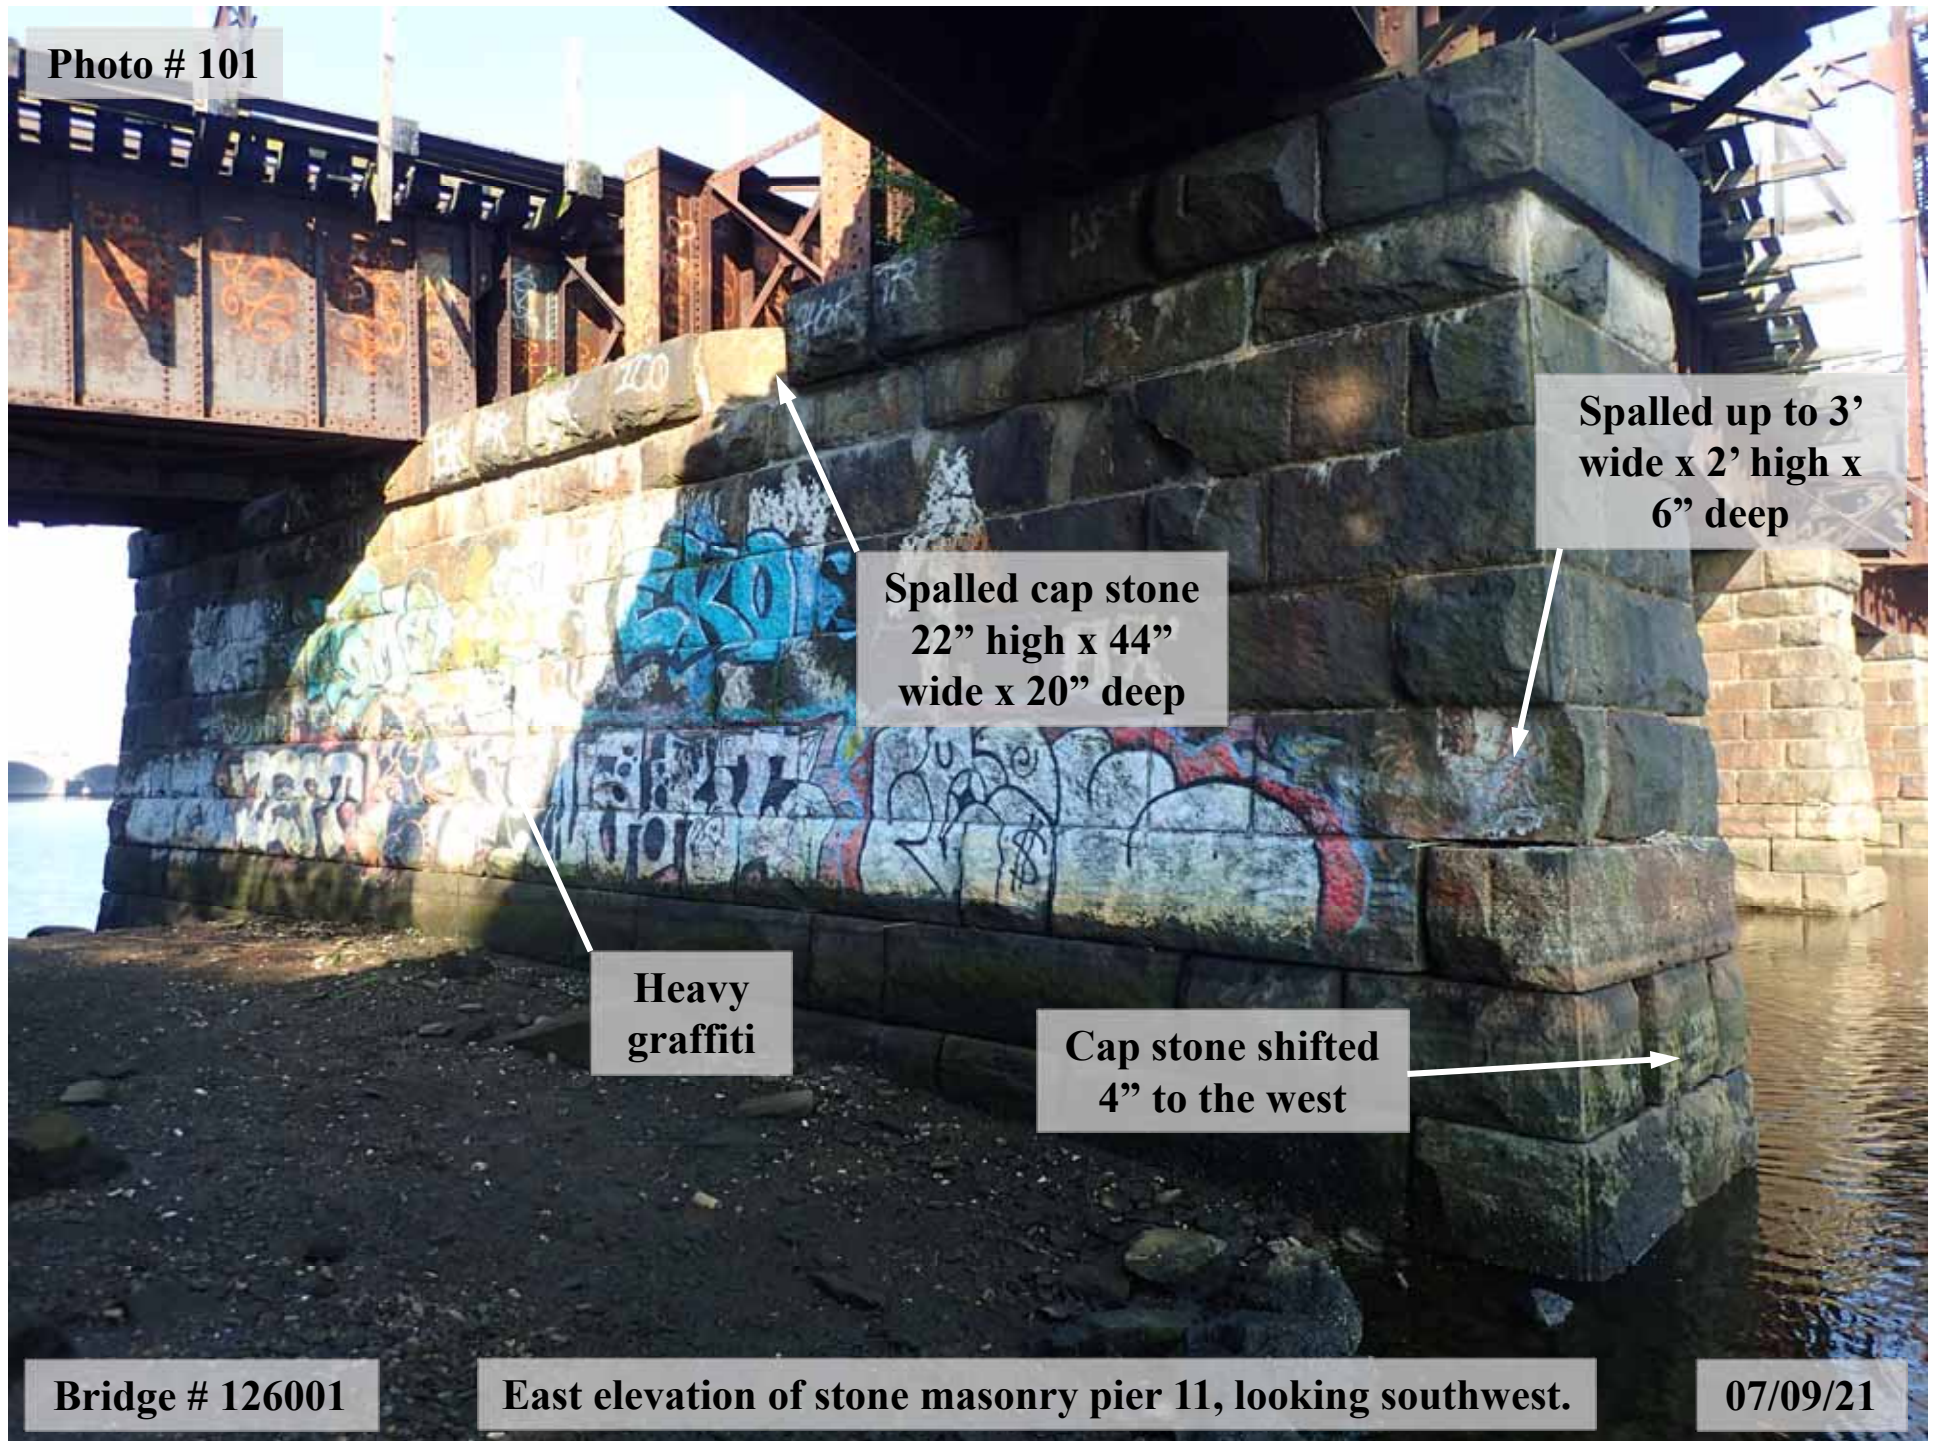
Photo # 101

**Spalled up to 3'
wide x 2' high x
6" deep**

**Spalled cap stone
22" high x 44"
wide x 20" deep**

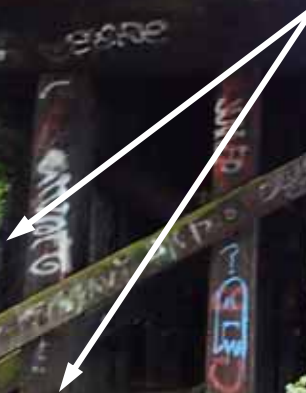
Heavy rot and fire damage to timber piles.

Typical elevation view of timber support system at abutment#3, looking east.

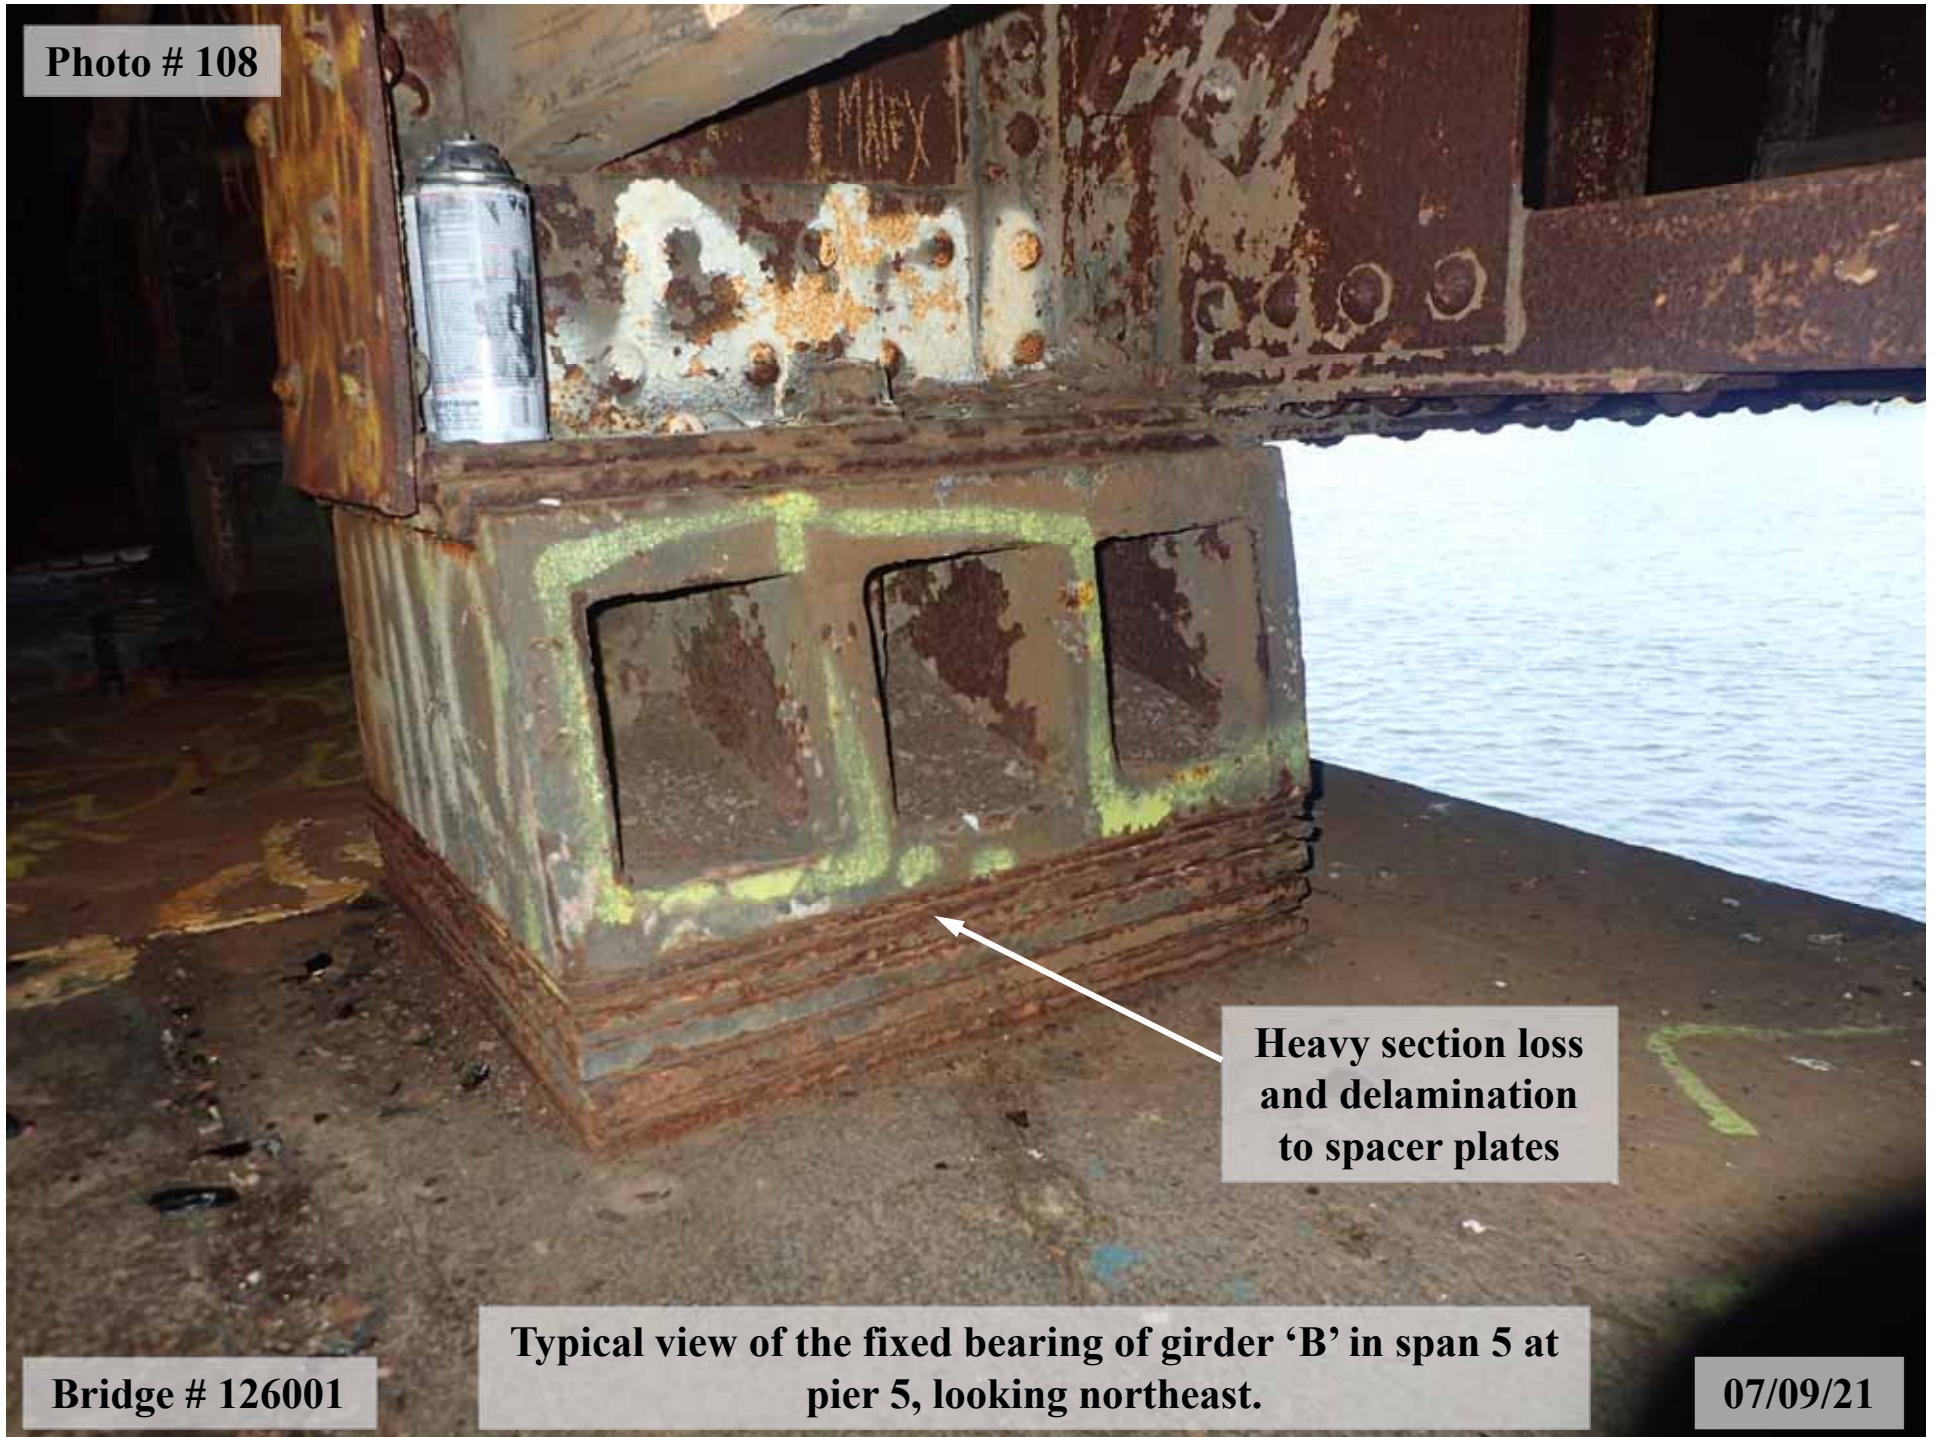
Photo # 108

**Heavy section loss
and delamination
to spacer plates**

**Typical view of the fixed bearing of girder 'B' in span 5 at
pier 5, looking northeast.**

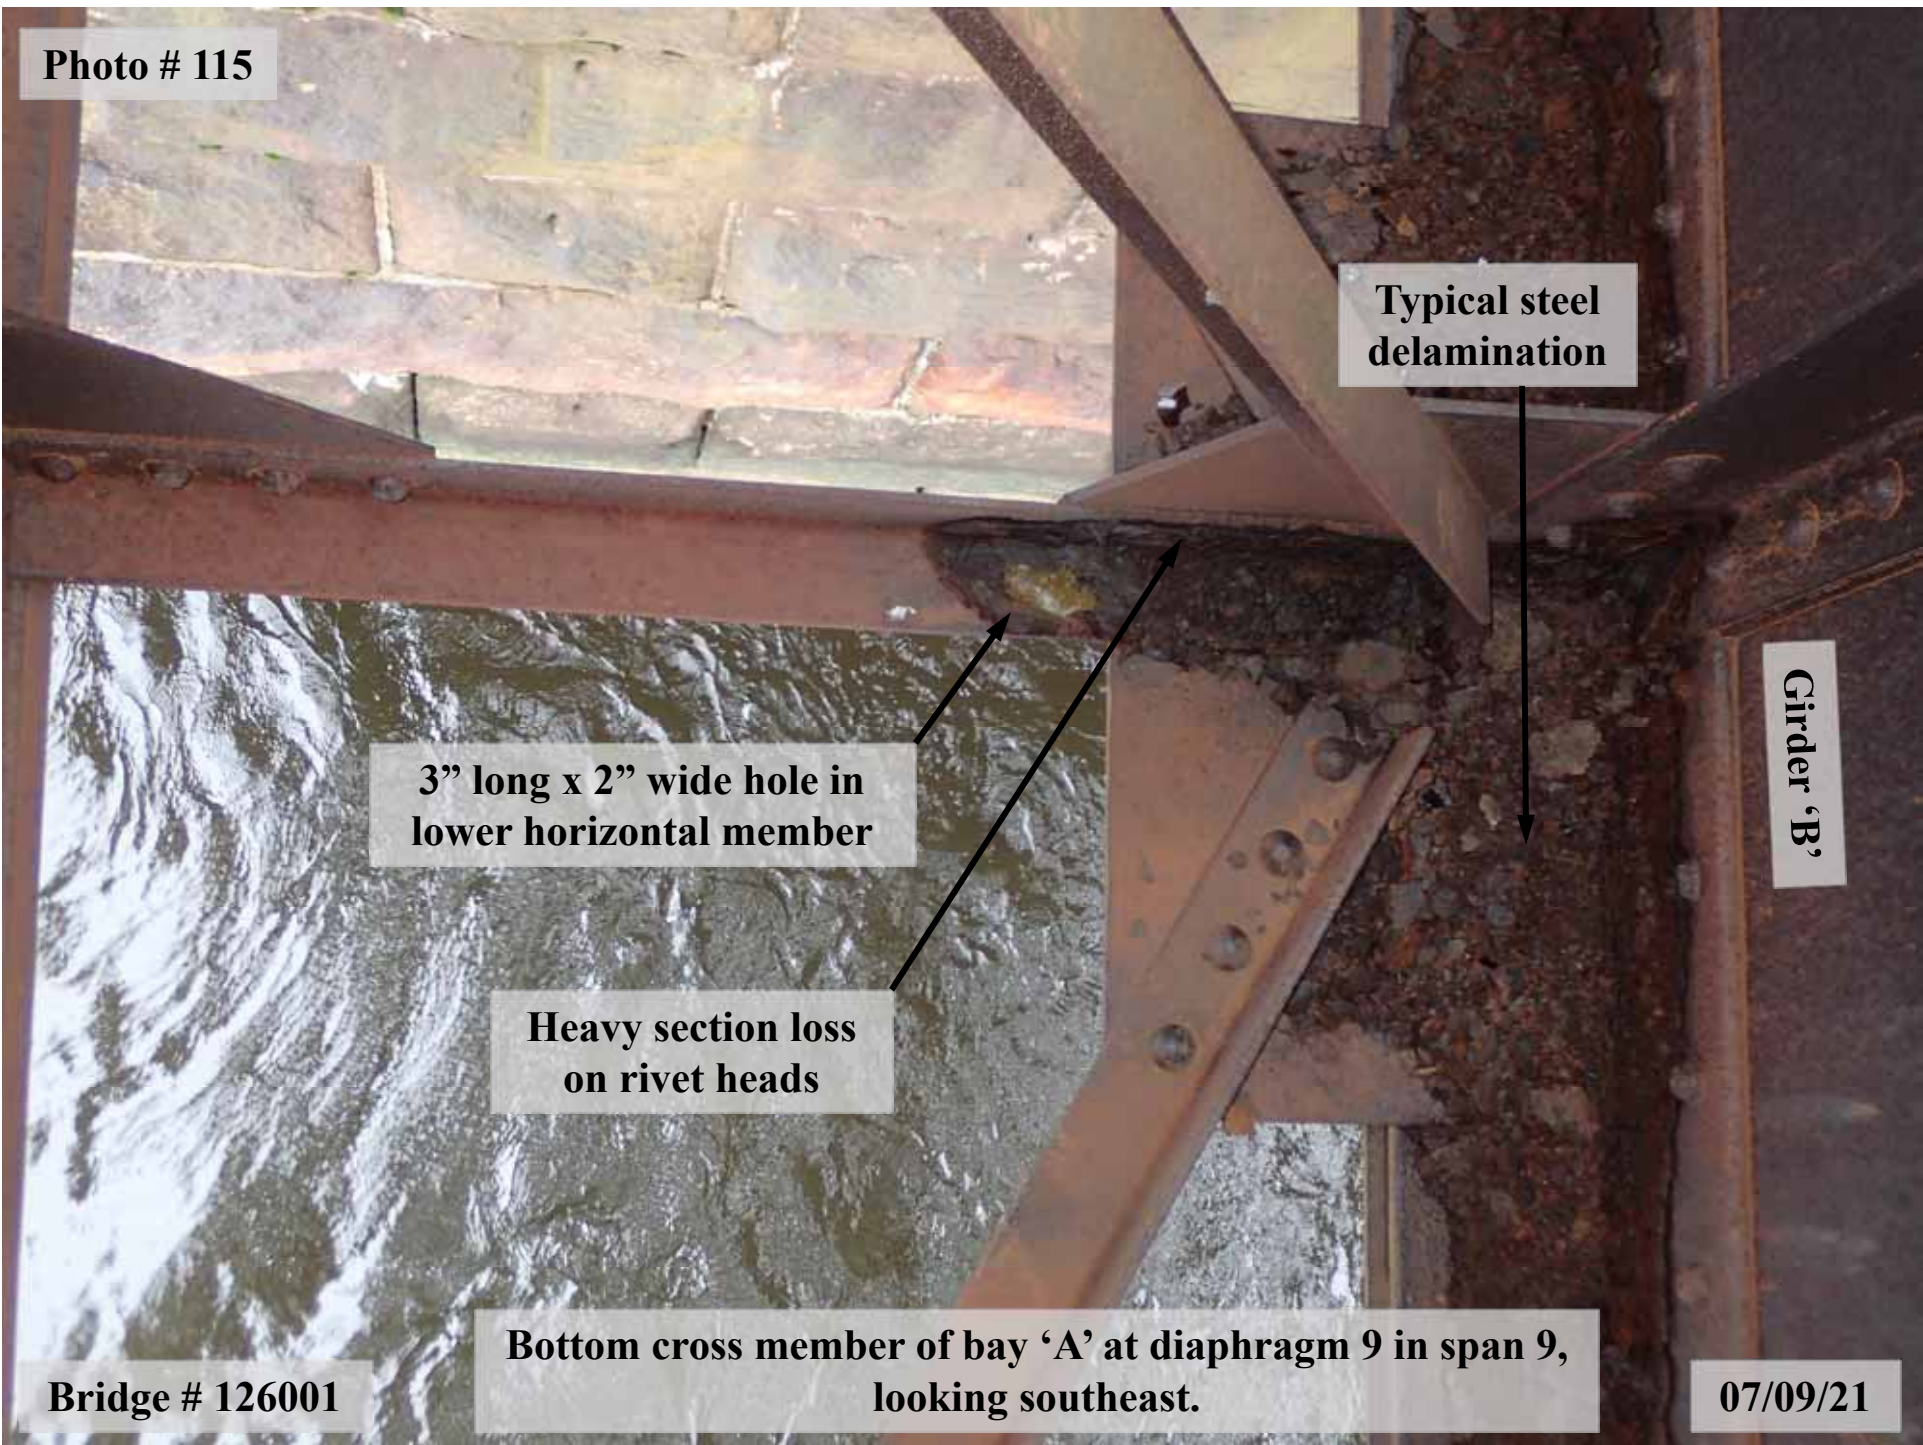
Photo # 115

Typical steel delamination

3" long x 2" wide hole in lower horizontal member

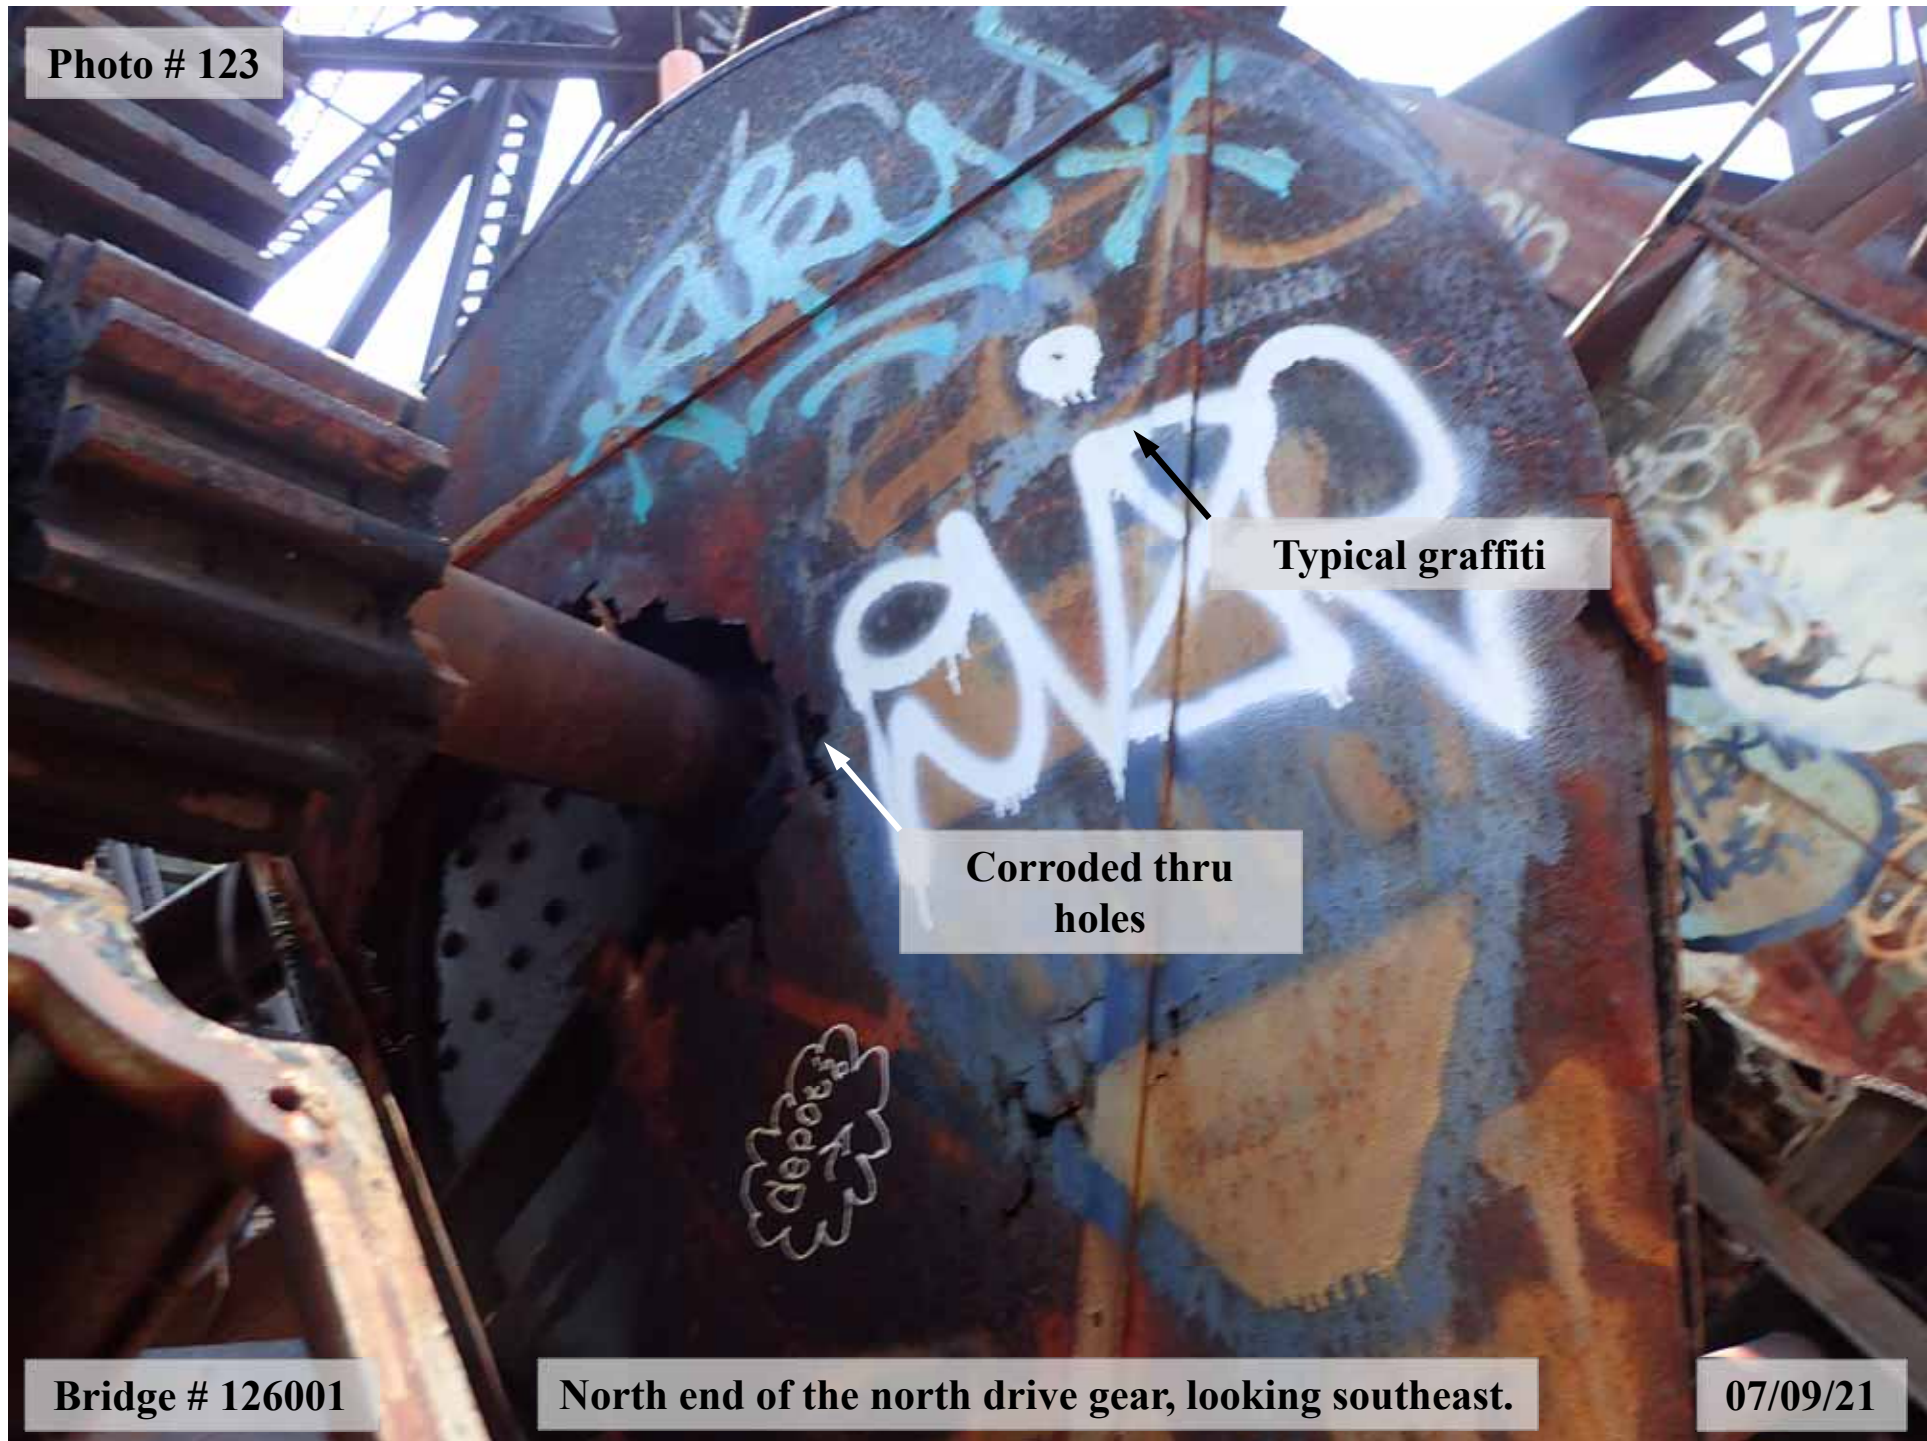
Photo # 123

Typical graffiti

Corroded thru holes

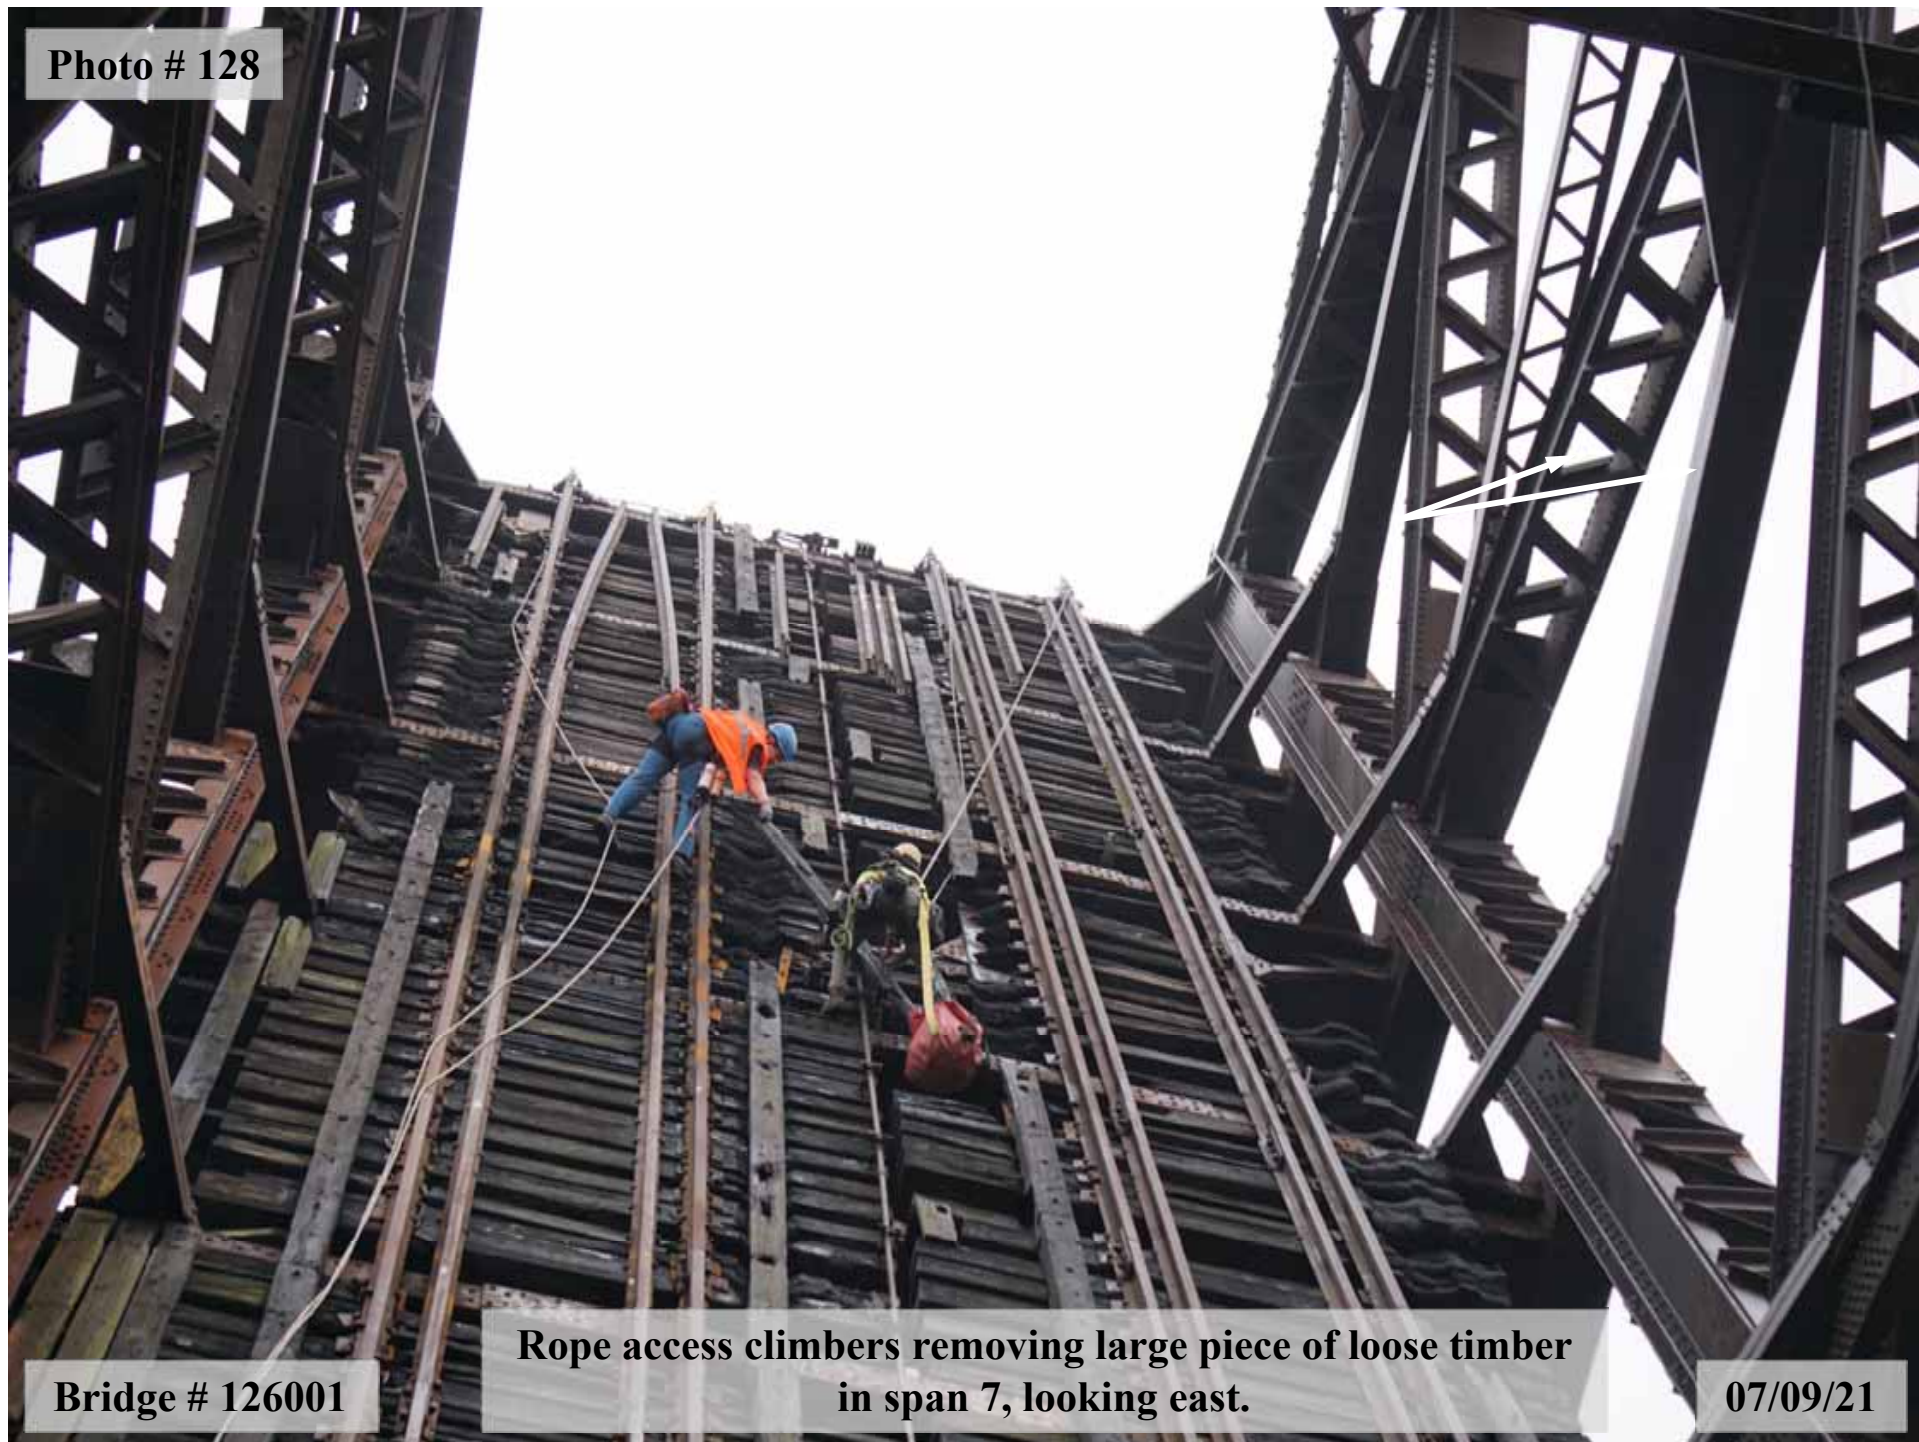
Photo # 128

**Rope access climbers removing large piece of loose timber
in span 7, looking east.**

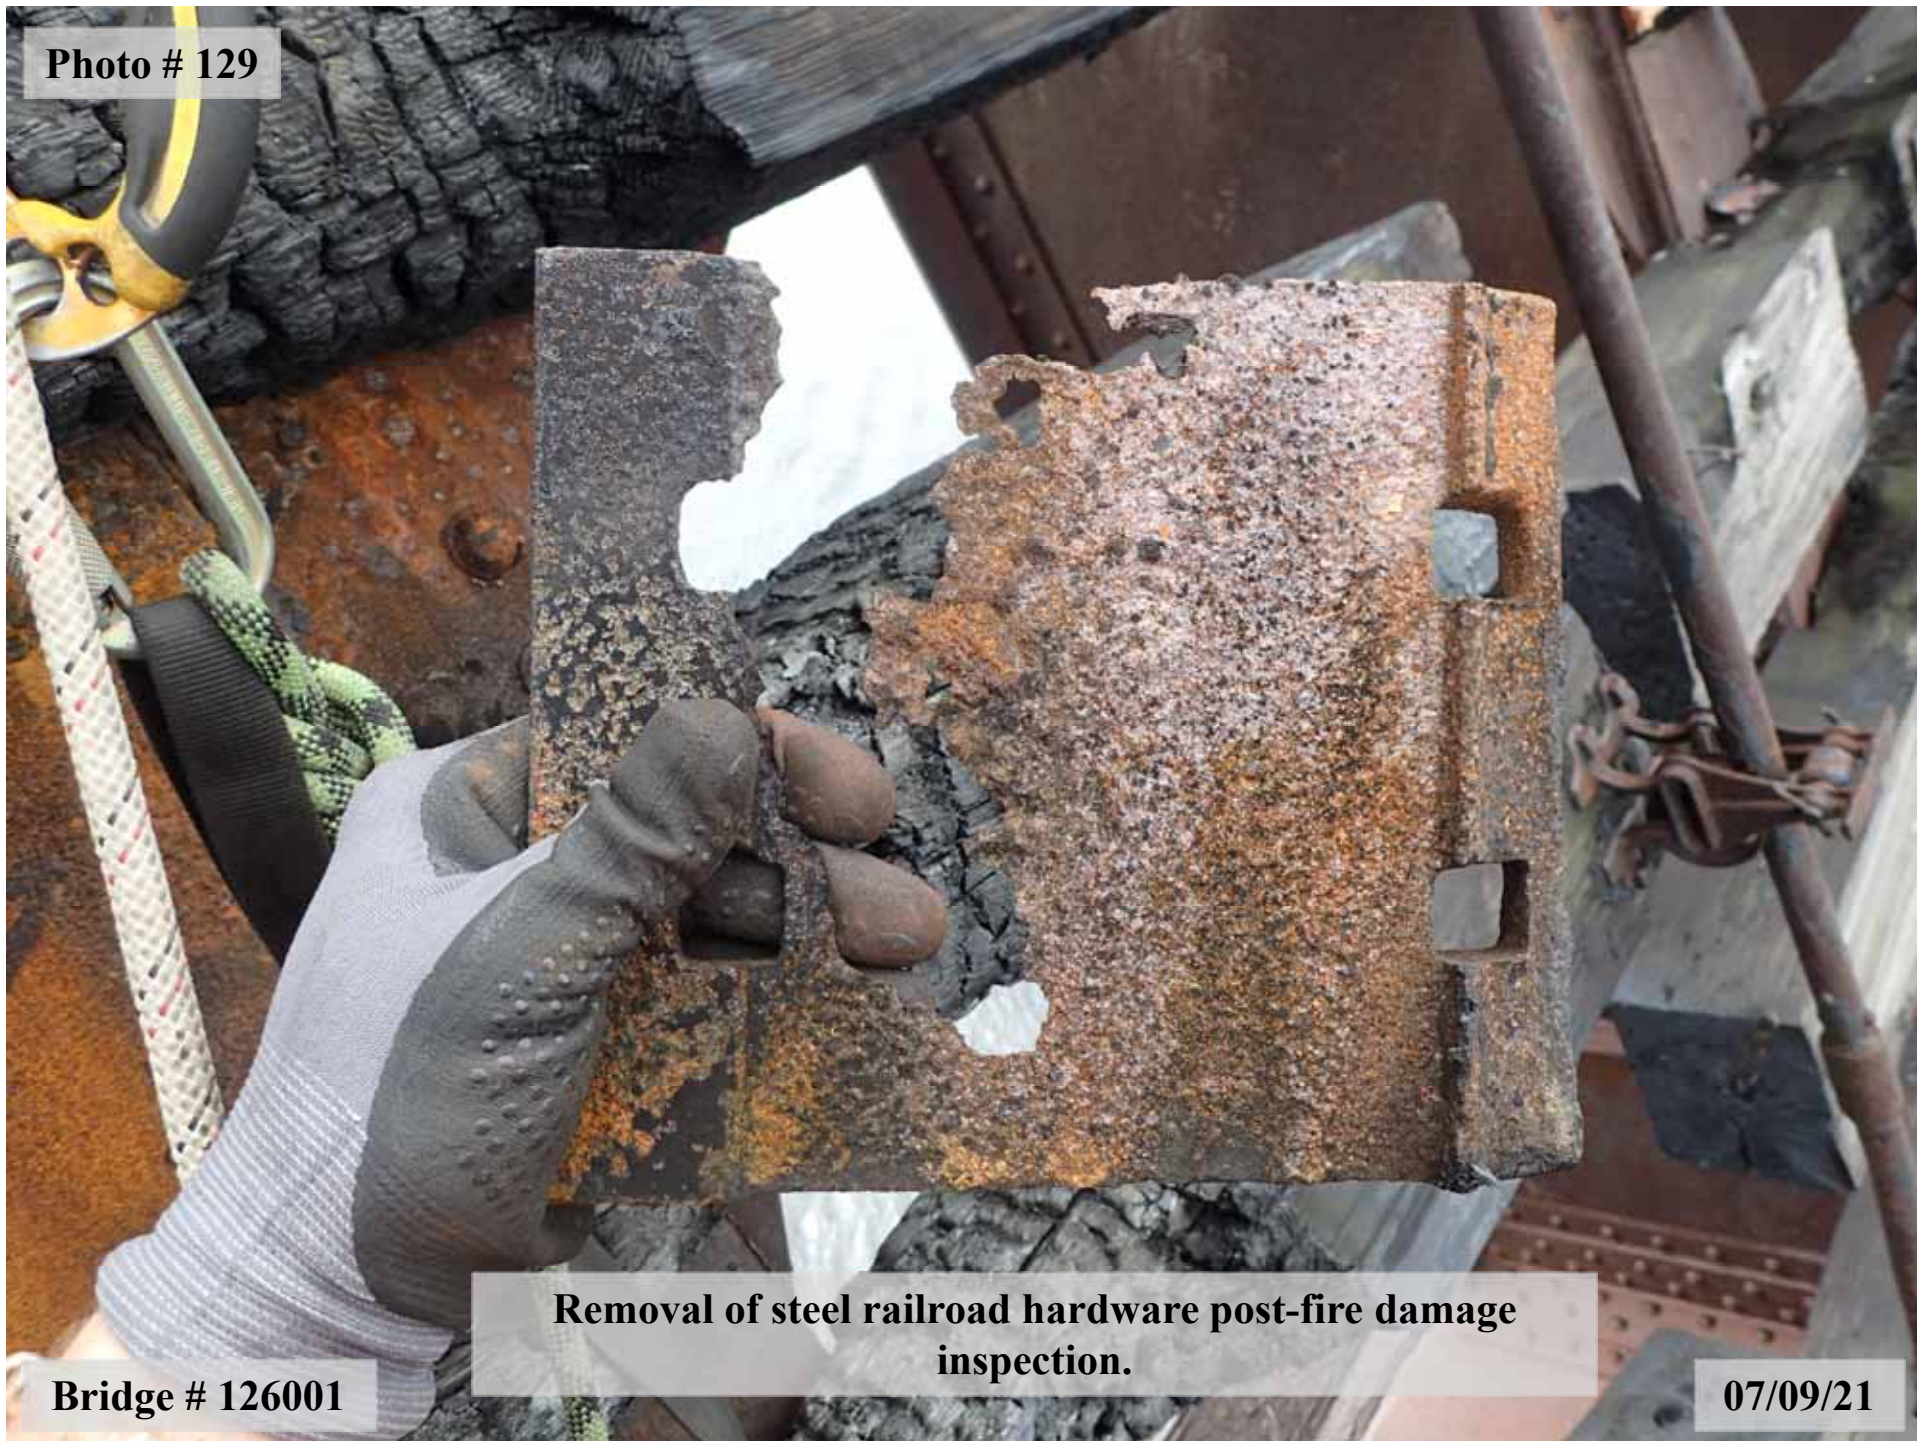
Photo # 129

Removal of steel railroad hardware post-fire damage inspection.
