**4. CASE 24.131, 20 ARNOLD STREET, Zachariah Carpenter House, 1795-96 (COLLEGE HILL)**

Project: Single Family Residence – Zachariah Carpenter House  
Address: 20 Arnold Street, Providence, RI 02906  
Date: 9 September 2024  
Re: Application Information

**Sash Replacement**

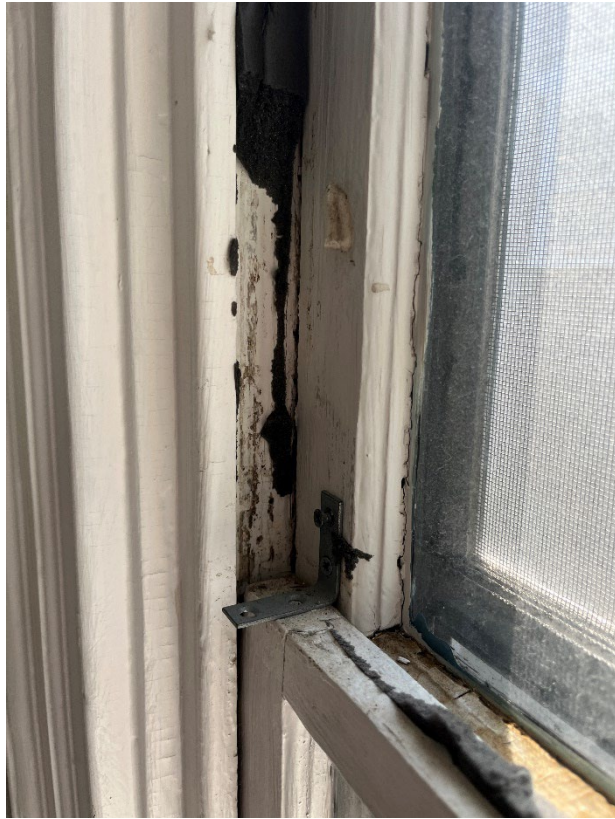
*Figure 19 - Typical condition*

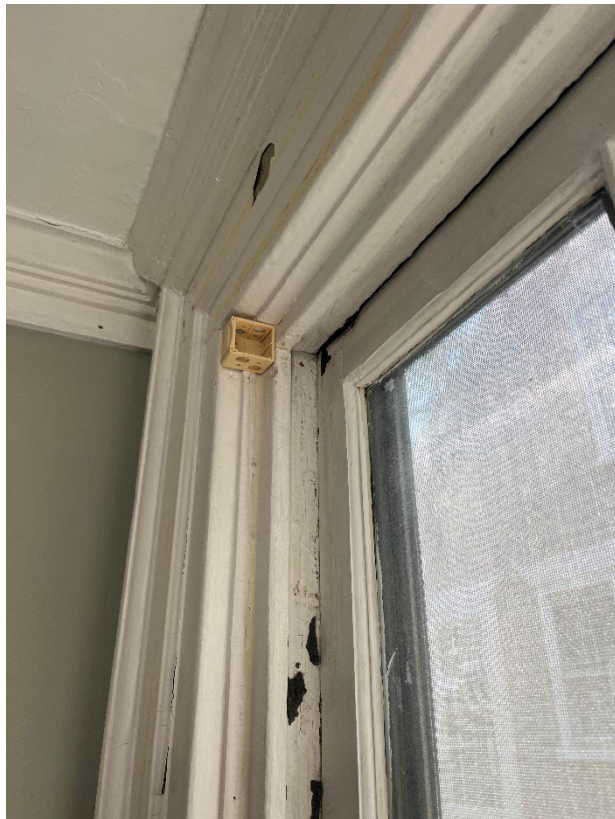
*Figure 20 - detail of sash rubbing on frame*

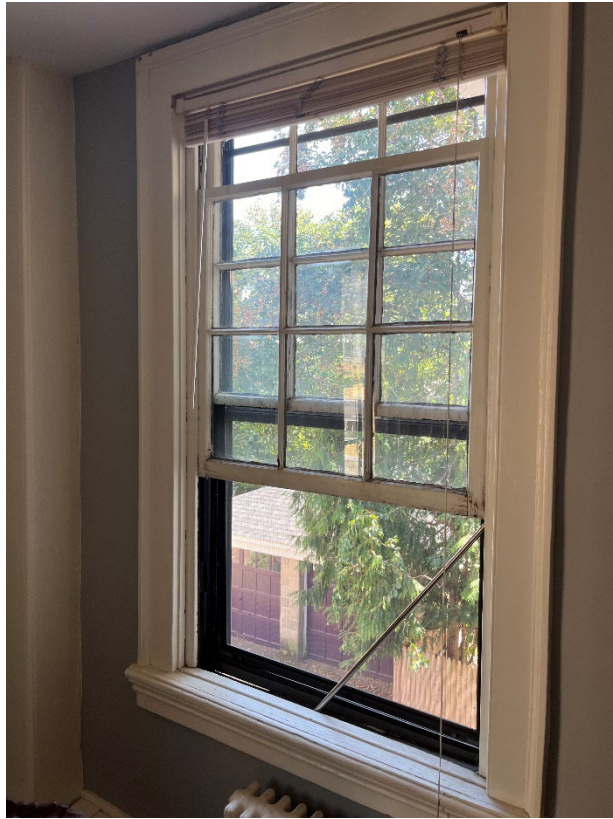
*Figure 21 - Window "A" with stick to hold open*

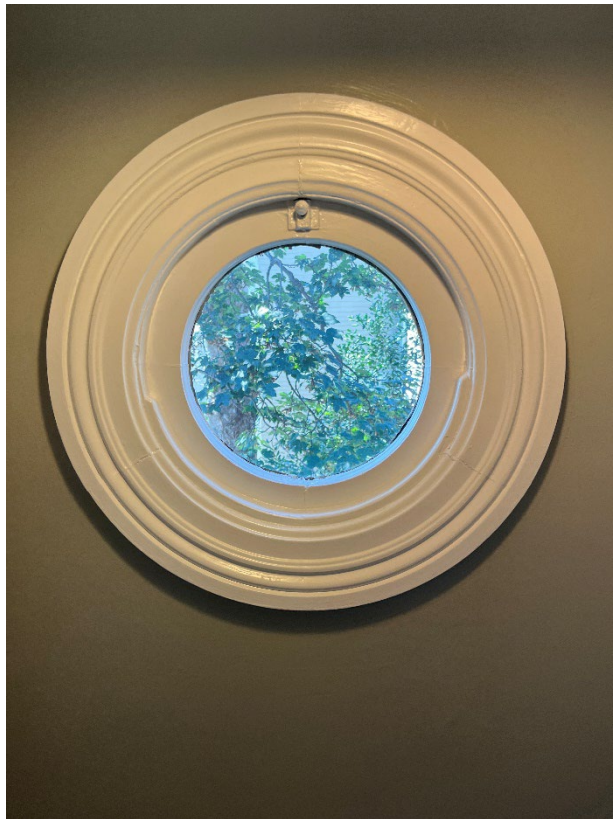
*Figure 22 - Window "E" - no change*
