Owner/Applicant: Touchdown Realty, 319 Main Street, North Kingstown, RI 02852
Architect: David Sisson Architecture PC, 345 Taunton Ave, East Providence, RI 02914

Proposal: The scope of work proposed consists of Major Alterations and includes:

- requesting permission for the painting/staining of the stone exterior.

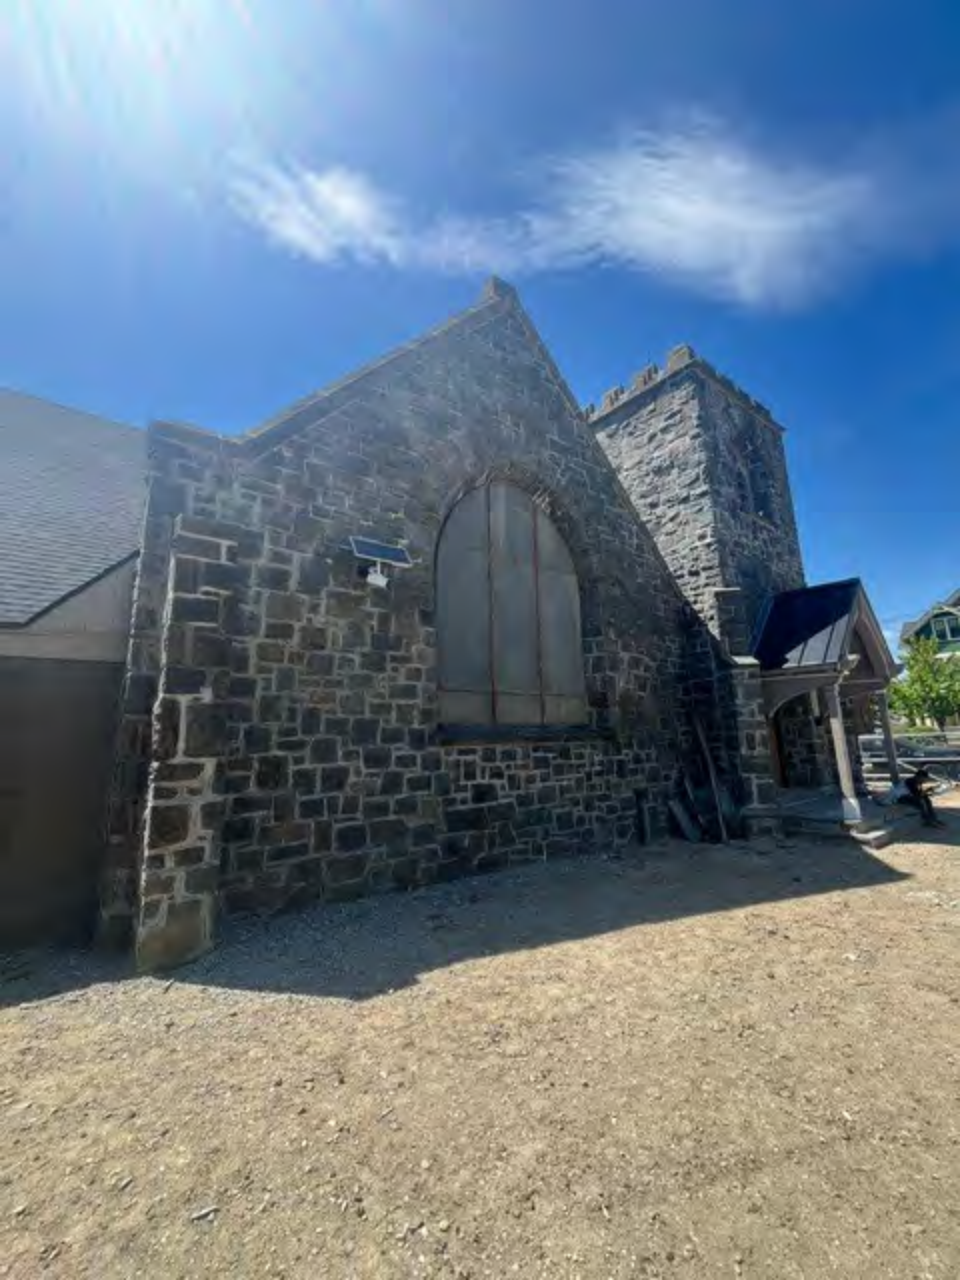
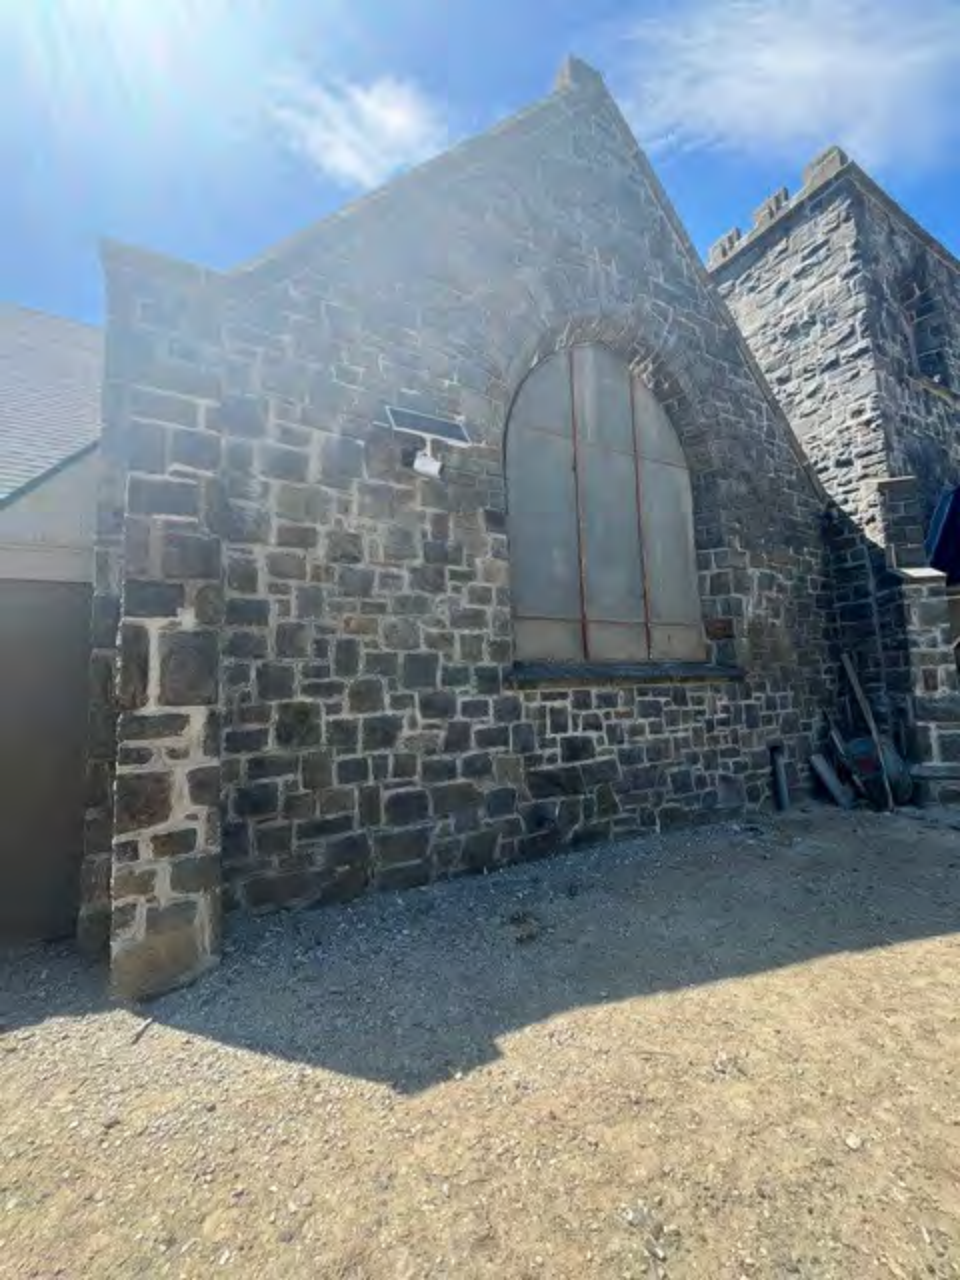
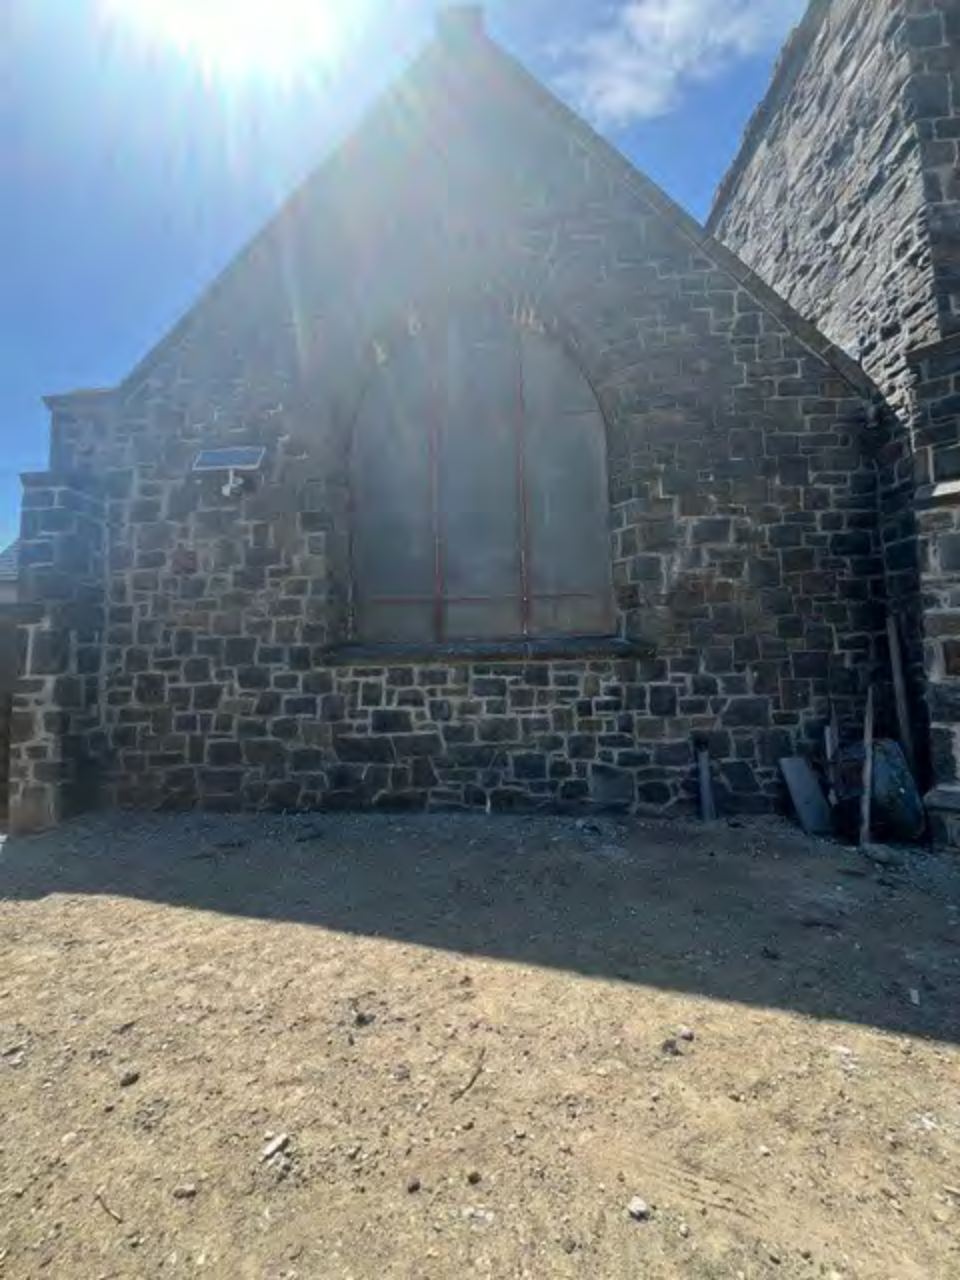
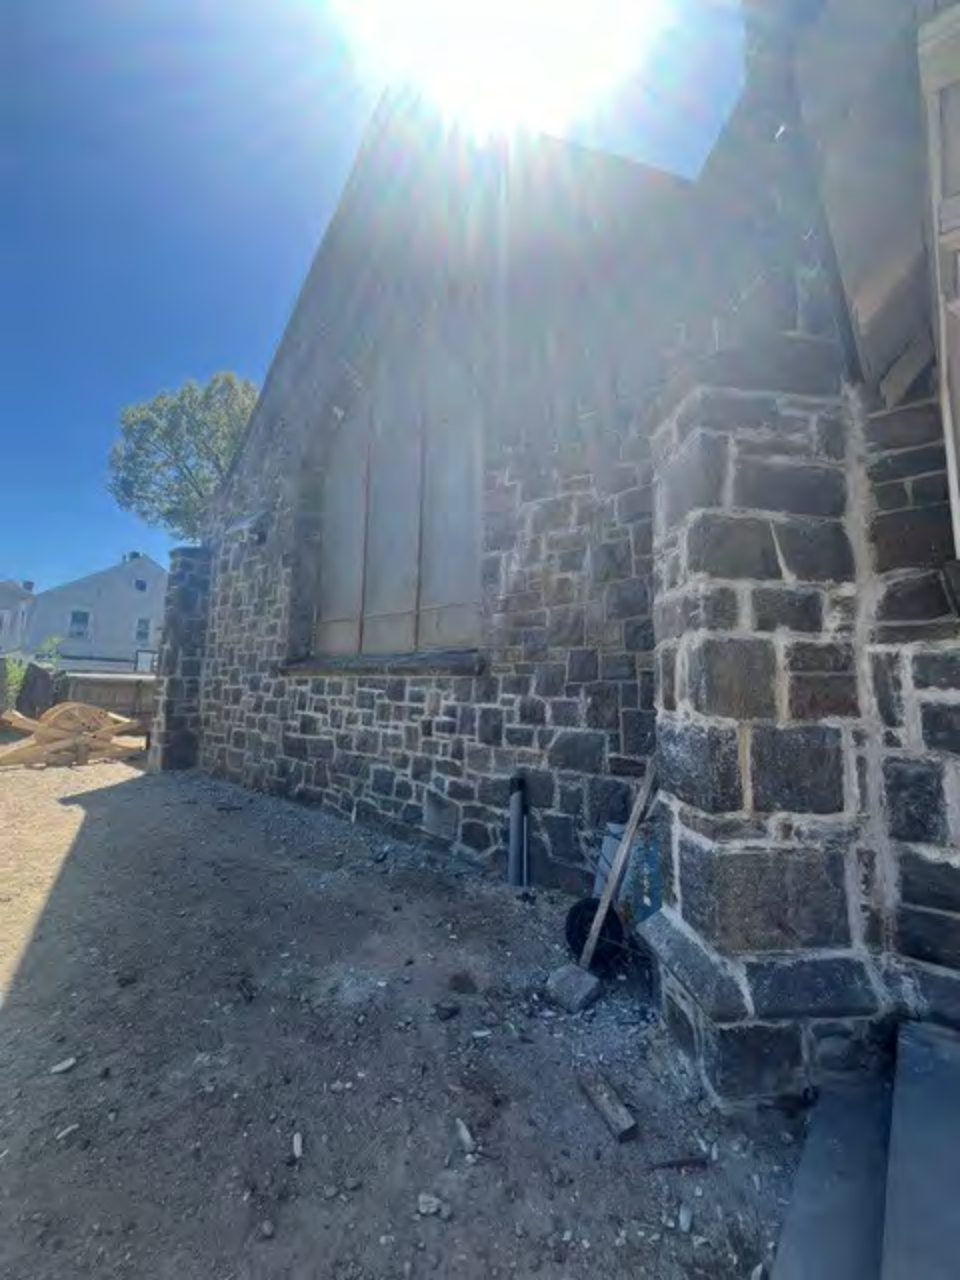
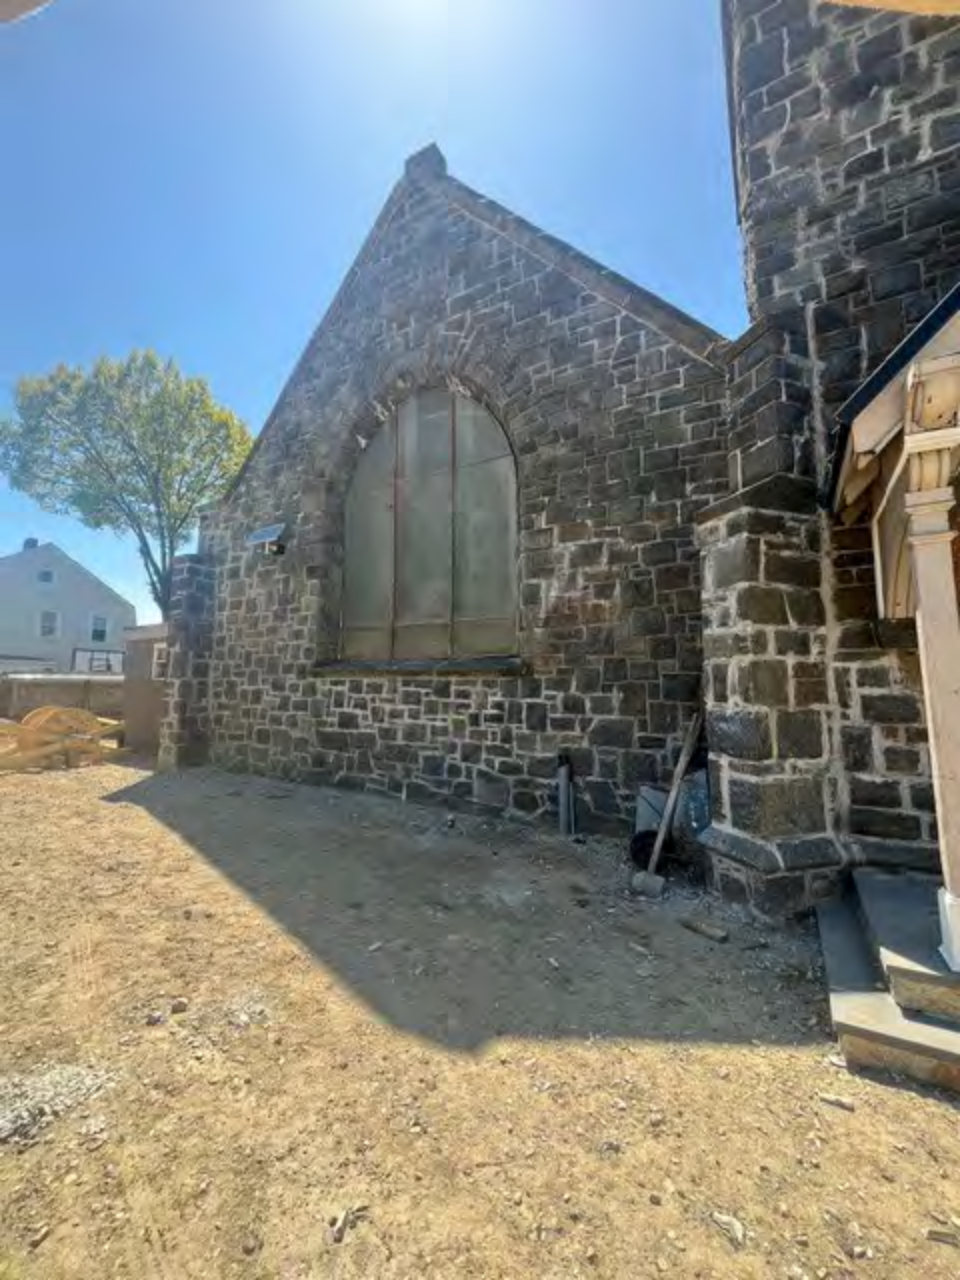
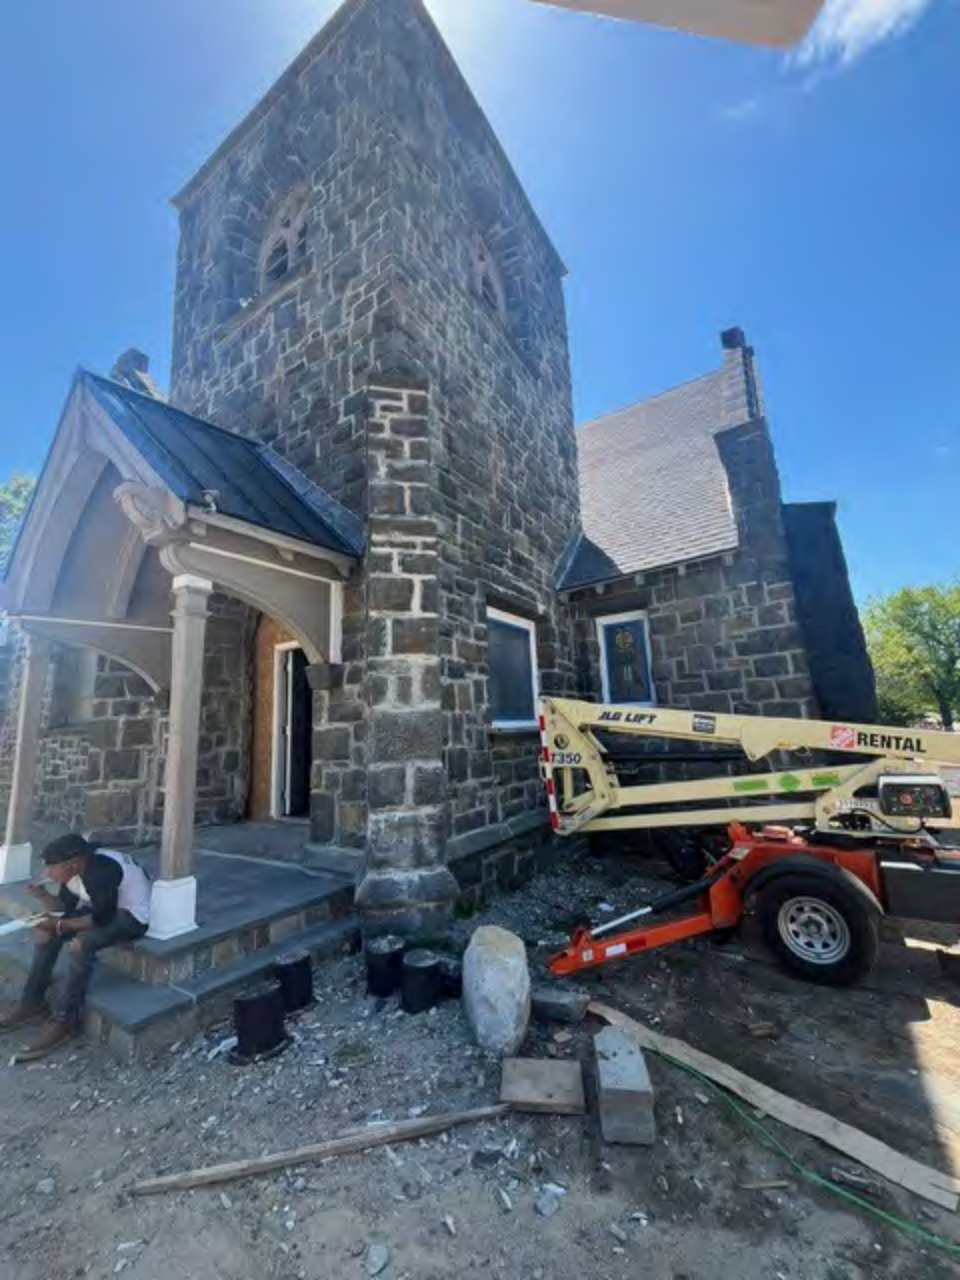
- The applicant contacted staff to discuss the potential painting/staining of the building due to issues with the condition of the stone and repointing, which is producing an uneven appearance. Staff stated that the Standards do not allow for painting of unpainted masonry. If the applicant wished to explore, Staff recommend doing a few discrete samples with different colors on the building and having the sub-committee convene to look at the samples and make a recommendation; the applicant agreed to this. Unfortunately, there was a miscommunication between the applicant and painters and portions of the building have now been painted/stained black. Staff contacted the applicant and requested no further work be done, and would schedule matter before full Commission. Applicant agreed.

- The applicant has submitted the following to me via email and will provide additional information at the meeting:
 - "Jay, please see photos of the current state of unpainted stone and mortar @ 126 Adelaide. As you can see, the stone and mortar are still very much in distress even after being treated, and re-mortared. After being neglected for decades and uncared for, the stone needed extensive work, far beyond anything we imagined nor budgeted for. Water was seeping in to the building due to compromised areas on the stone, cracks etc, and failed mortar in countless areas. Well before esthetics, stopping the water from penetrating the interior was our top priority, and a different task to say the least. Once water leaks were mitigated (large expense), we then realized just how bad the condition of the stone was overall, with massive amounts of discoloration, previous make-shift mortar jobs, and algae build up scattered throughout. The above issues alone sparked the thought to unify the stone with paint.

Conversely, the Commission may consider that the masonry has deteriorated has progressed so far that a protective surface coating is needed. In such cases, a breathable masonry paint in a color consistent with the natural masonry is recommended. It is the applicant's assertion that the Obsidian color is a natural color and has been used in other historic applications and may be deemed appropriate. If the Commission agrees the staff recommends the PHDC make the following findings of fact:
