Owner/Applicant: Touchdown Realty, 319 Main Street, North Kingstown, RI 02852

Architect: David Sisson Architecture PC, 345 Taunton Ave, East Providence, RI 02914

Proposal: The scope of work proposed consists of Major Alterations and includes:

- requesting permission for the painting of the stone exterior.

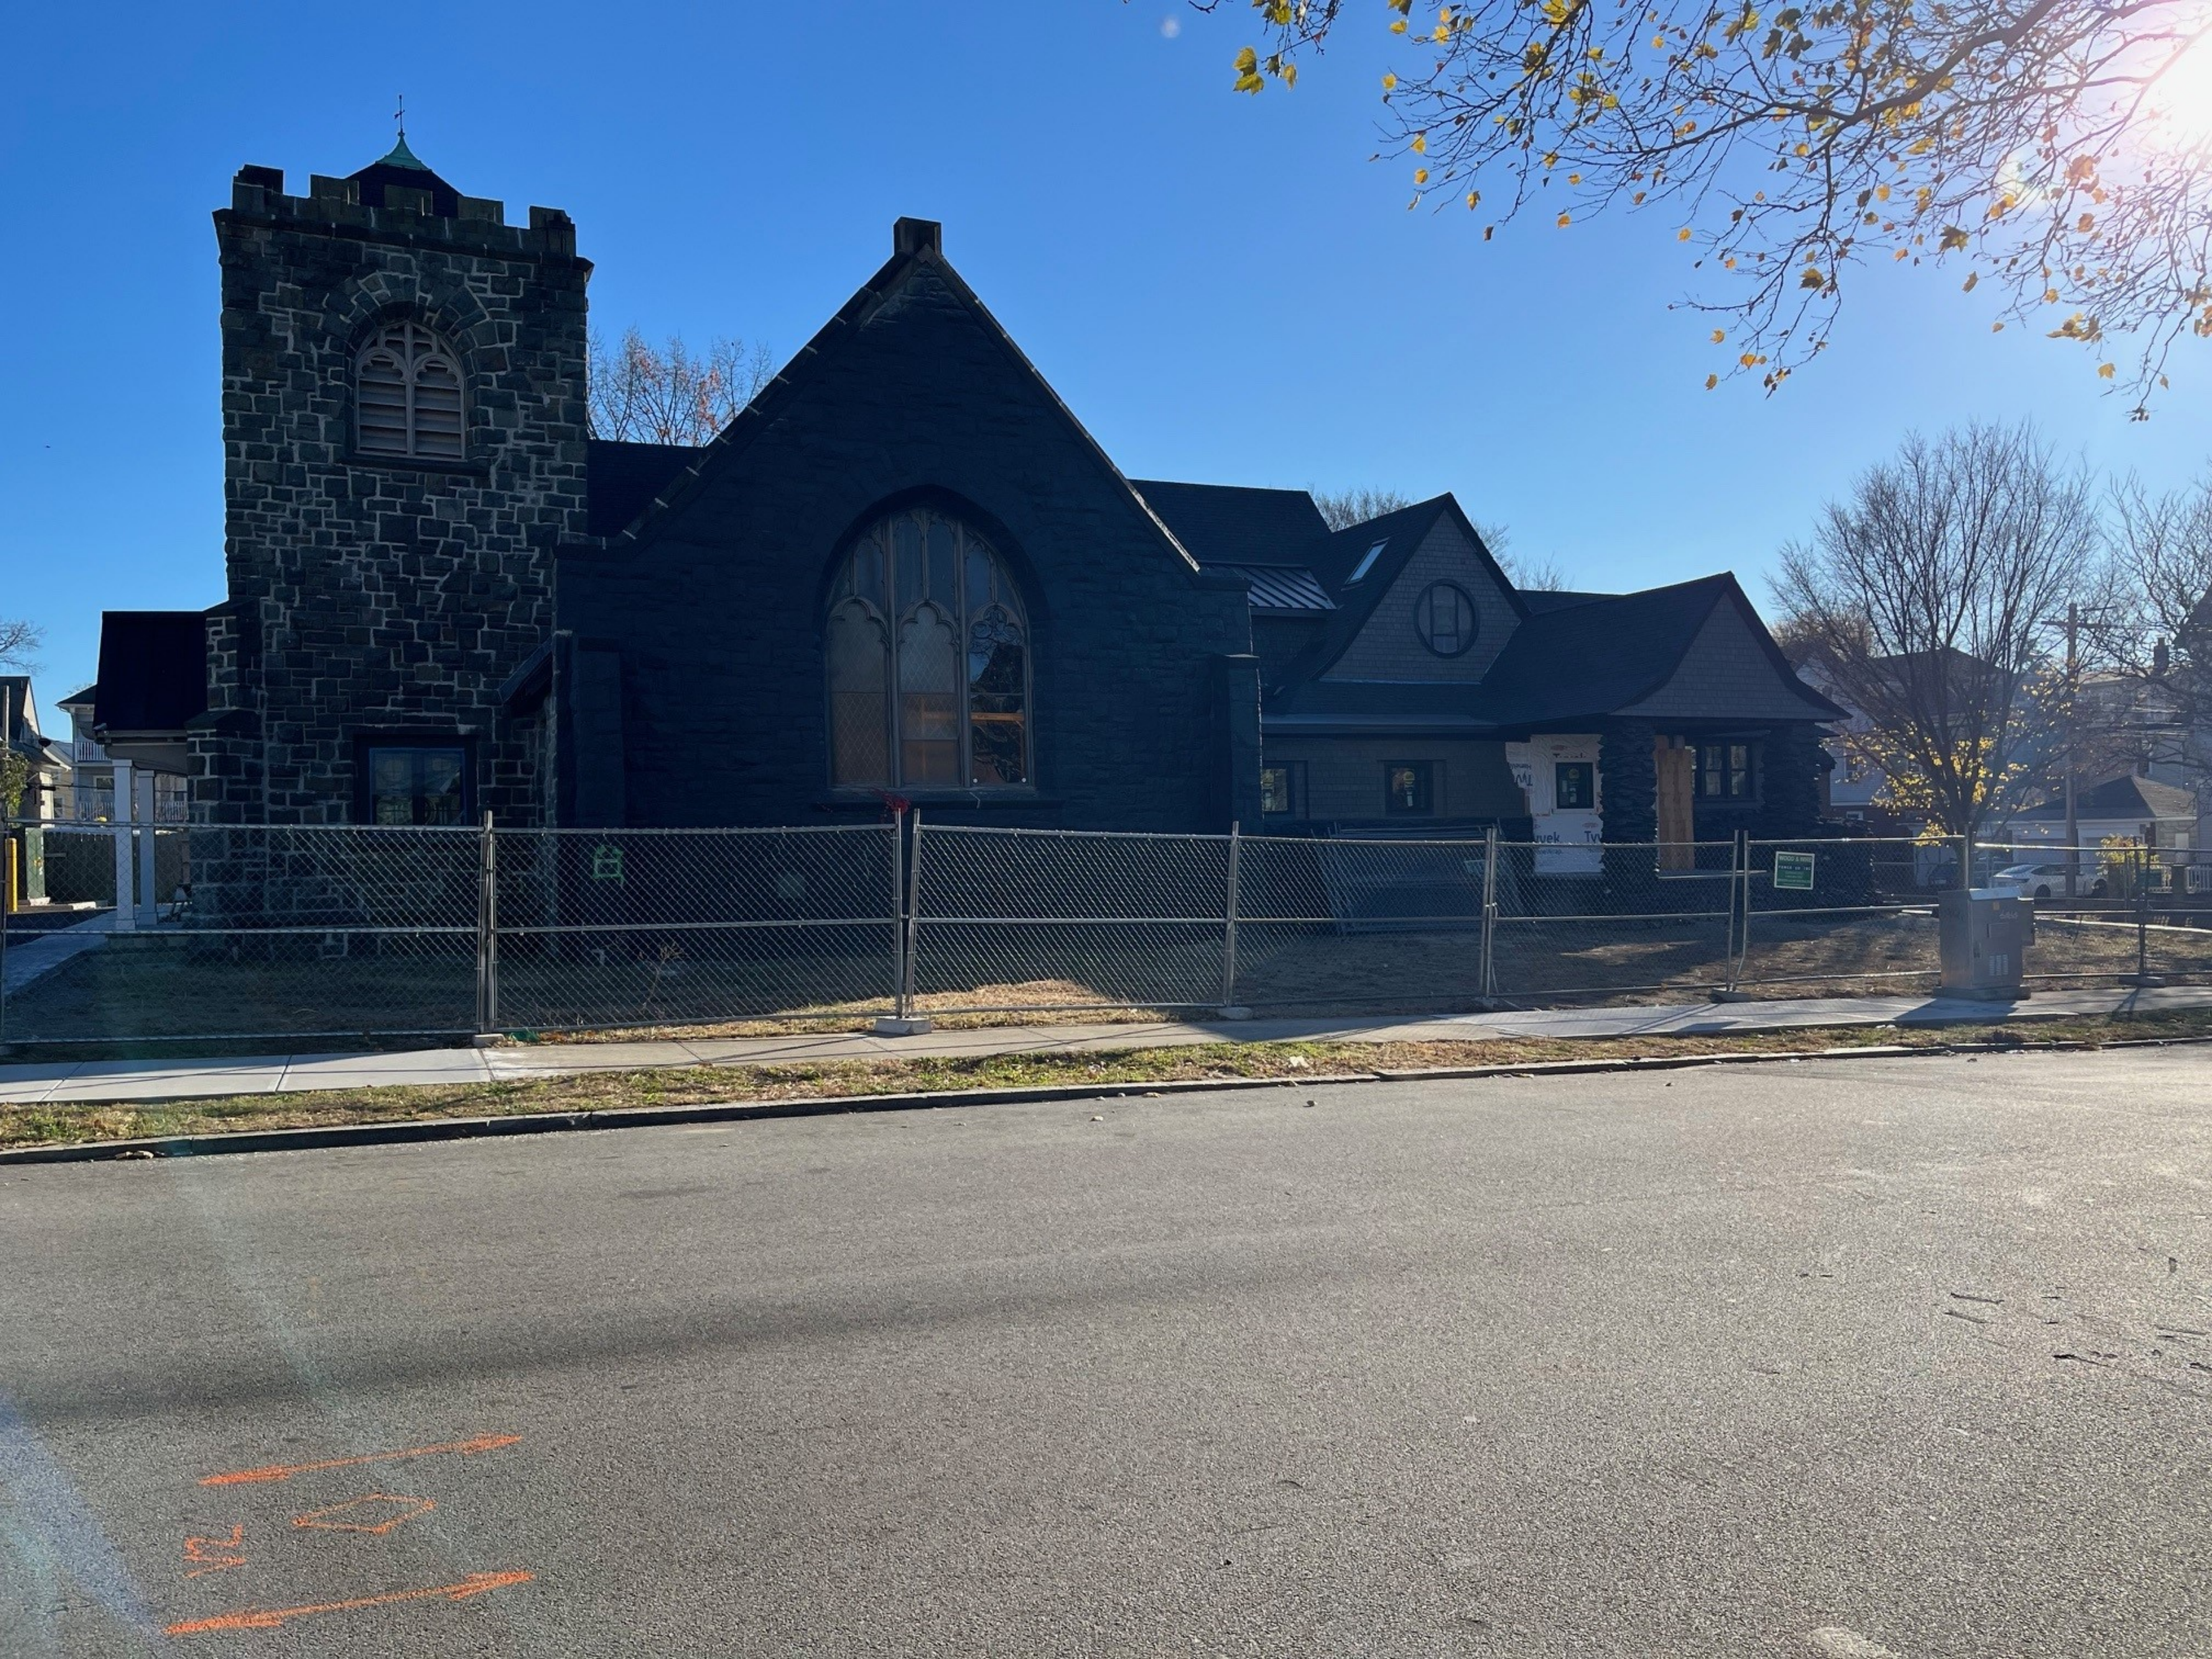
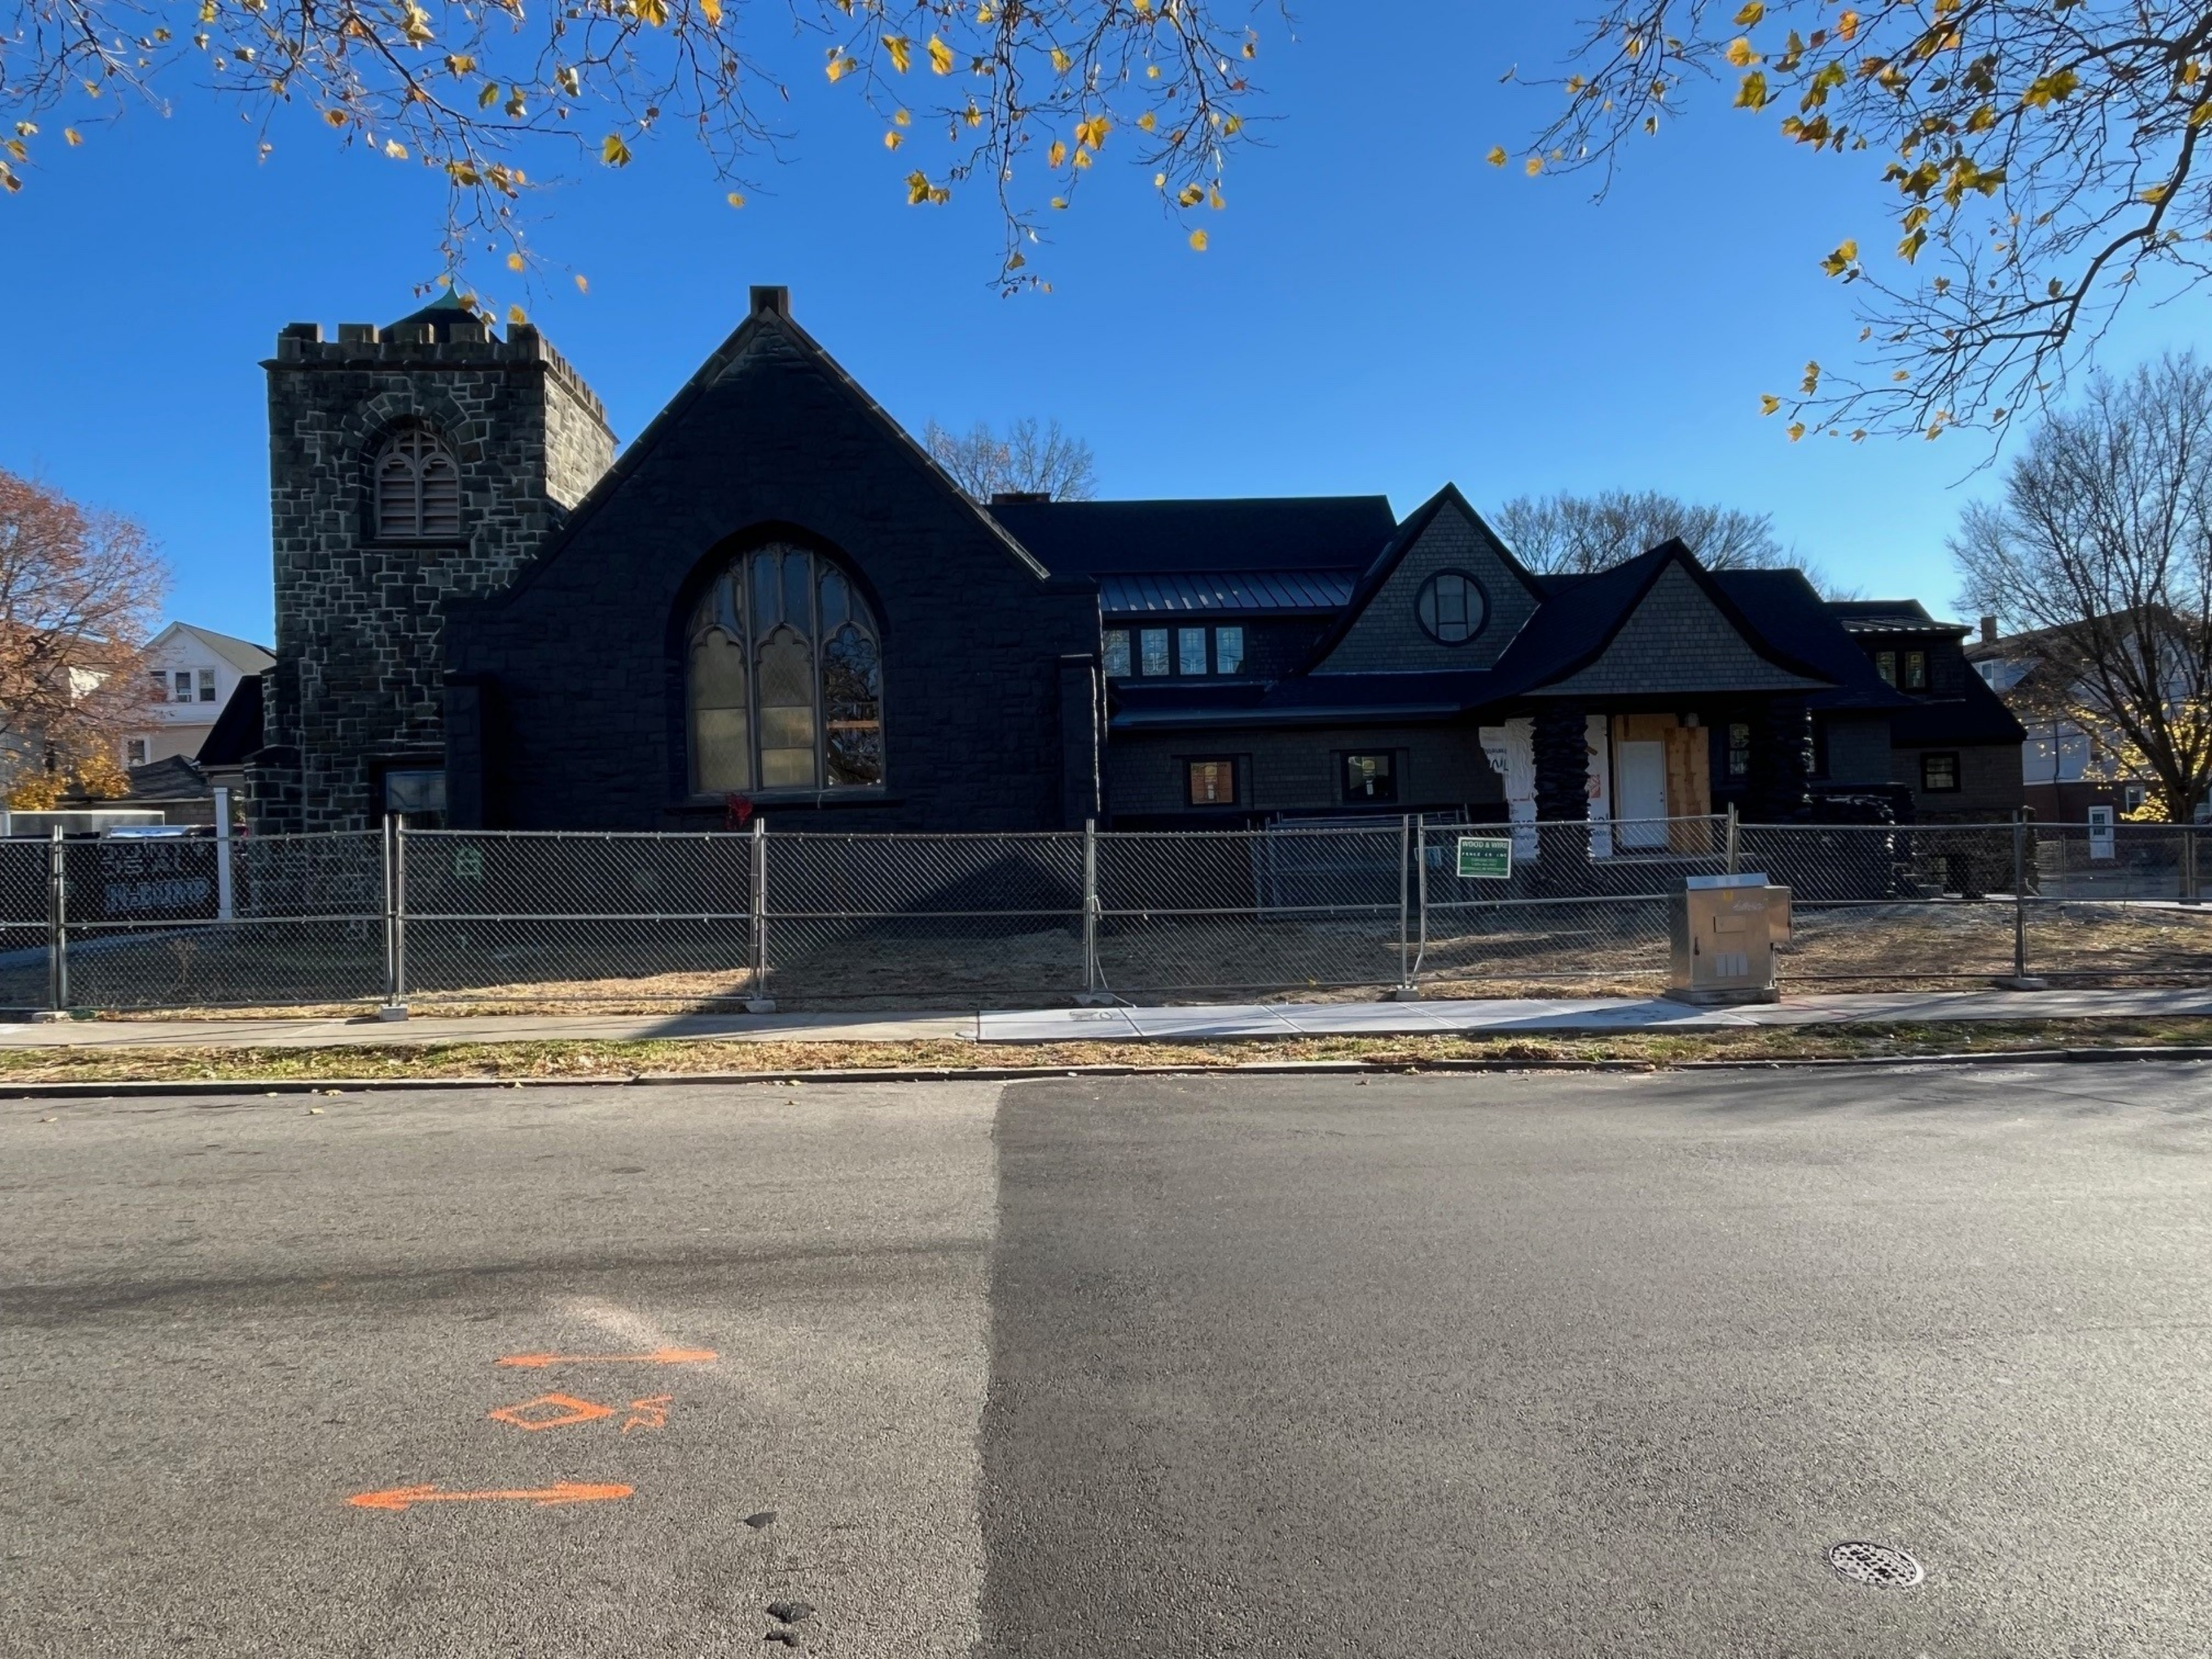
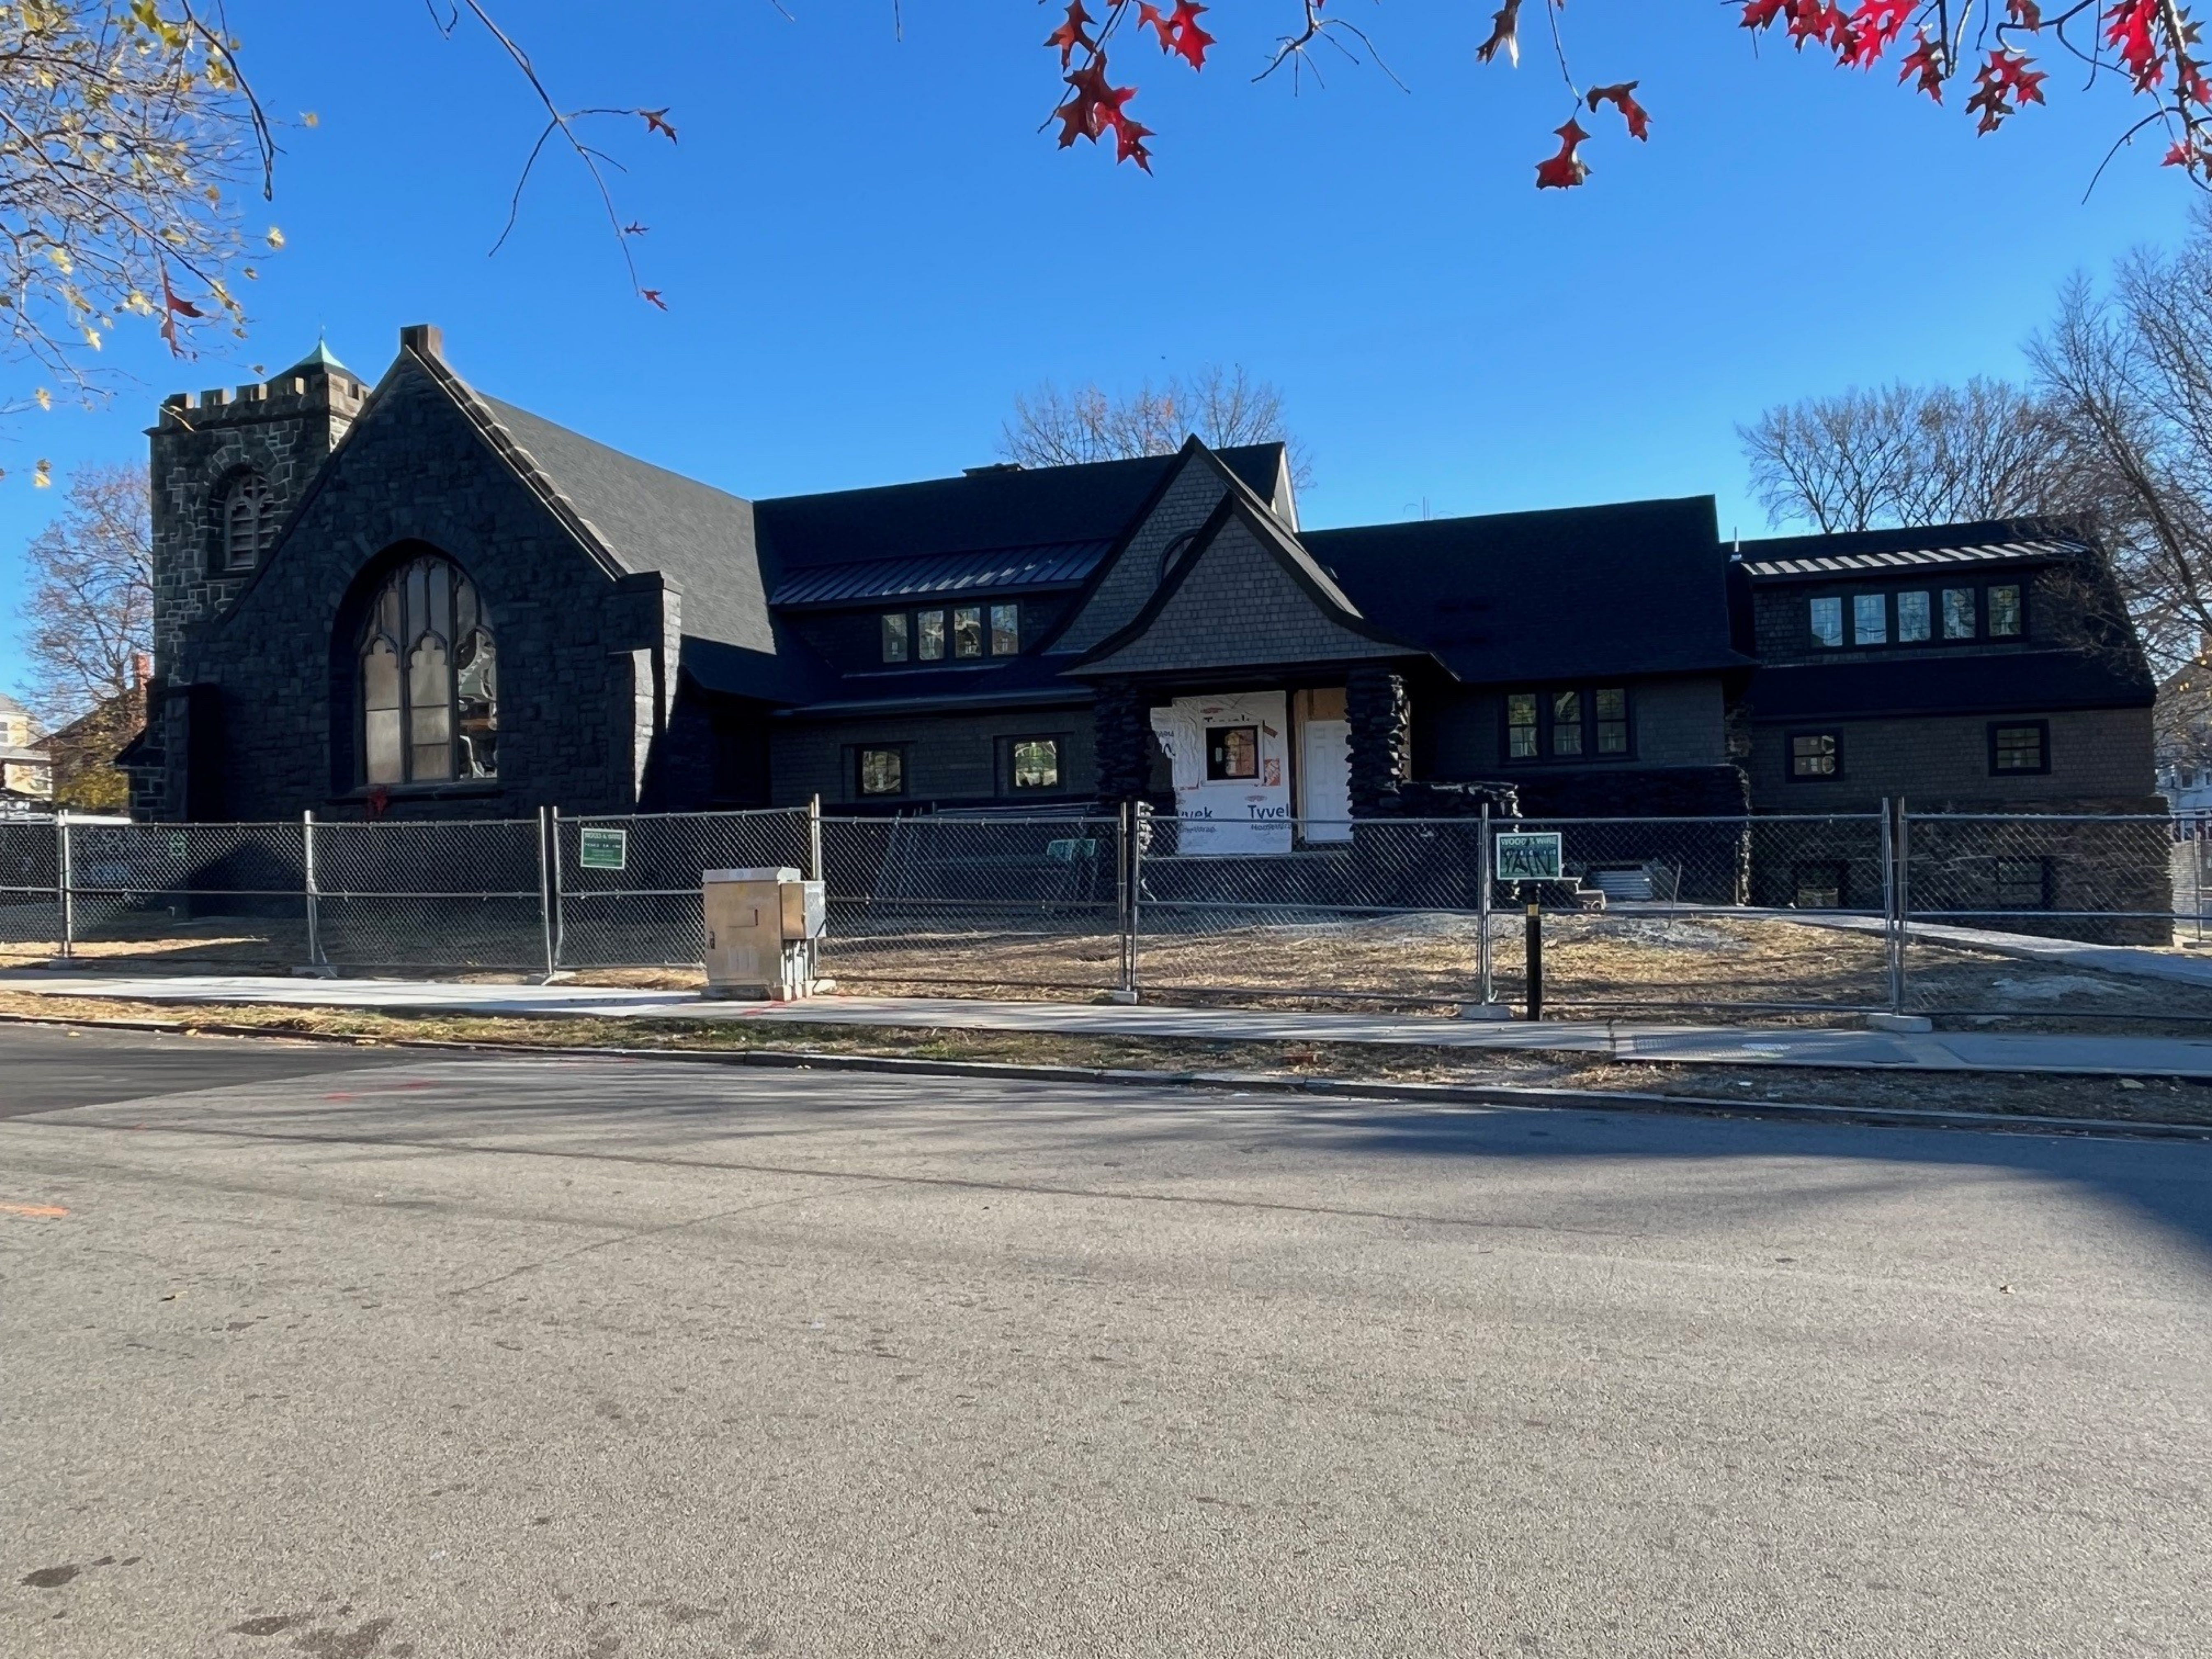
A Gothic-style stone building with a large, pointed-arch window and a small tower on the roof.

A large, dark-colored building with a mix of stone and wood siding, featuring a prominent Gothic-style window and a tower.

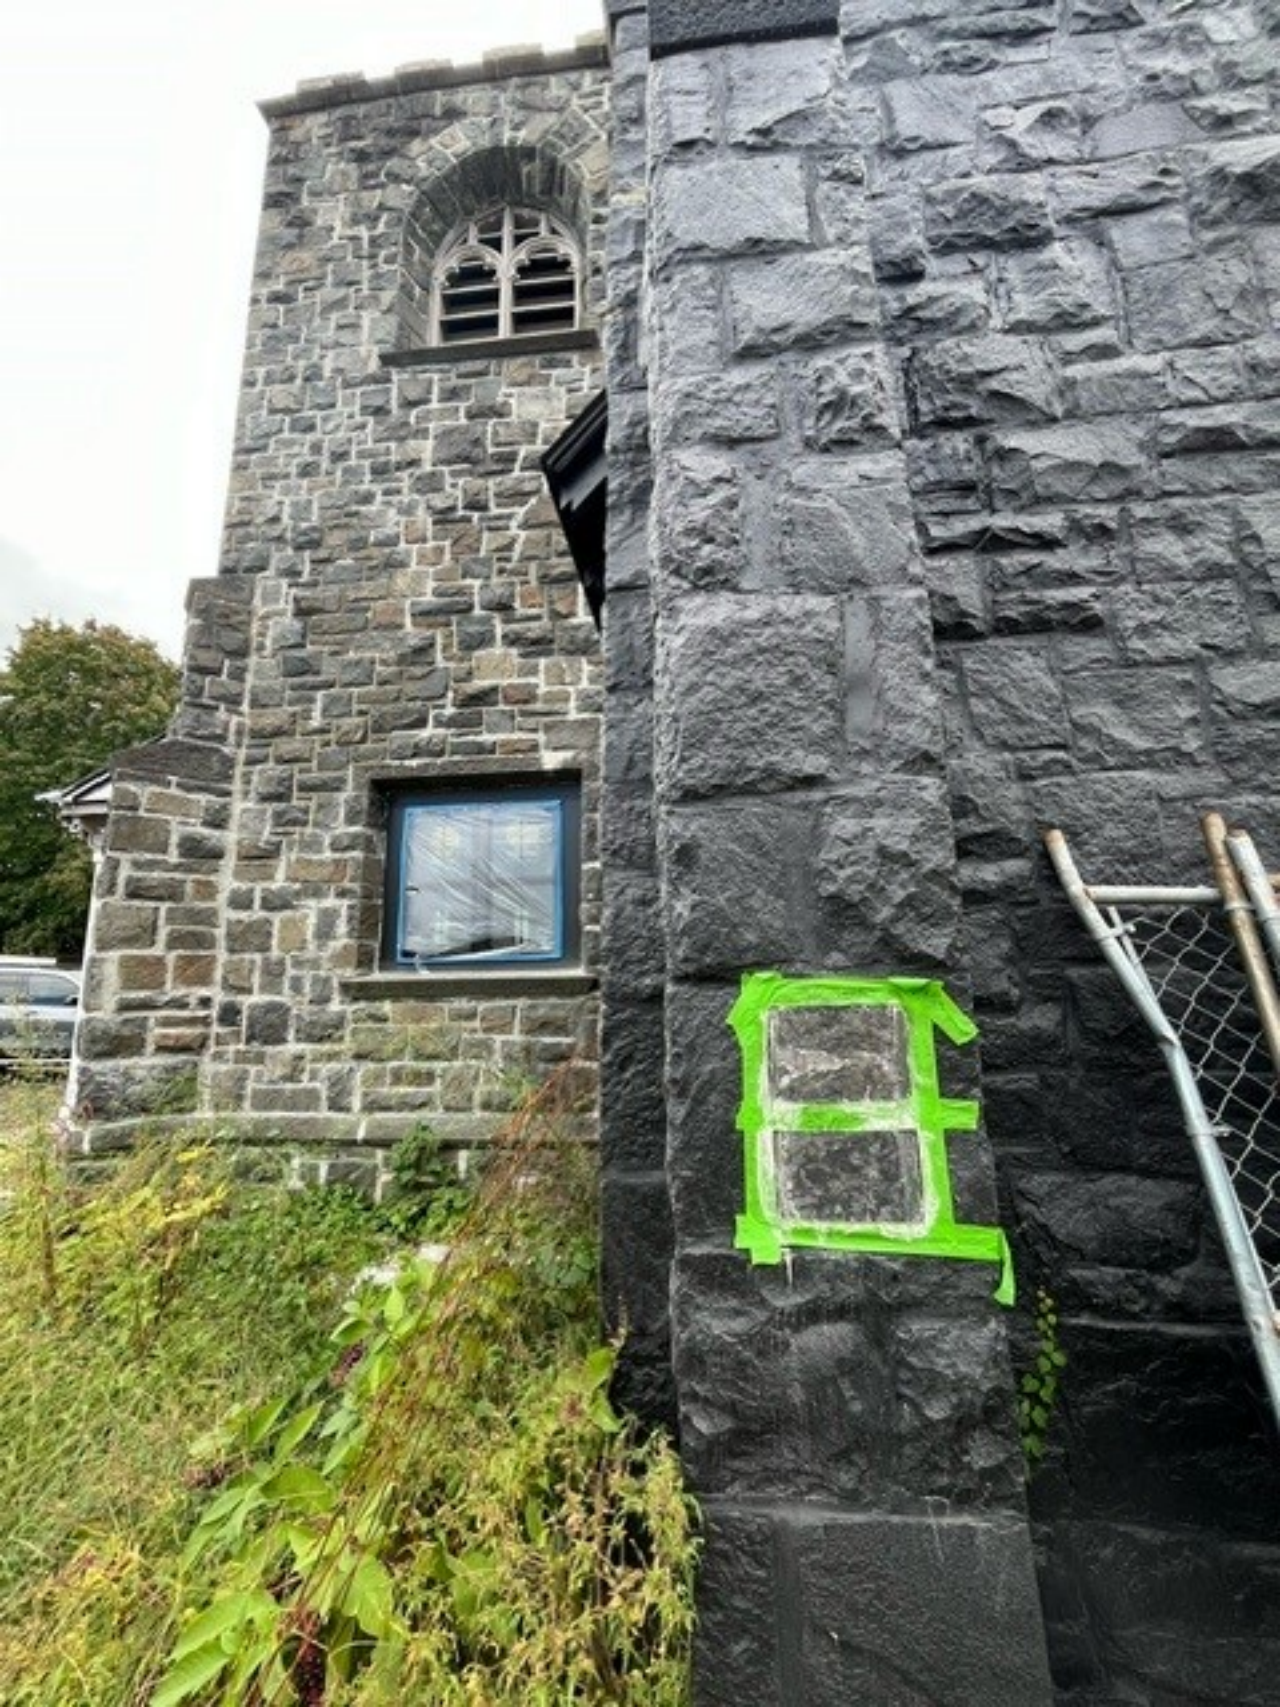
Stripper has been applied 30 minute set and scraping and wire wheeling completed. The 24 hour scraping will be done at 3 o'clock tomorrow.
