CITY OF PROVIDENCE, RHODE ISLAND

**RFP Title: URBAN DESIGN CONSULTING SERVICES RELATING TO CROOK POINT BRIDGE
PRESERVATION**

Addendum #: 1

A potential respondent has asked for supporting pictures referenced in the bid materials. This addendum adds those pictures.

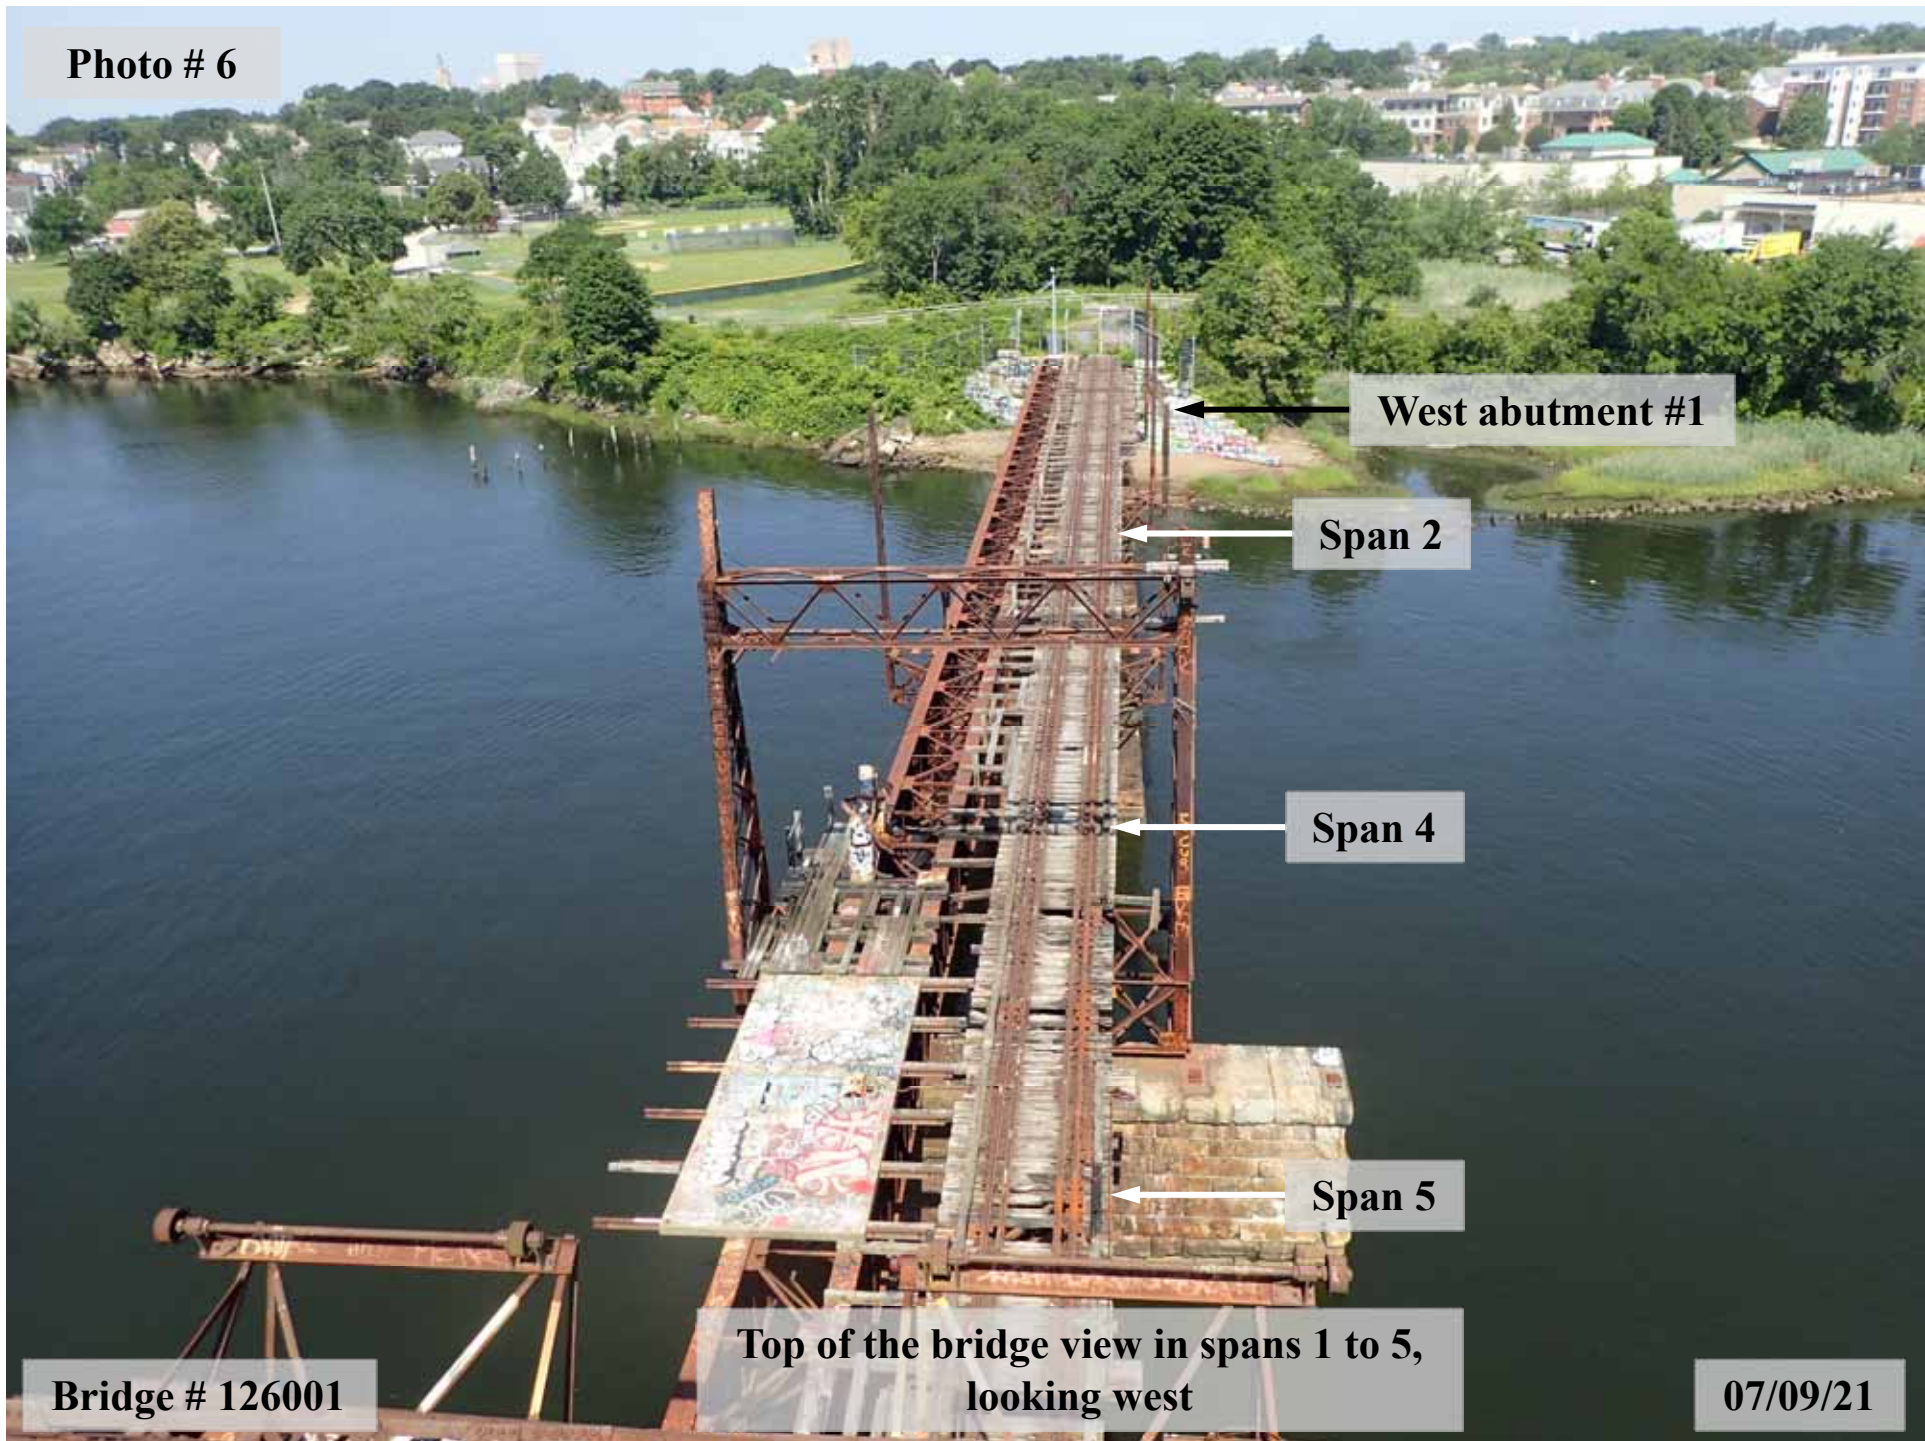
Photo # 6

**Top of the bridge view in spans 1 to 5,
looking west**

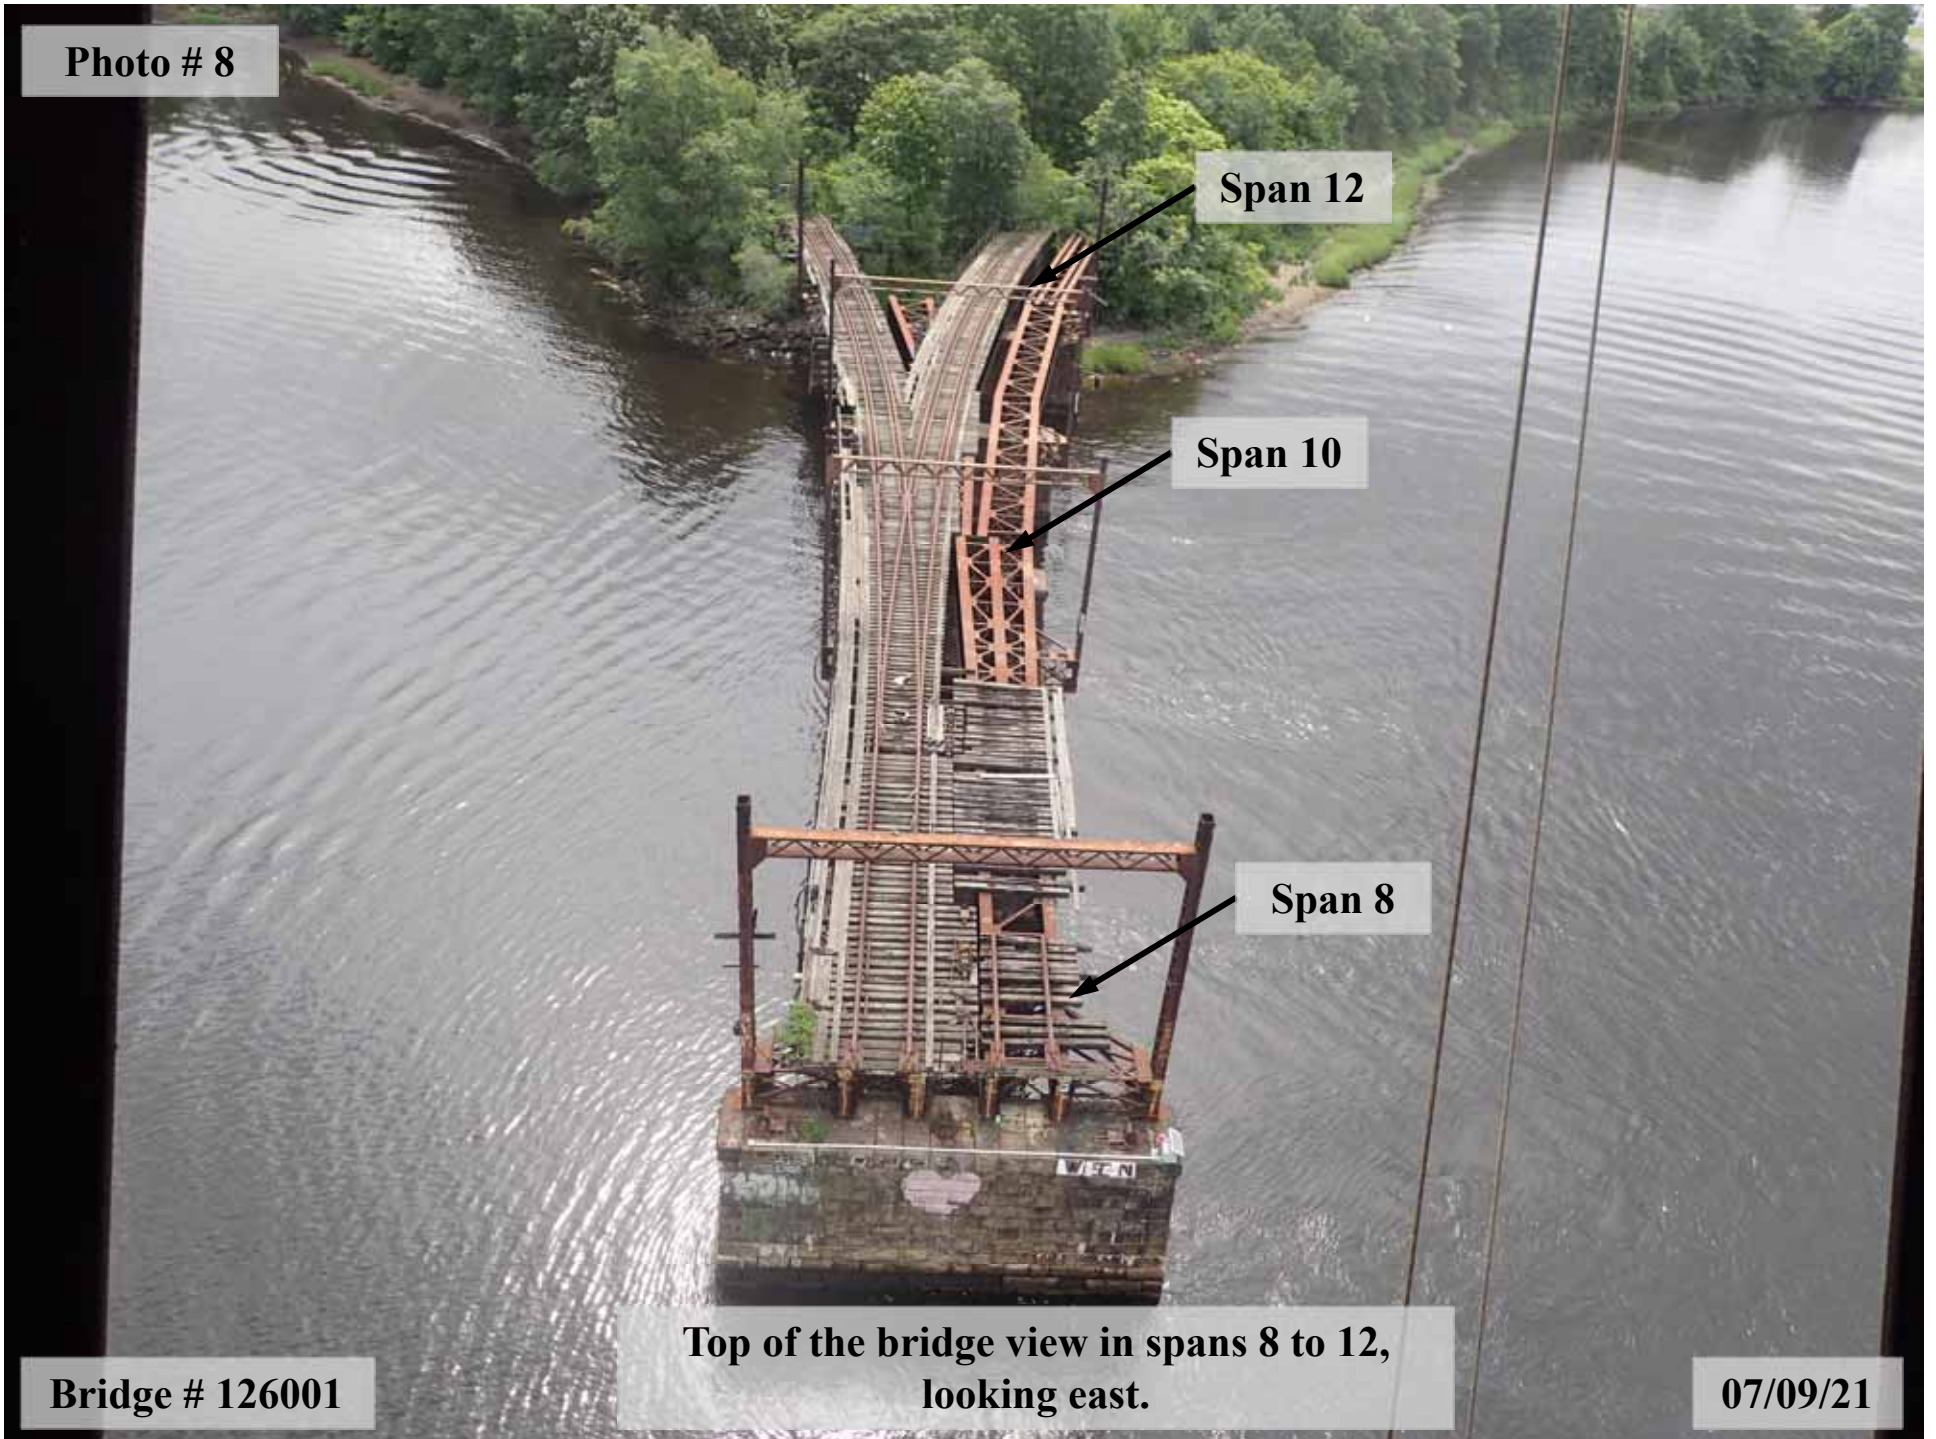
Photo # 8

**Top of the bridge view in spans 8 to 12,
looking east.**

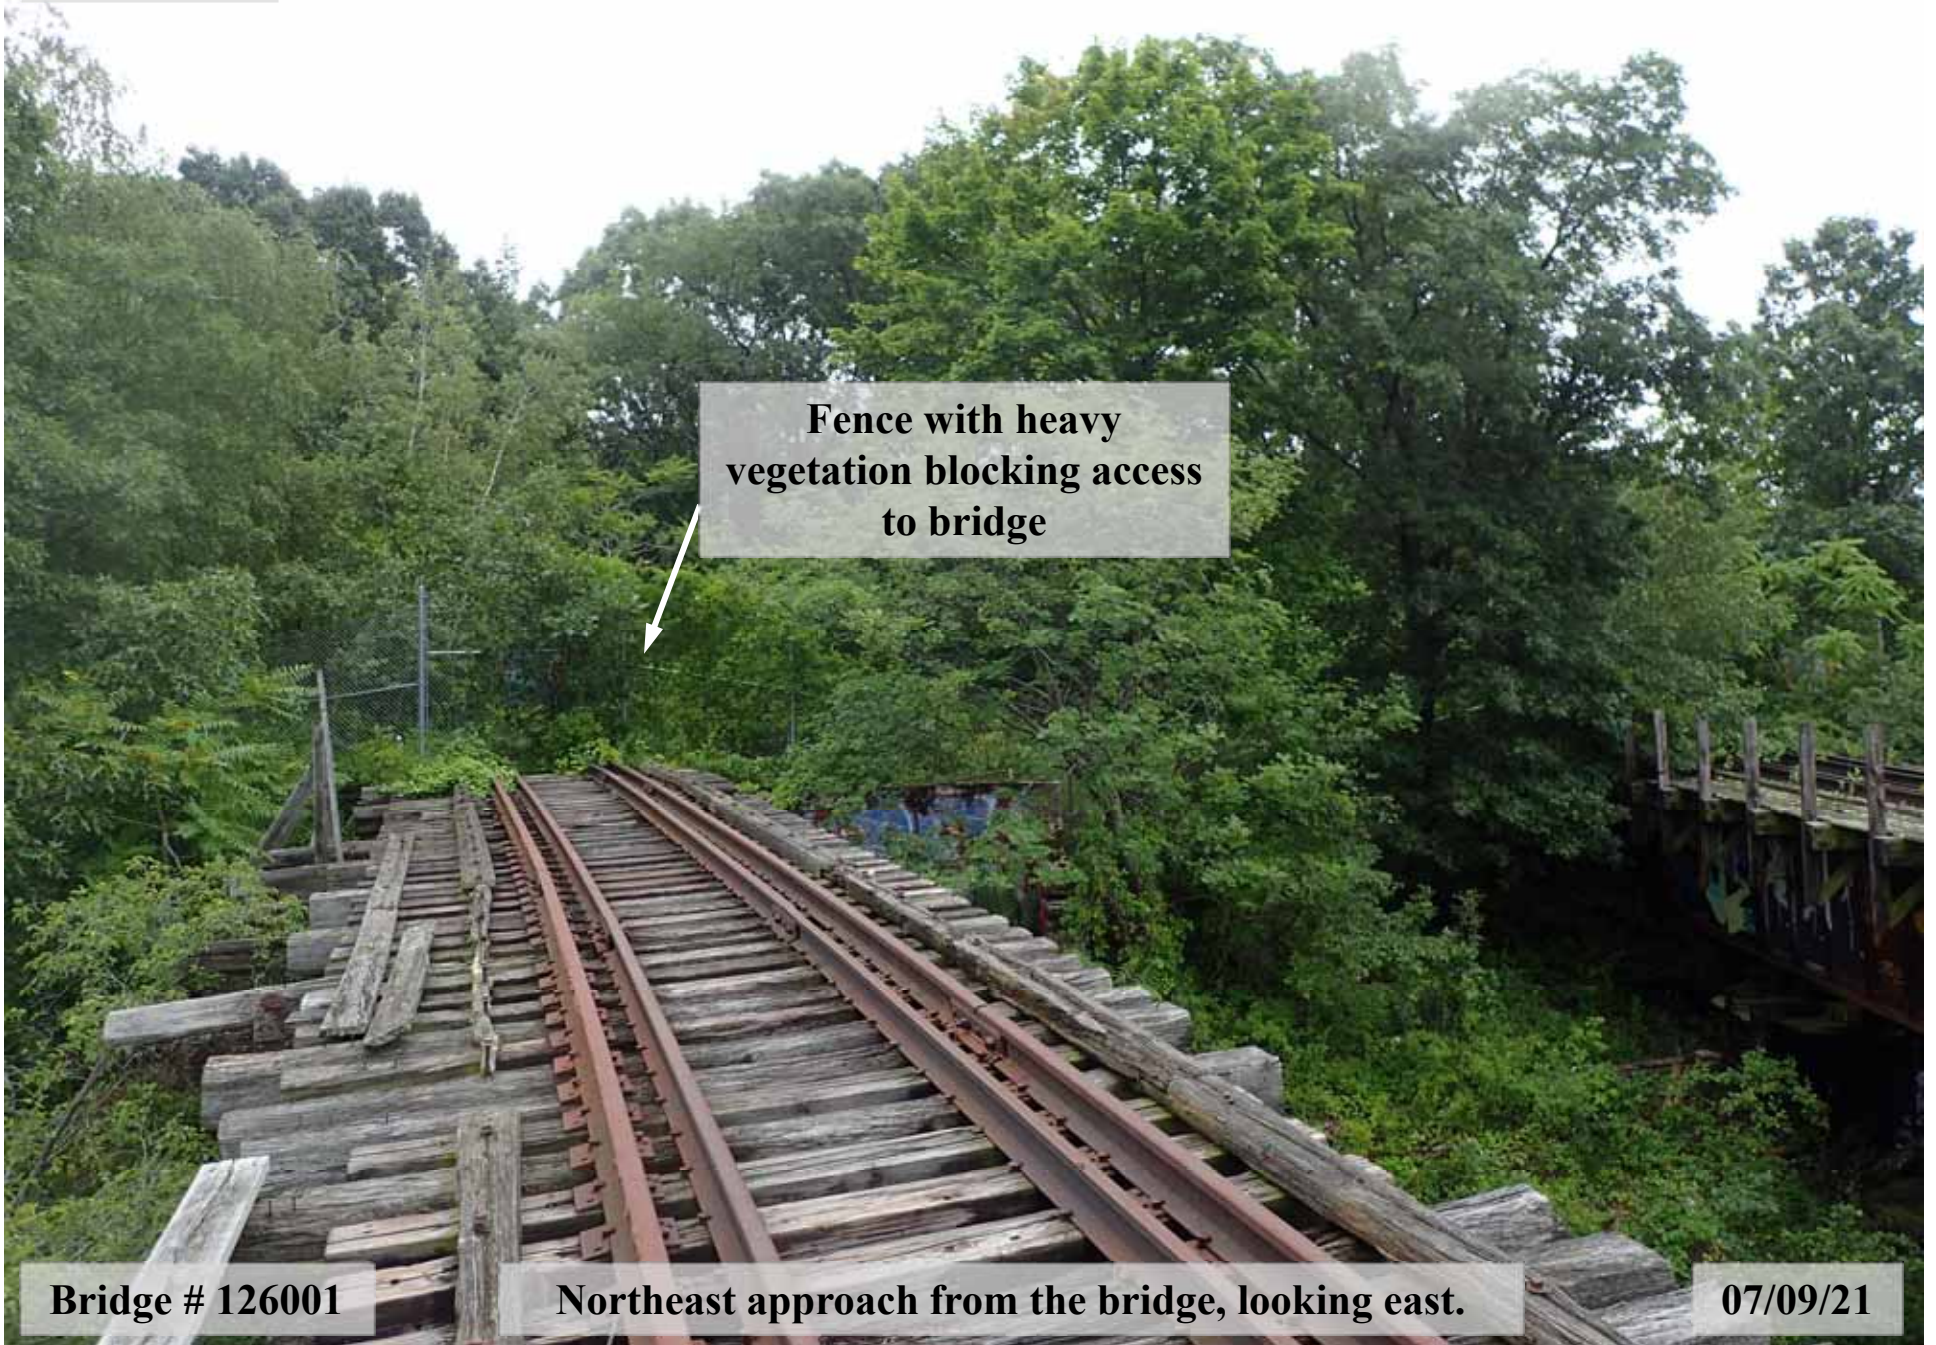
Photo # 9

**Fence with heavy
vegetation blocking access
to bridge**

Northeast approach from the bridge, looking east.

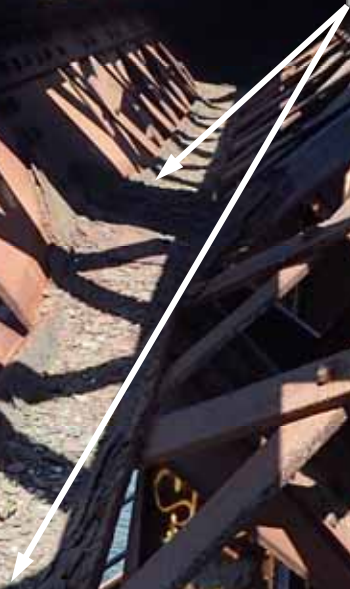
Photo # 54

**Heavy steel
delamination and
accumulation of debris**

**U1 horizontal member between trusses in span 7
lower west angle, looking north.**

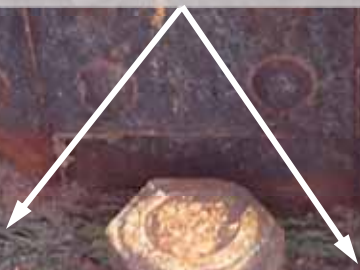
Photo # 98

**Section loss 3-1/2" long
x full width x 1/8" deep**

**West face of catwalk and rack southwest column at pier 5,
looking east.**

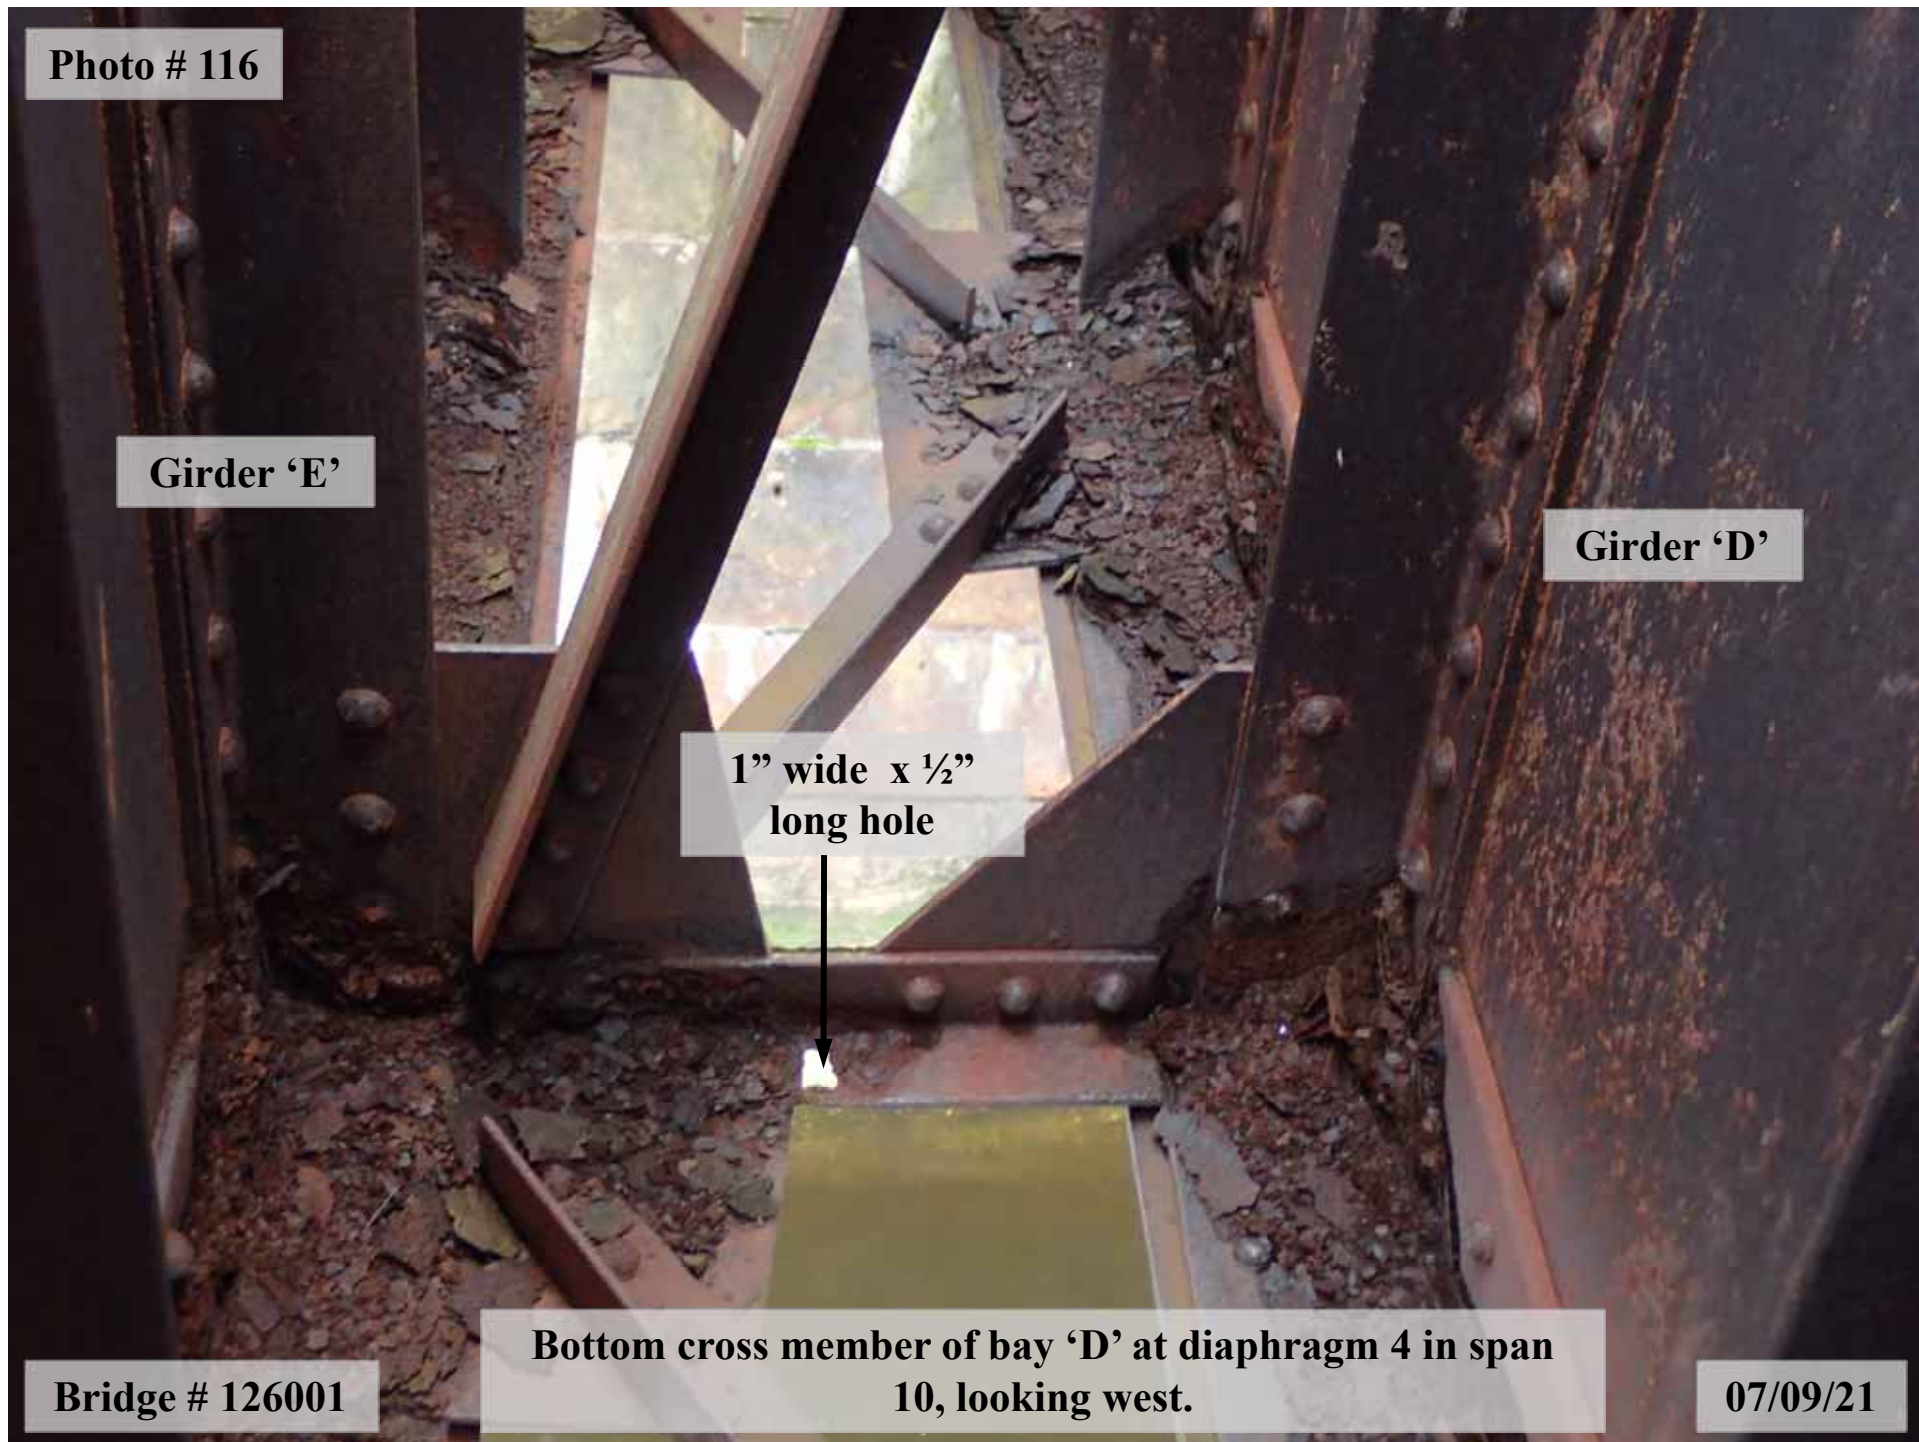
Photo # 117

Girder 'A'

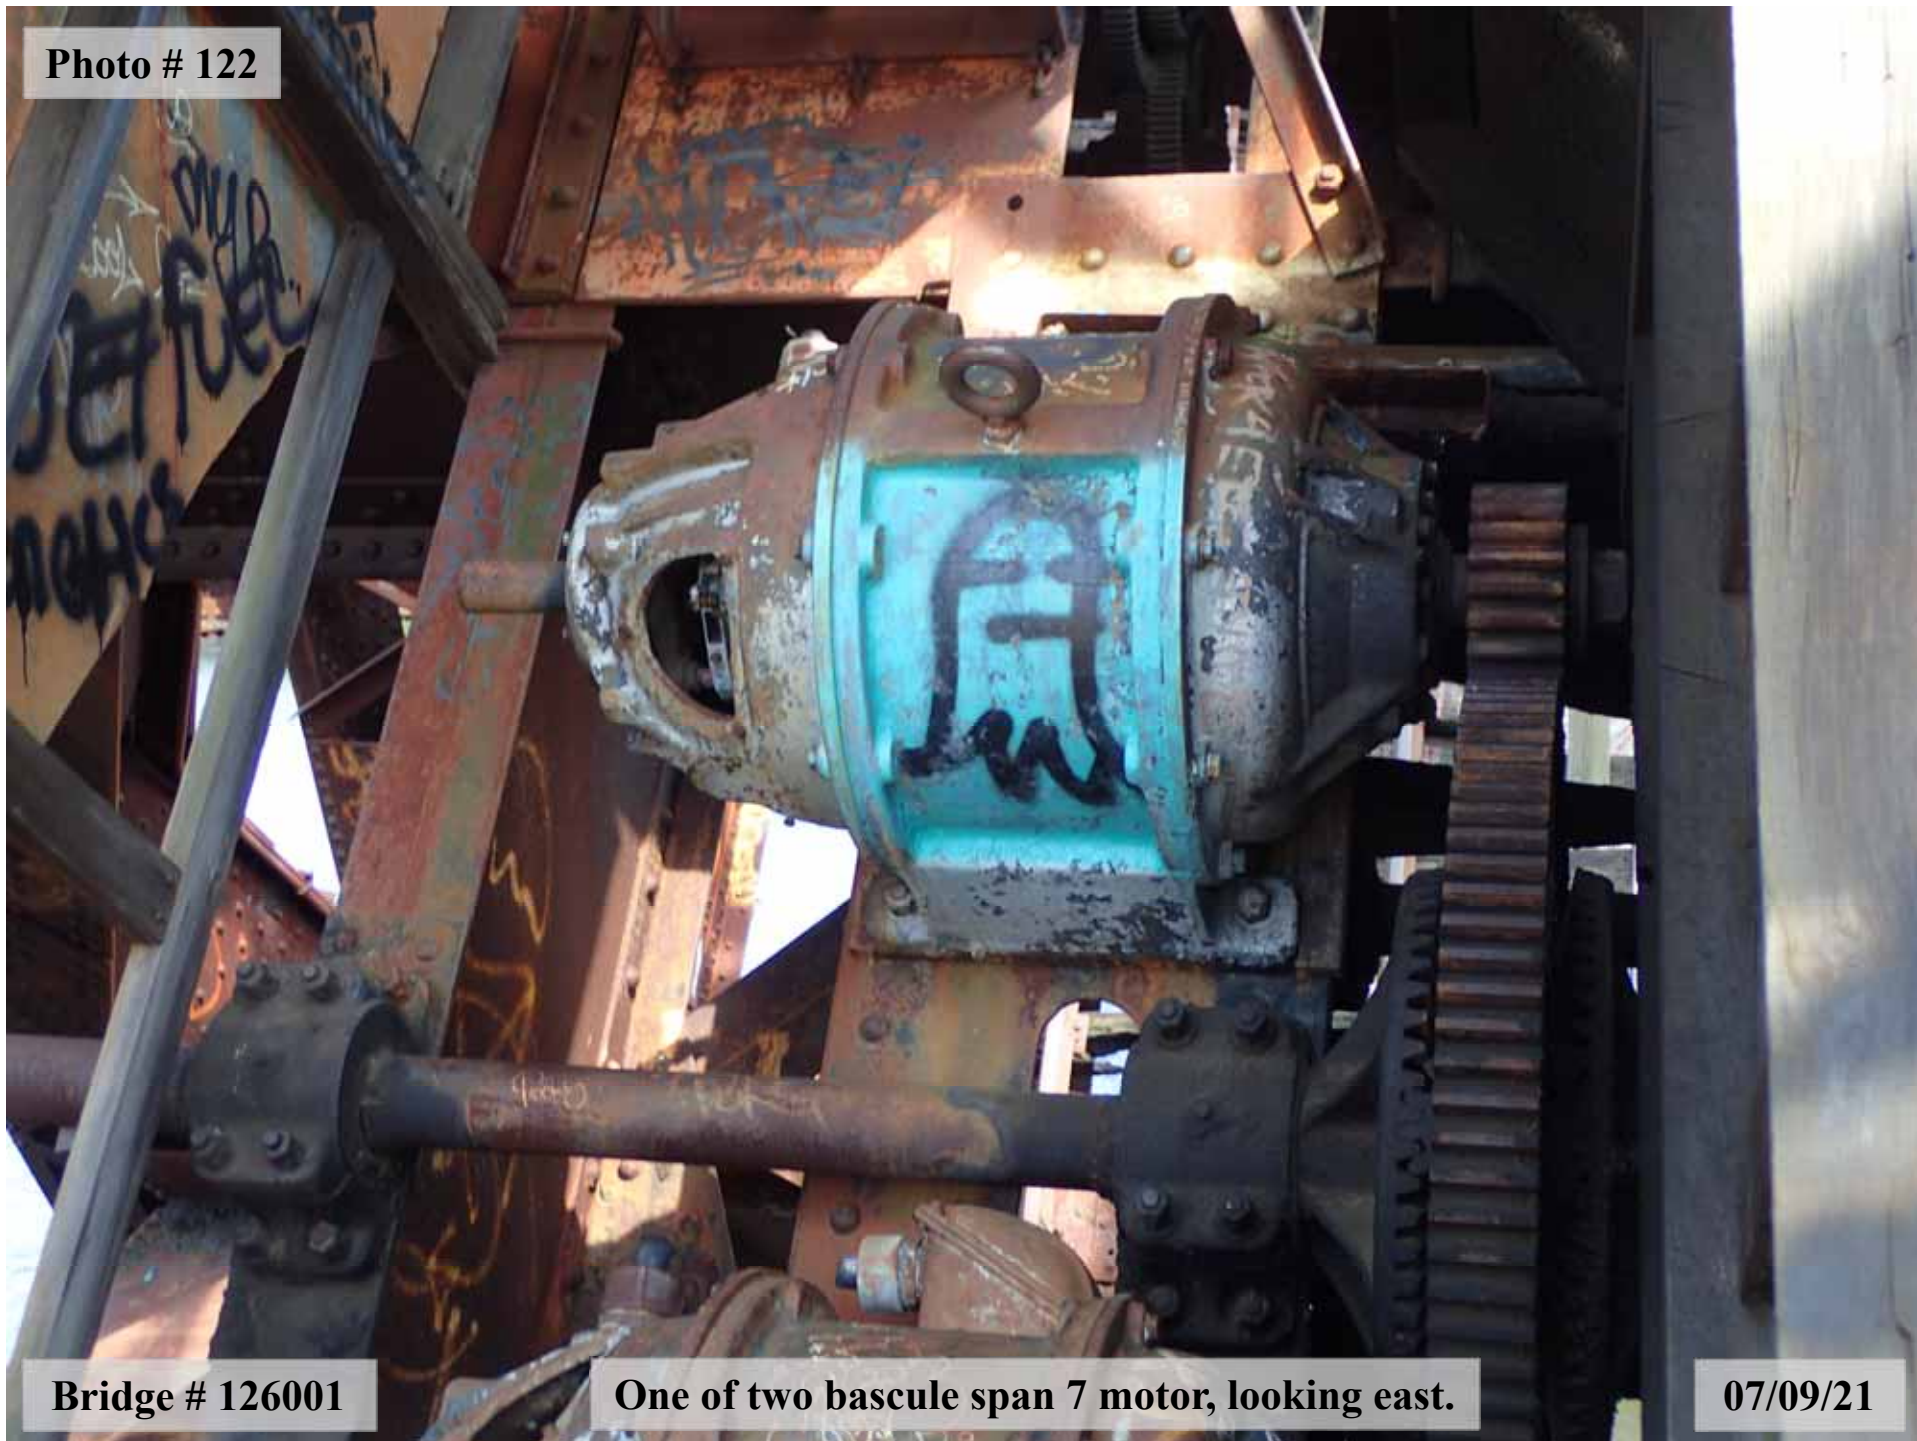
Photo # 122

One of two bascule span 7 motor, looking east.

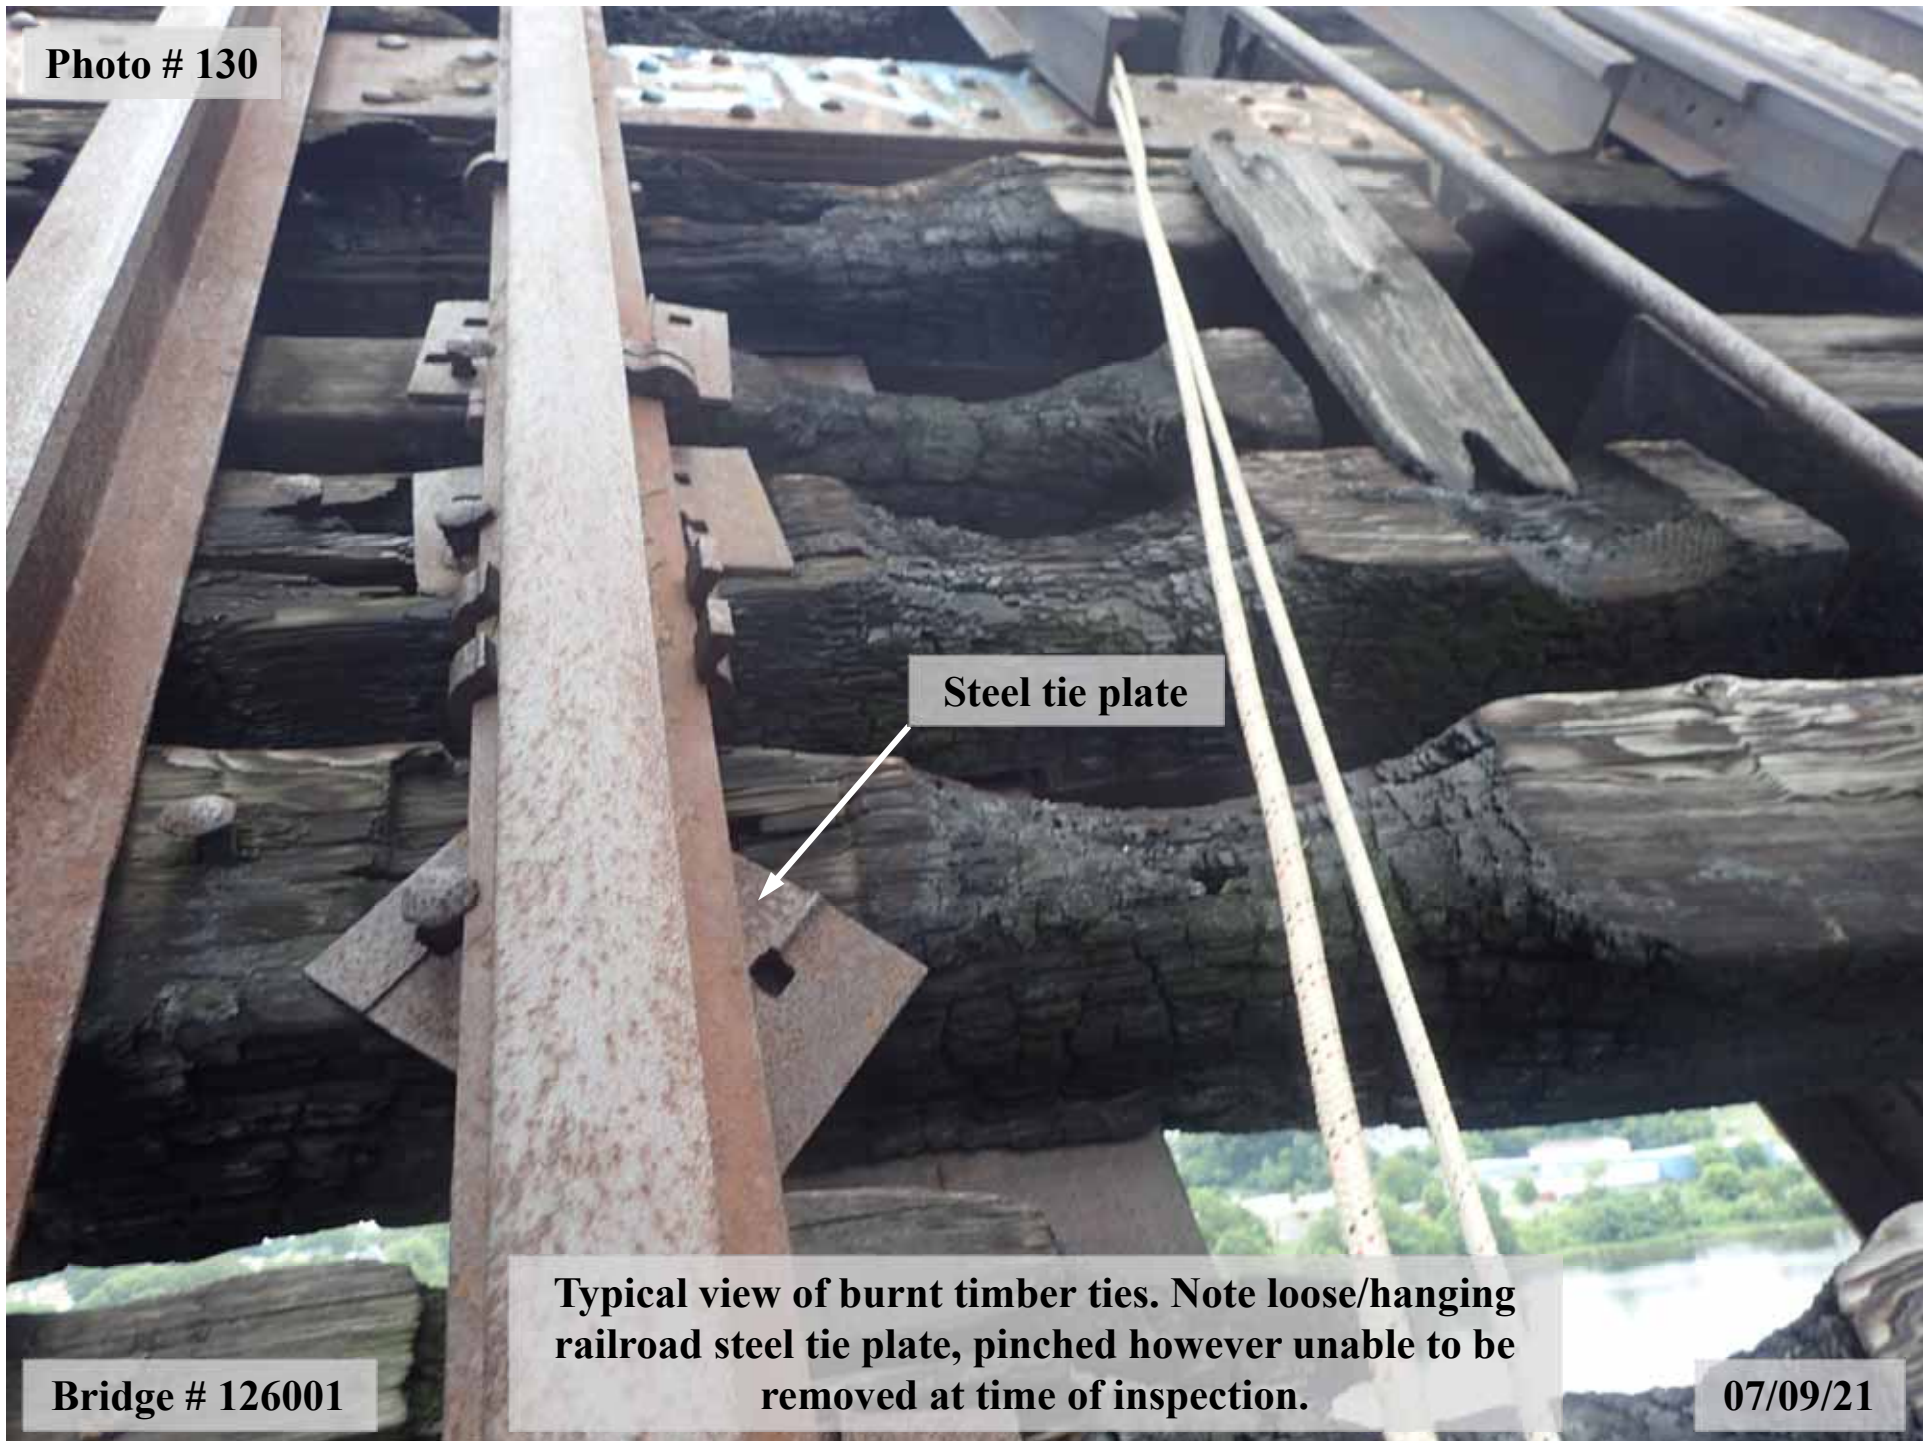
Typical view of burnt timber ties. Note loose/hanging railroad steel tie plate, pinched however unable to be removed at time of inspection.
